Accident to the ROBIN - DR400 – 160 registered F-GKQG and the ROBIN – DR400 – 120 registered F-GXJR on 05 June 2021 at Loudun (Vienne)

Loss of control during take-off, collision with an aeroplane parked in the parking area

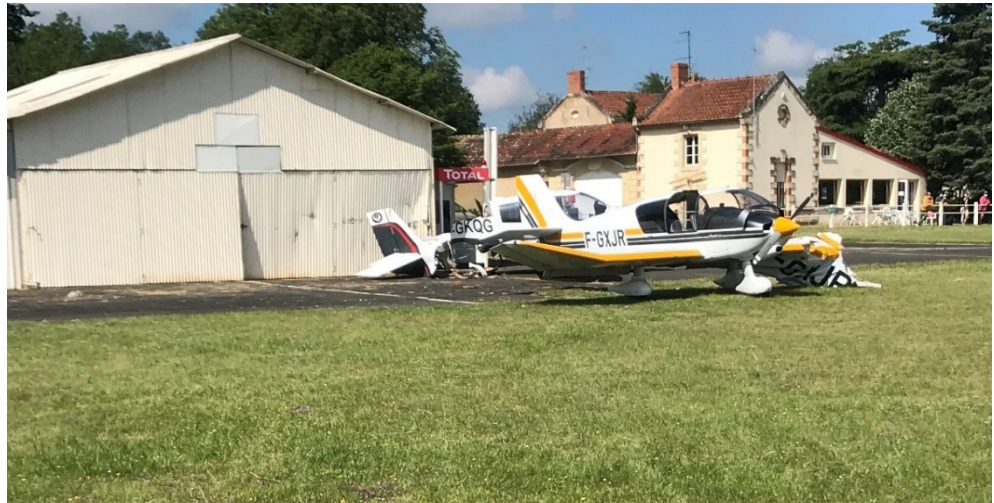
Figure 1: Accident site

The three occupants of the DR400-160 F-GKQG took off from Rennes airport (Ille-et-Vilaine) in the morning bound for Loudun aerodrome (Vienne) to have lunch there. A pilot change was made for the return flight in the afternoon. Take-off took place at about 15:30 from grass runway 26. The aeroplane rose a few metres and gradually deviated to the left. A few seconds later, it touched down again outside the runway and ran in a direction of 30° in relation to the runway centreline. It reached and crossed the flying club's parking area, where its right wing hit the left wing of the parked DR400 registered F-GXJR. A student and an instructor were preparing for start-up on board the parked aeroplane. The collision caused the parked aeroplane to rotate by 180 degrees and F-GKQG to rotate by 90 degrees. The elevator of F-GKQG struck the door of the hangar, and the trailing edge of its left wing struck the self-service refuelling station before the aeroplane came to a stop (see [Figure 1](#)).

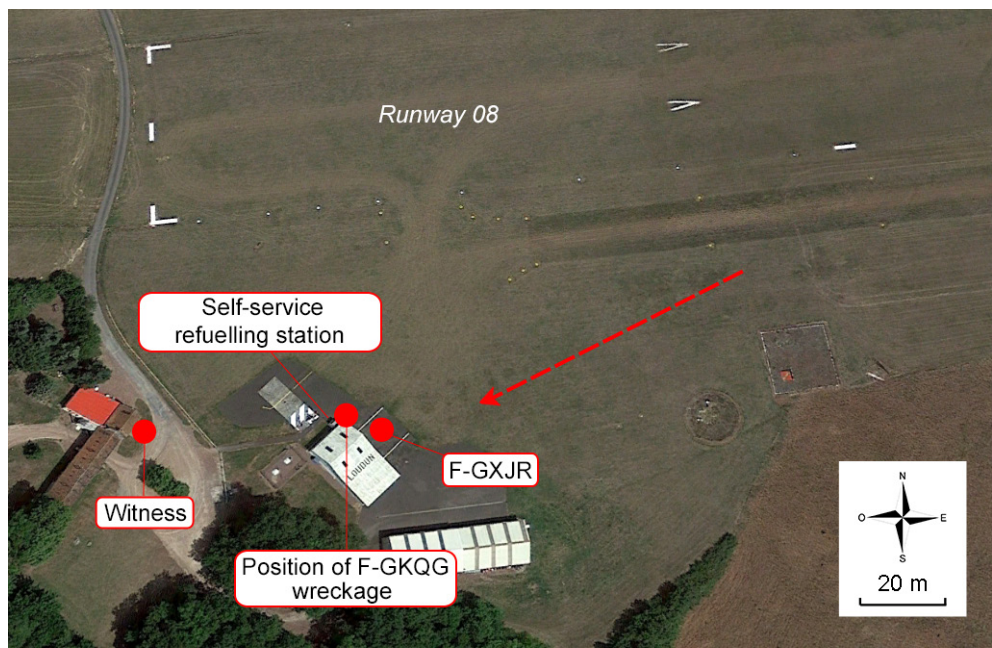
Figure 2: Diagram of the accident site

The DR400 registered F-GKQG was located in the parking area of the Aéroclub Loudunais, at a lateral distance of about 50 m from the threshold of runway 08 (see Figure 2). Run marks were observed at an angle of about 30° in relation to the runway, starting in the grass, through the signal area and continuing down to the wreckage. The spacing of the marks showed that the aeroplane had skidded during part of the run.

Approximate path of F-GKQG based on markings on the ground

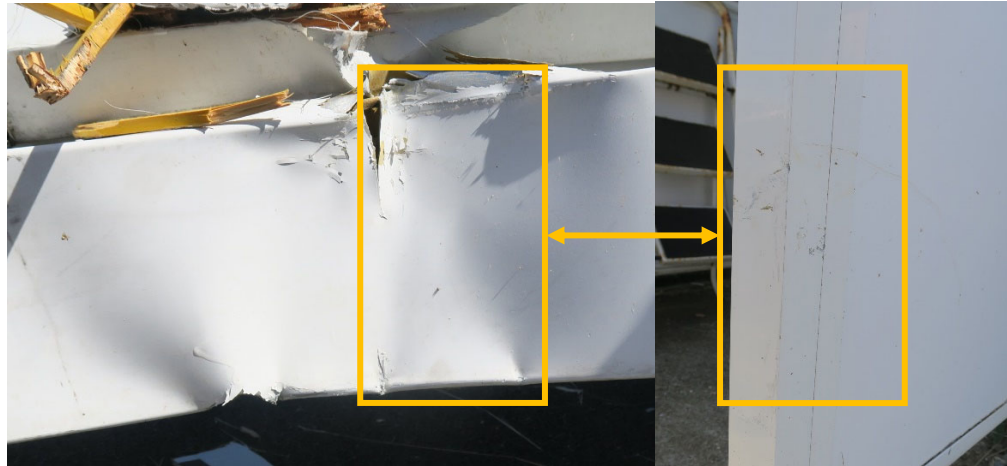
Figure 3: Damage to the left flap and impact marks on the self-service refuelling station

The fuselage was cut in two, approximately 50 cm aft of the wing's trailing edge, behind the cabin. The flaps were damaged.

The observed flap position, combined with the continuity of the control linkage, is consistent with the flap control lever⁽²⁾ locked in the fully extended position. The damage observed on the self-service refuelling station and the distortions found on the left flap confirm that the flaps were fully extended when they struck the refuelling station (see Figure 3).
