Accident to the ROBIN – HR 100/250 TR registered F-HRDM

on 12 June 2021
at Wambrechies (Nord)

Problem in cabin at take-off, turn-around, loss of control in turn, collision with ground, fire

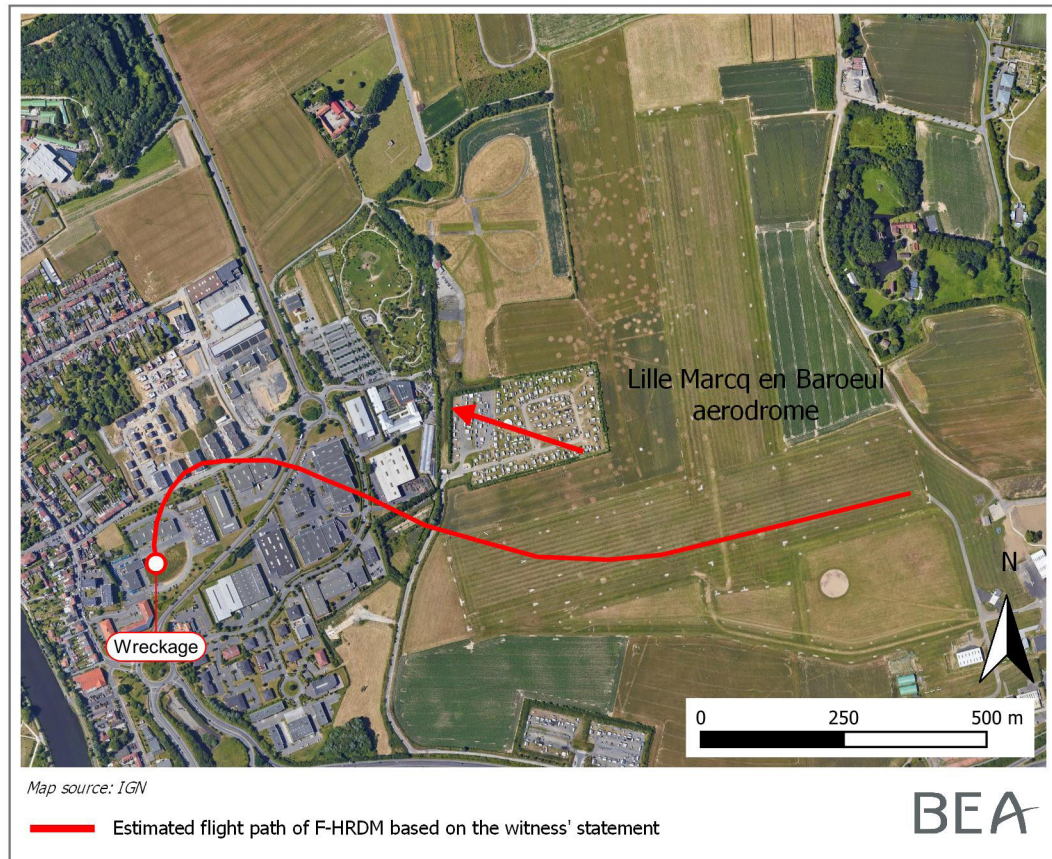
Figure 1: flight path of F-HRDM

On the day of the accident, after loading the luggage into the aeroplane's hold, they took off at 11:30 from runway 25 bound for Antwerp (Belgium). Shortly after take-off, the pilot announced over the frequency that he was going to land on the reciprocal QFU due to a problem⁽²⁾ in the cabin. The pilot initially made a right turn followed by a left turn, at a height of around 300 ft, with a bank angle of around 45° according to a witness on the ground. The pilot lost control of the aeroplane during the turn. The aeroplane collided with the ground a few seconds later and caught fire.

The accident site was located 1,300 m from the threshold of runway 25 and 170 m to the right of the runway axis.

The wreckage was not dispersed and was almost entirely burned. The aeroplane collided with the ground with a steep left bank angle and a nose-down attitude.
