Accident to the FLIGHT DESIGN – CTLS-ELA registered F-HVAT

on 18 June 2021

at Col des Prés, in the commune of Thoiry (Savoie)

Attempted turn-around before flying over a pass, collision with trees then with the ground, fire, in instruction

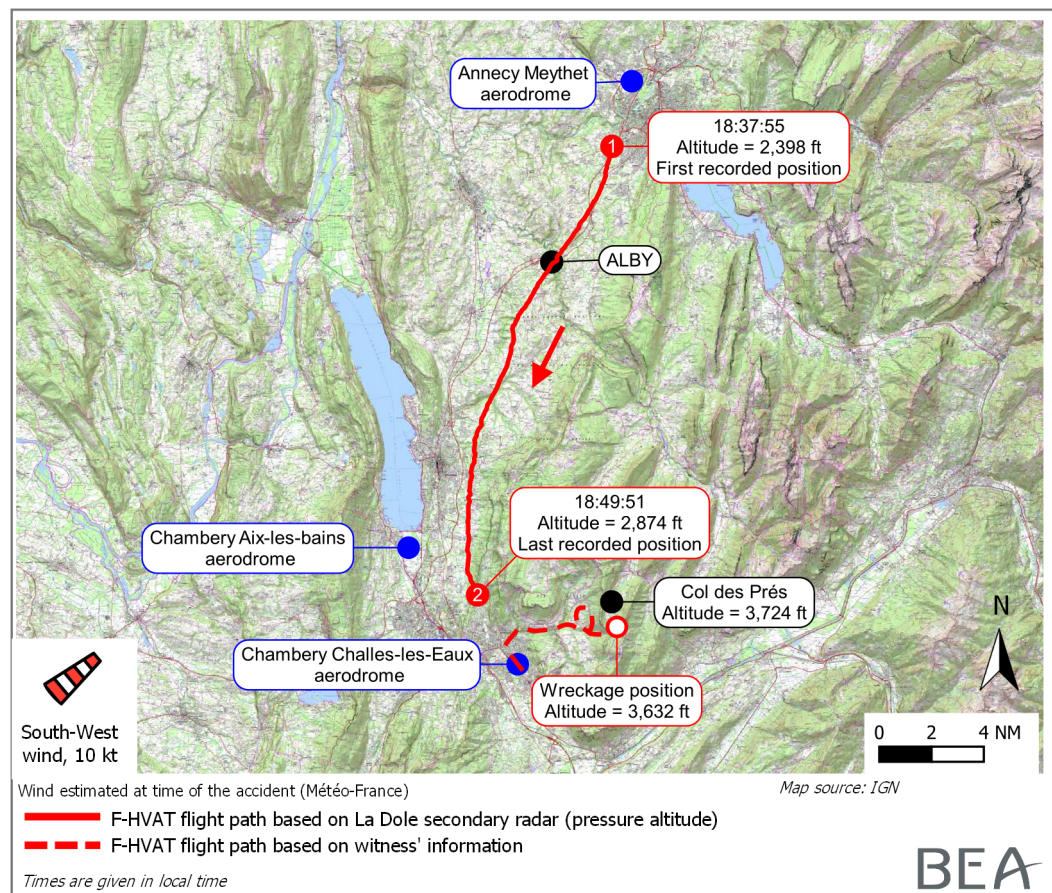
Figure 1: flight path of the aeroplane

The student-pilot, accompanied by an instructor, took off at 18:27 (see [Figure 1](#)) from Annecy-Meythet aerodrome (Haute-Savoie). After two aerodrome circuits, including one at low height, the instructor announced to the air traffic controller their intention to head towards Chambéry - Challes-les-Eaux aerodrome (Savoie) passing via ALBY⁽³⁾ (see [Figure 1](#)) and to return approximately 45 minutes later.

A security camera at Chambéry - Challes-les-Eaux aerodrome recorded the landing of the aeroplane on runway 32 at 18:56. Two minutes later, the camera recorded the aeroplane taxiing on the Bravo taxiway to runway 32, followed by a take-off at 19:00 (see [Figure 1](#)).

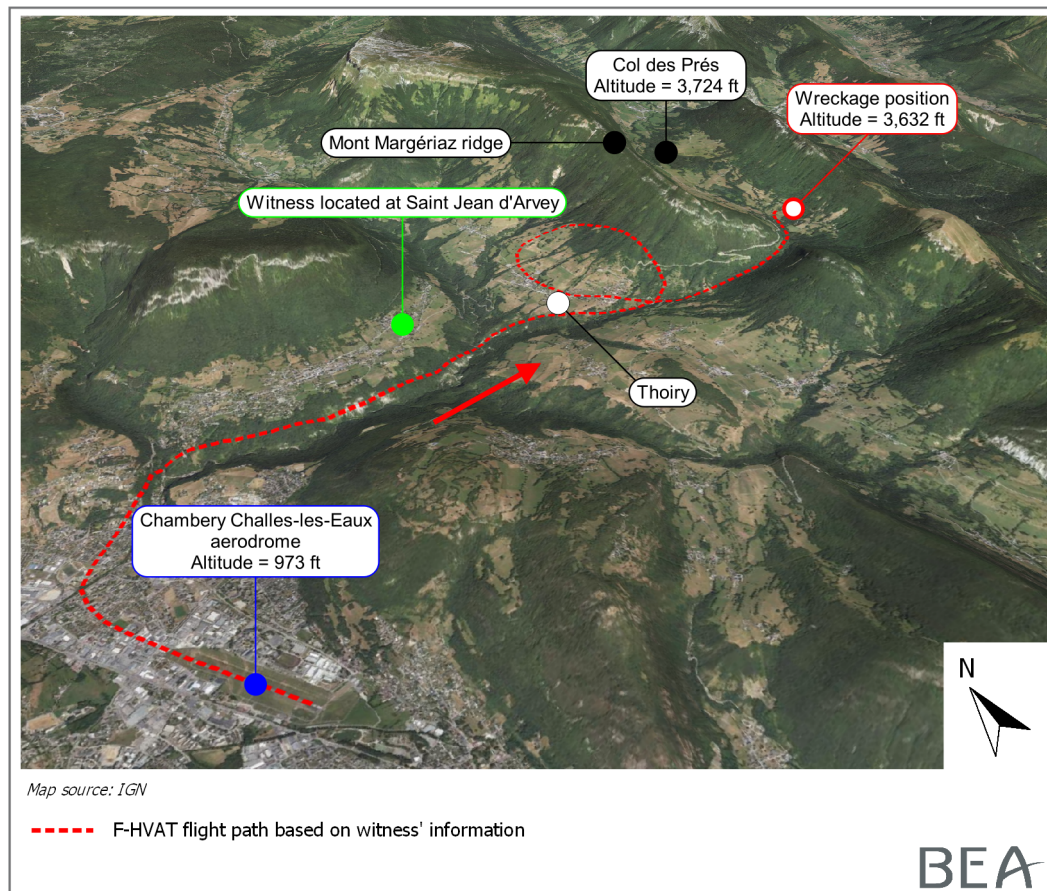
Figure 2: final path of the flight according to the statements

Shortly after 19:00, a witness who lived at Saint-Jean-d'Arvey (Savoie) saw an aeroplane coming from the direction of Chambéry - Challes-les-Eaux and heading towards Col des Prés pass in the Bauges Mountains. He saw the aeroplane make a full left turn in the vicinity of the commune of Thoiry before heading back towards the pass (see [Figure 2](#)). He thought that the aeroplane had been lower than he was used to seeing. He specified that he had not seen any other aeroplanes at around 19:00.

Shortly after 19:00, several groups of witnesses who were in the vicinity of Col des Prés pass (see [Figure 3](#)) saw the aeroplane flying low, at a height of several tens of metres above the trees in the centre of the valley and heading towards Col des Prés pass. A witness who had been driving her car down the pass towards Chambéry saw the aeroplane make a right turn at low height. The different witnesses all stated that a few seconds after they had seen the aeroplane fly past, they heard a loud noise and then saw smoke.

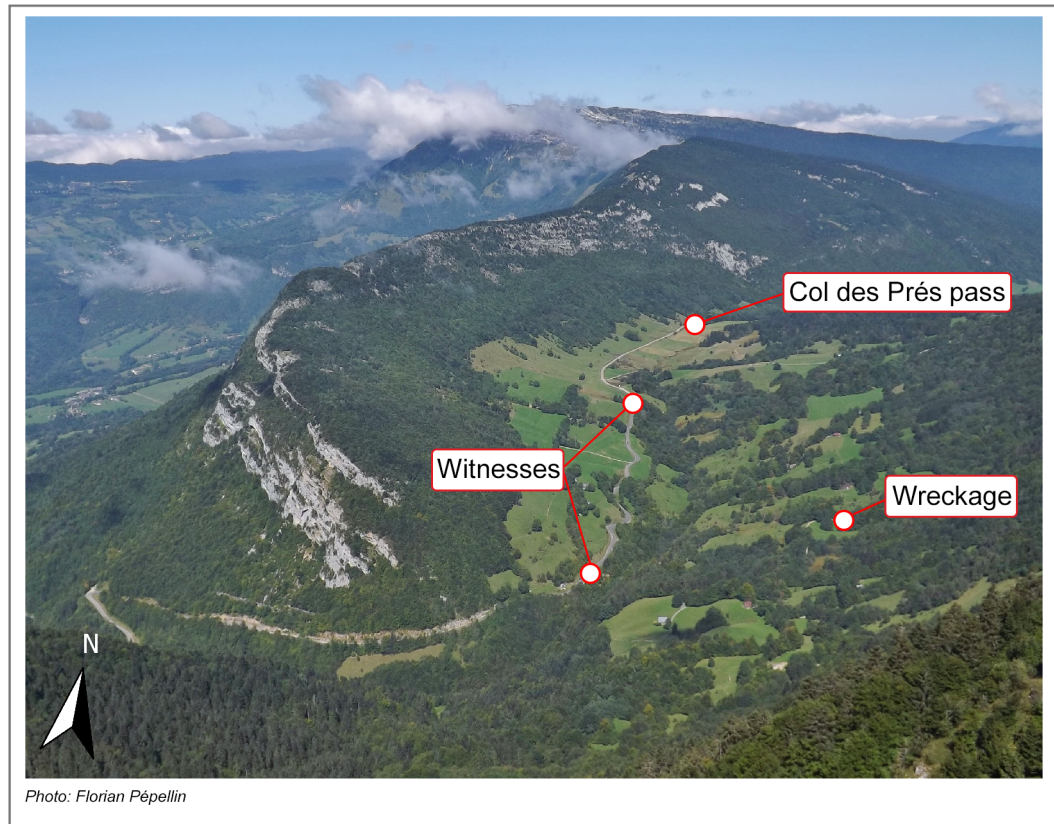
Figure 3: view of Col des Prés pass and location of the wreckage

The wreckage was located in an area of pastures, at an altitude of 3,632 ft (approximately 1,100 m), around 1.5 km below Col des Prés pass which is at an altitude of 3,724 ft (approximately 1,135 m). Due to the vegetation, the area is not really suitable for a forced landing (see [Figure 3](#)). The bottom of the valley from Thoiry towards Col des Prés pass has an upward slope of approximately 6 to 9%.

In the afternoon of the accident, glider pilots were flying over the western slope of Margériaz ridge, on the other side of the ridge with respect to Col des Prés pass (see [Figure 3](#)). According to their statements, the wind, calm at ground level, picked up at around 1,200 m blowing from the south west. They specified that the gliders had been climbing very steeply with a rate of climb of approximately 3-4 m/s. They estimated that there would have been downdrafts on the eastern slope (corresponding to the valley leading to Col des Prés pass), downwind of the terrain.

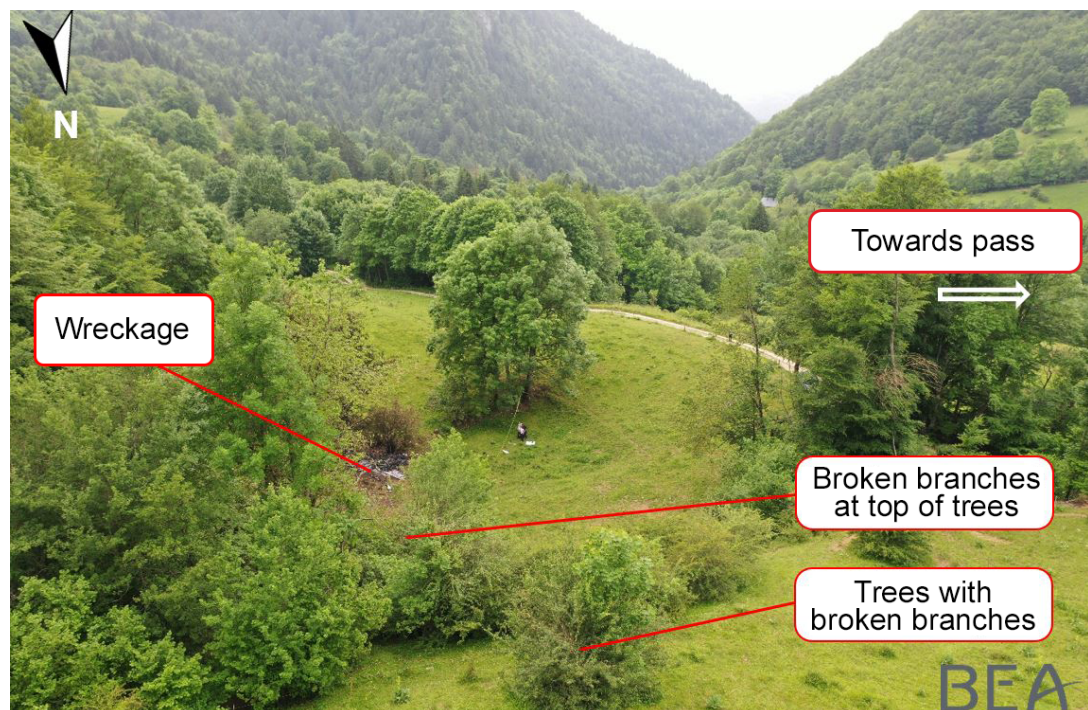
Figure 4: accident site

The aeroplane was completely destroyed in the fire that broke out after impact.

The examination of the site and marks in the vegetation indicated that the right wing had very likely struck trees during a right turn (see Figure 4). The aeroplane turned over on contact with the vegetation and before collision with the ground.

Probably realising, after bypassing the ridge, that the aeroplane's altitude was not sufficient to clear the pass, the pilots attempted a right-hand turn-around during which the aeroplane collided with the vegetation then the ground. A fire broke out immediately on impact.

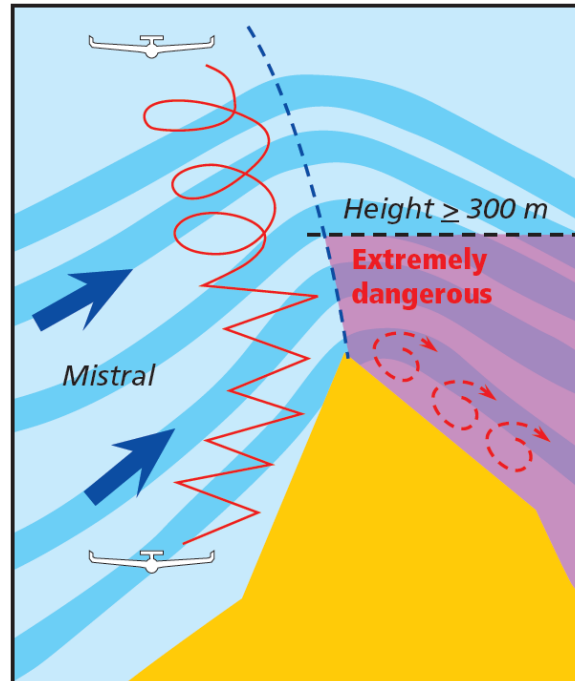
Figure 5: illustration of downdrafts downwind of the terrain

- The turn radius of a light aeroplane increases with altitude as the difference between the true speed and the indicated air and ground speeds also increases. It is therefore advisable for pilots to always fly along the side of a valley in order to be able to easily perform a turn-around, if possible into the wind to avoid turbulence downwind of the terrain (see Figure 5), and on the sunny side to ensure optimum lift.

- Flying the aeroplane in the centre of the valley:
 - reducing the possibilities of turning around;
 - potentially restricting the climb performance of the aeroplane that was downwind of the crest, in the presence of downdrafts and possibly in the shade.
