## Accident to the LA MOUETTE - ORYX (P) identified 31RS

on 29 July 2021

at Fousseret (Haute-Garonne)

### Loss of control after take-off, collision with the ground

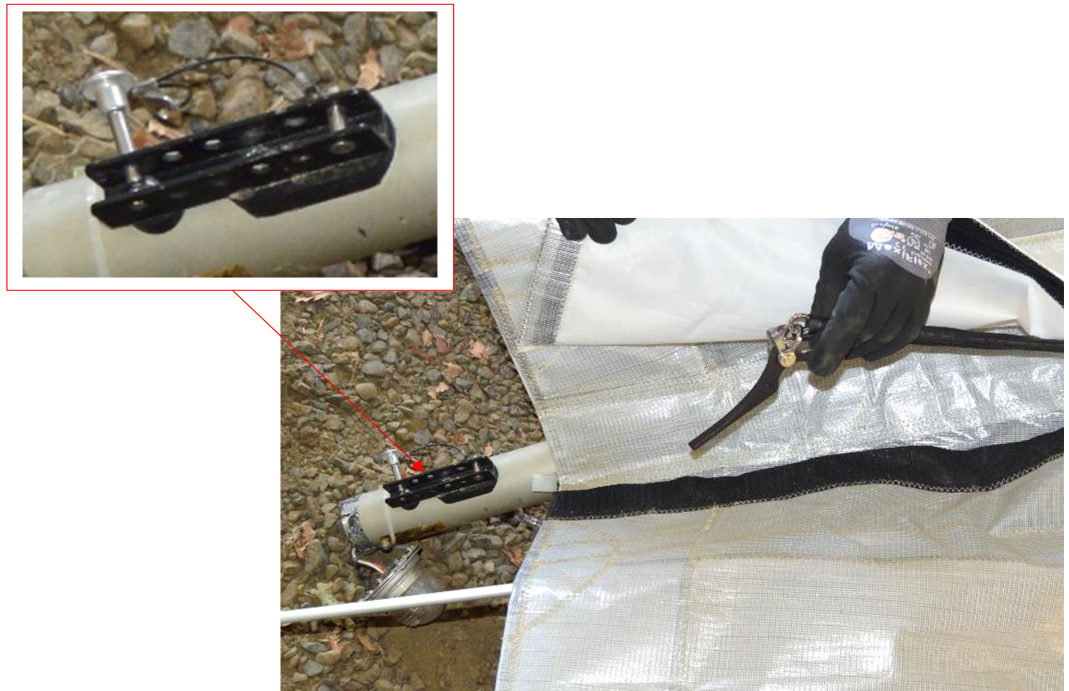
Figure 4: Tautening system as it was found on the wing

The Xbar was not taut. The hook was not in place in the rear hanger. The tautening system components were not damaged. The ball pin securing the hook in the hanger was partially inserted in drill-hole 6R (see [Figure 2](#)). This position does not hold the tautening system in place.

A few days before the accident, the pilot performed a maintenance operation to replace a batten on the right wing. To do this, he handled the rear tautening system of the wing. It is likely that he did not remove the wing from the trike. After replacing the batten, when he tautened the wing, he did not put the hook and the ball pin back into position.

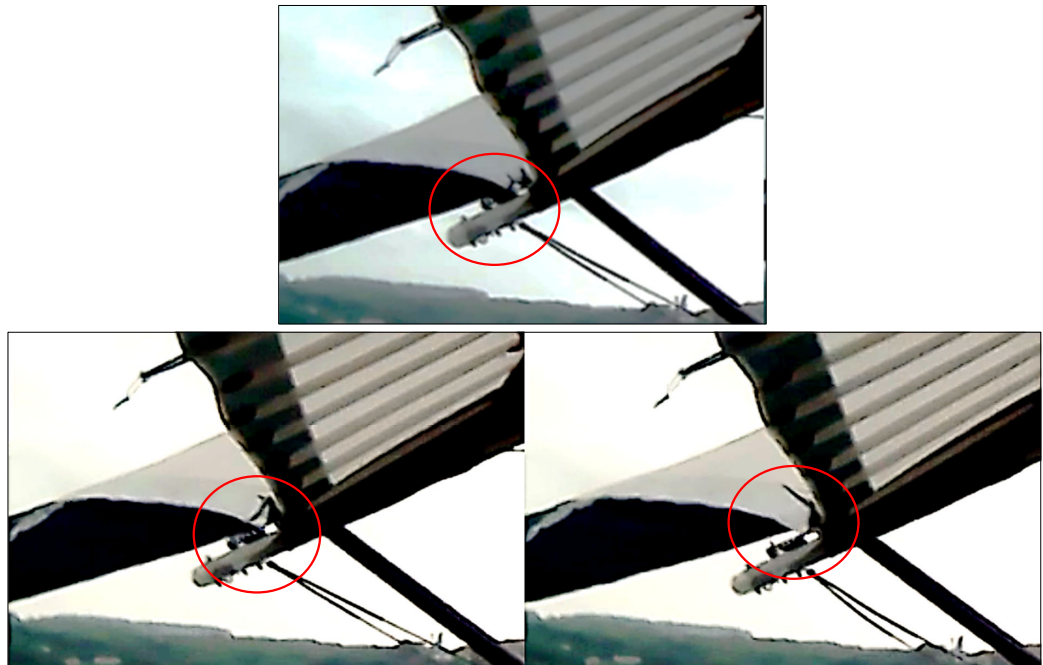
Figure 5: Tautening system at time T not in place (excerpt from the video)

Figure 5 shows, image by image, the movement of the tautening hook and its lever which can be seen moving forwards.

T-20 s	The pilot applies power, the microlight accelerates ❶.
T-12 s T-1 s	The acceleration seems normal during the take-off run, the microlight takes off and climbs, there is nothing unusual about the initial climb.
T  T+5 s	The wing deforms and folds very suddenly ❷, the trike oscillates (swings under the sail), the pilot loses control, the microlight starts to quickly descend towards the ground, the engine rating is constant.  When the wing deforms, the hook is not in position in the rear hanger.
T+6 s	The trike strikes the ground ❸.

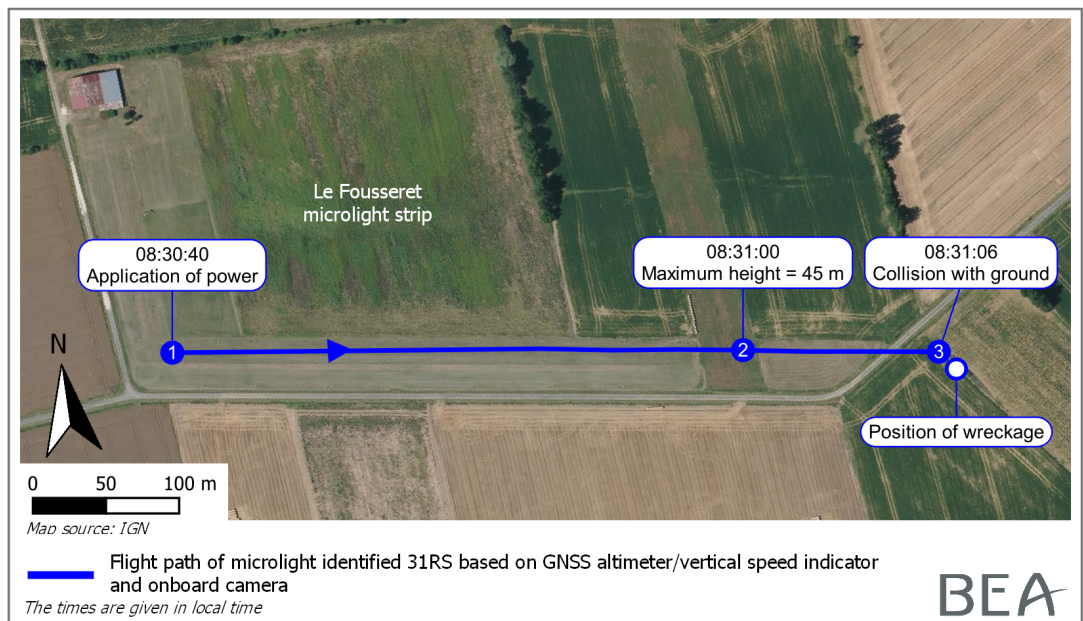
Figure 6: Path of 31RS

During the first flight following this operation, with the rear tautening system device not in position, the pilot took off in 31RS and rose to a height of 45 m. The force of the air on the leading edges of the wing caused it to partially fold. The trike swung then the microlight descended rapidly. The pilot tried to push on the control bar but was unable to control the descent. The microlight struck the ground.
