## **Serious incident** to the AIRBUS A320

Registered **9H-EMU**

On 23 May 2022

**Incorrect QNH information, RNP approach with LNAV/VNAV minima conducted below the descent profile, near CFIT, go-around performed at low height before the runway without visual references, second approach performed below descent profile**

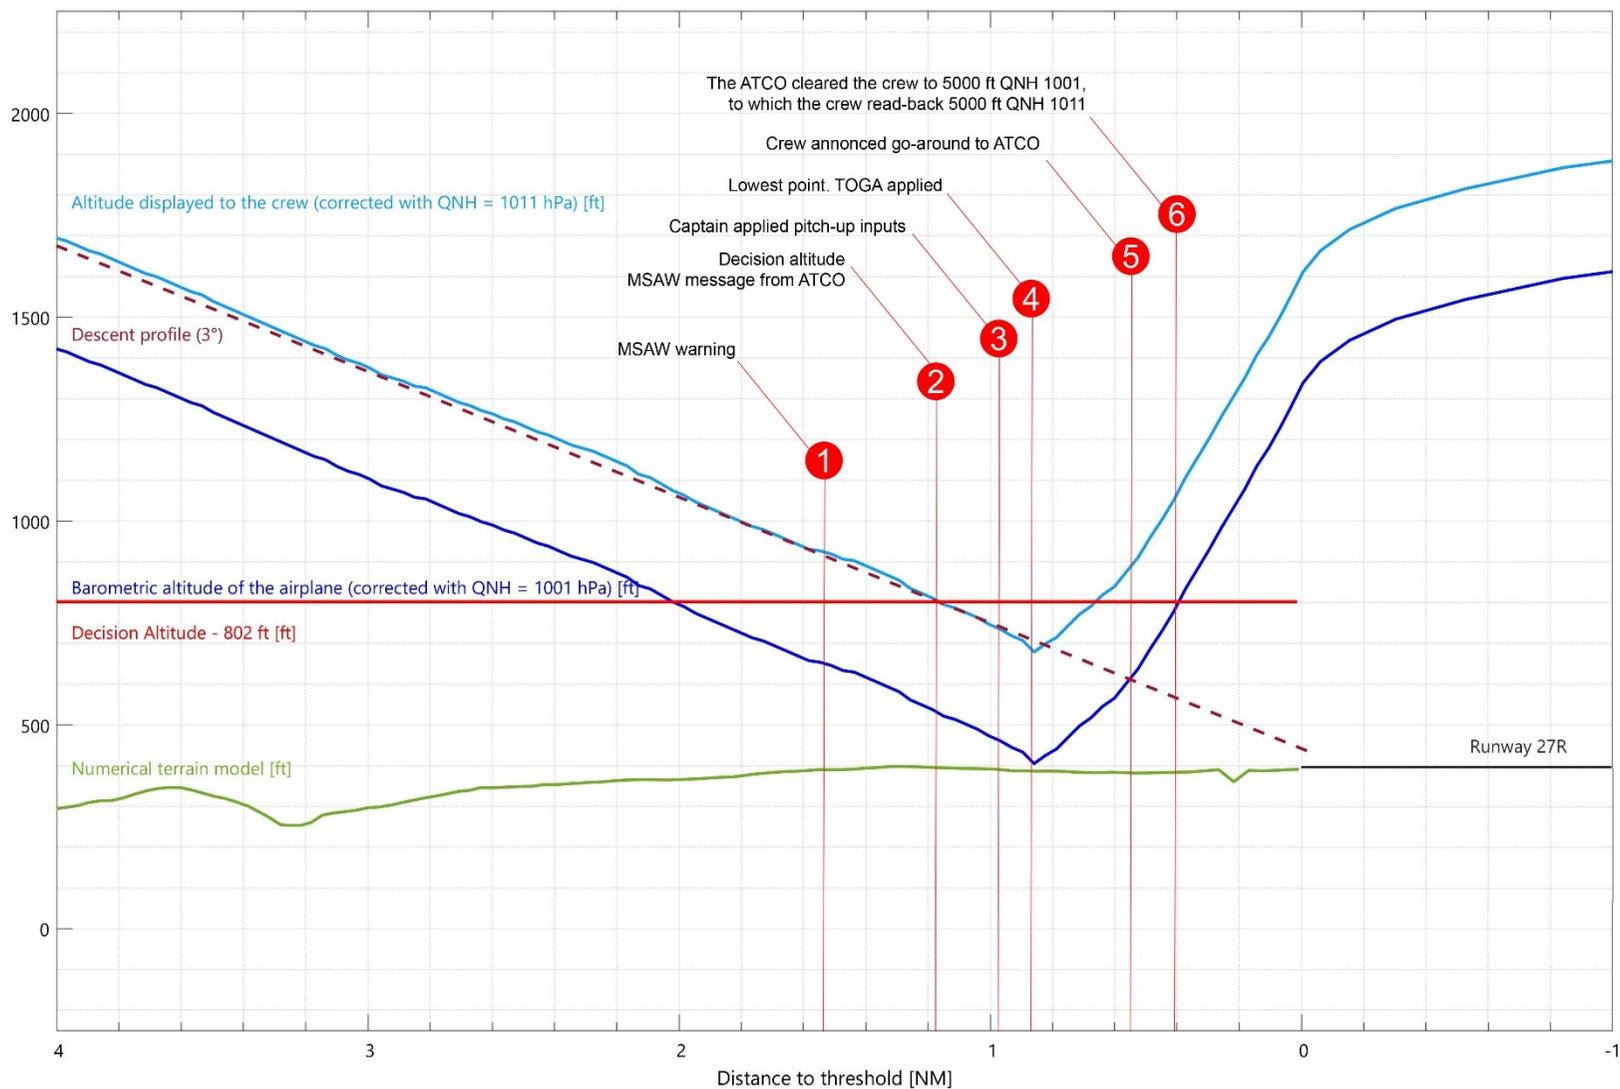
Figure 1: First approach profile, flight path computed from recorded flight parameters (source: BEA)

At 11:41:32, the ground Minimum Safe Altitude Warning (MSAW) was triggered (Point 1 Figure 1). The aircraft was at an indicated altitude of 891 ft QNH 1011 (617 ft QNH 1001, 200 ft RA), at 1.53 NM from the runway threshold.

At 11:41:41, at 1.2 NM from the runway threshold, and with a vertical speed of -717 ft/min, the aircraft passed the indicated altitude of 802 ft QNH 1011 (537 ft QNH 1001, 122 ft RA), which corresponded to the Decision Altitude<sup>6</sup> (DA) for the crew (Point 2 Figure 1).

At the same time (11:41:41), nine seconds after the MSAW was triggered, the LOC N advised the crew, “*Red Nose 4 3 1 1, I just had a ground proximity alert, are you okay? Do you see the runway?*” (Point 2 Figure 1).

At 11:41:47 and during the controller's message, at an indicated altitude of 735 ft QNH 1011 (461 ft QNH 1001, 52 ft RA), and at 1 NM from the runway threshold, the AP was disengaged, and the captain pitched up (Point 3 Figure 1).

Three seconds later, at 11:41:50, at an indicated altitude of 679 ft QNH 1011 (405 ft QNH 1001), the minimum radio-altimeter height was recorded at 6 ft above the ground. The aircraft was 0.8 NM from the runway threshold. At the same time, the captain moved the thrust levers forward into the TOGA detent (Point 4 Figure 1).

At 11:42:00, the flight crew announced to the controller that they were going around (Point 5 Figure 1). He replied, *"Roger Red Nose 4 3 1 1, turn right on heading 3 6 0 and climb altitude 5,000 ft, 1 0 0 1."* The crew read back with the previous incorrect QNH, which was not noticed by the LOC N, *"3 6 0 and climb 5,000 ft on 1 0 1 1, Red Nose 4 3 1 1"* (Point 6 Figure 1).

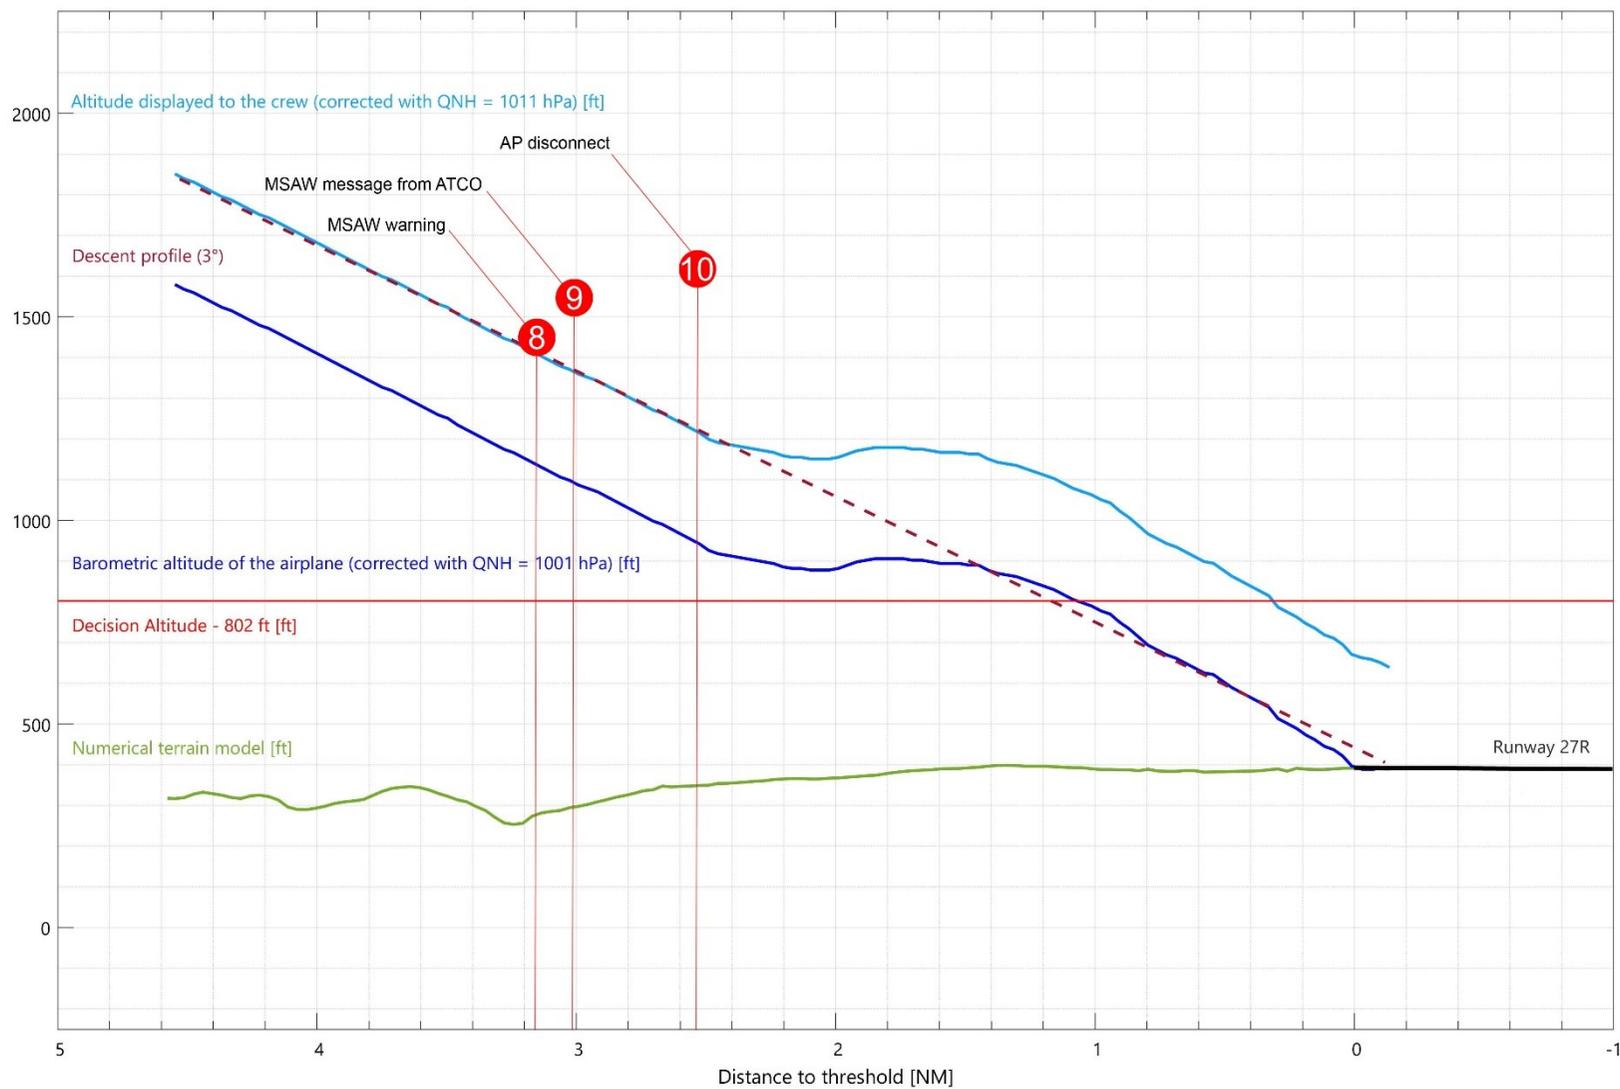
Figure 3: Second approach profile, flight path computed from recorded flight parameters (source: BEA)

*The aircraft continued to fly with an incorrect altimeter setting. Neither the crew nor the controllers were aware of the incorrect QNH setting which again put the aircraft around 280 ft below the published descent profile.*

At 11:55:43, a new MSAW was triggered (Point 8 Figure 3). The aircraft was at an indicated altitude of 1,403 ft QNH 1011 (1,131 ft QNH 1001, 842 ft RA), and at 3.1 NM from the runway threshold.

Four seconds later, the LOC N controller (who was the LOC-N assistant for the first approach) advised the crew of the MSAW warning, “Red Nose 4 3 1 1, I just got a ... a terrain alert, are you okay?” (Point 9 Figure 3).

At 11:56:00 at an indicated altitude of 1,227 ft QNH 1011 (954 ft QNH 1001, 572 ft RA), and at 2.54 NM from the runway threshold, the PF applied a nose up input on his sidestick. Simultaneously, the AP disconnected. Flight Directors (FD) were switched off eight seconds later.
