**Accident** to the HUMBERT AVIATION - TETRAS 912 CS  
identified **88SY**  
on Sunday 26 May 2024  
at Saint-Oger

**Steep banked turn in descent, collision with vegetation  
and then the ground**

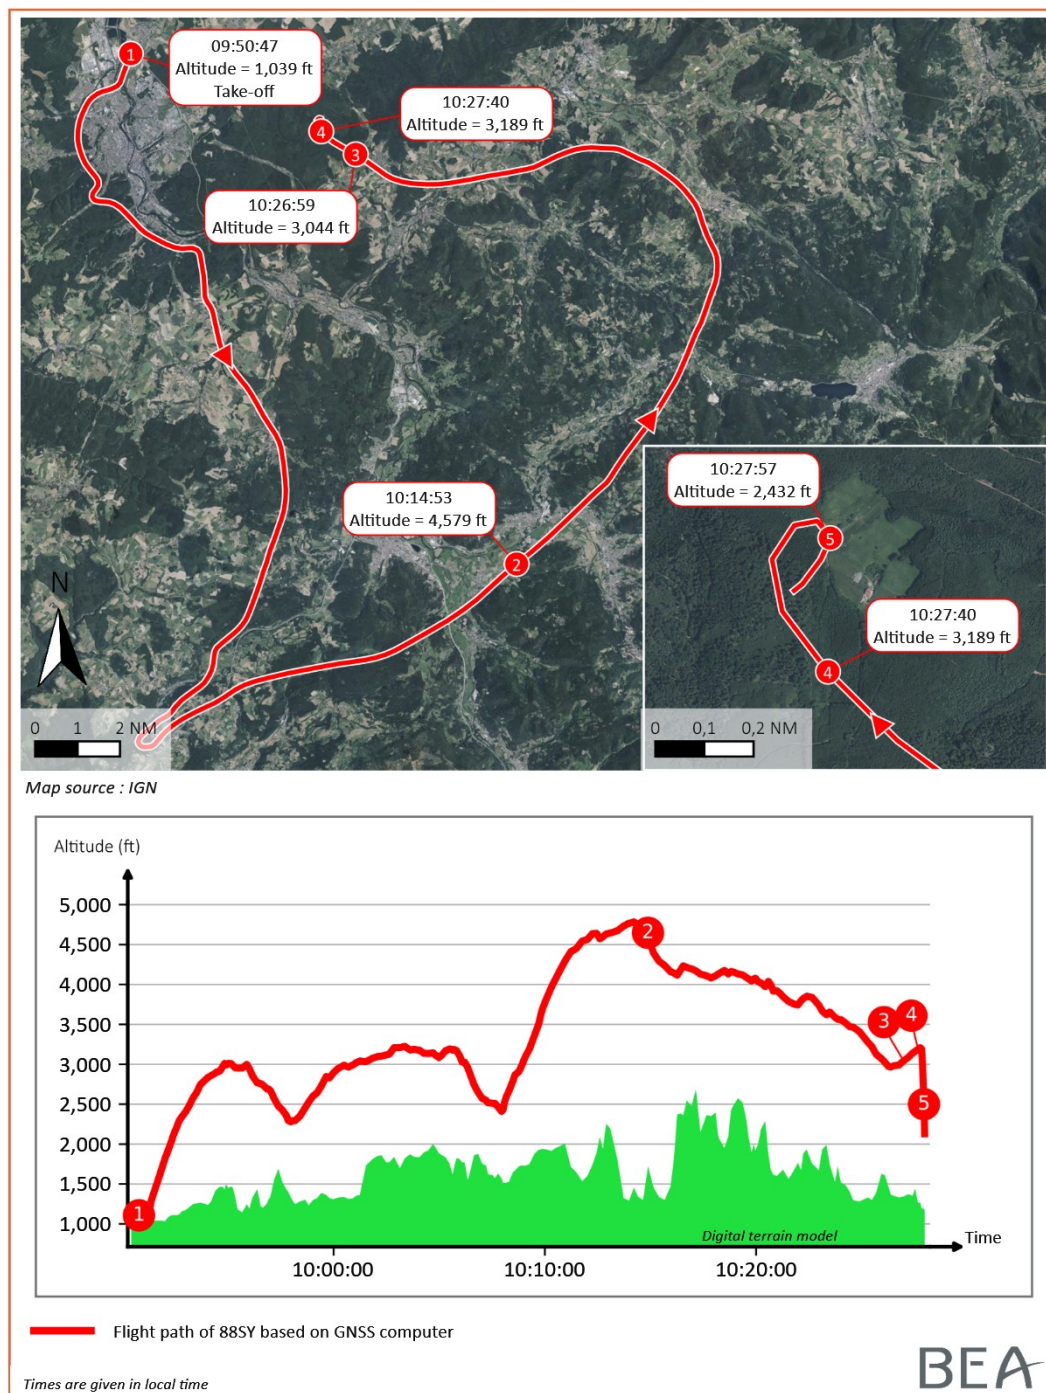
Figure 1: flight path of 88SY

The pilot carried out the first twenty minutes of flight at an altitude of around 3,000 ft. He then climbed to an altitude of around 4,500 ft (Point **②**), before descending to around 3,000 ft (Point **③**). When he was at 3,200 ft (Point **④**), he turned right. During the turn, the microlight rapidly lost altitude (Point **⑤**) and collided with the vegetation and then the ground.

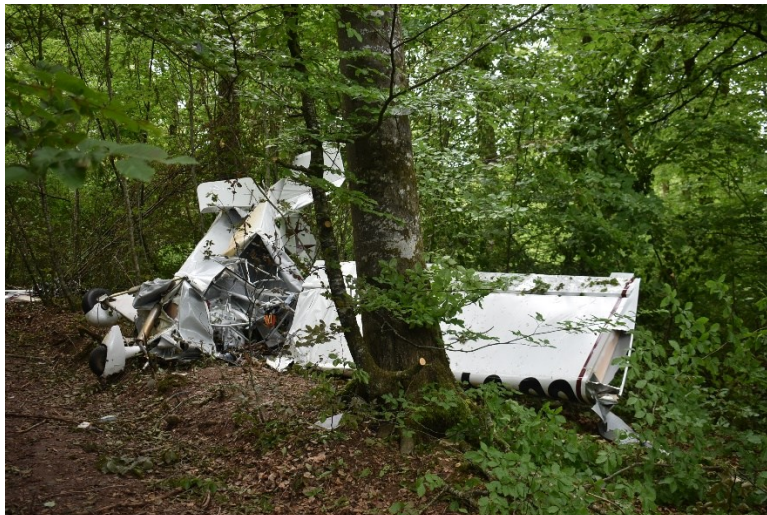
Figure 2: accident site (source: BEA)

The wreckage was situated in Saint-Oger forest. The trees were about twenty meters tall in this area. The marks left in the vegetation by the passing microlight indicated that the flight path was near vertical.

The airframe parachute was out of its housing. It had not been deployed. The ballistic system had very probably been activated by the deformation of the microlight structure on impact with the ground.

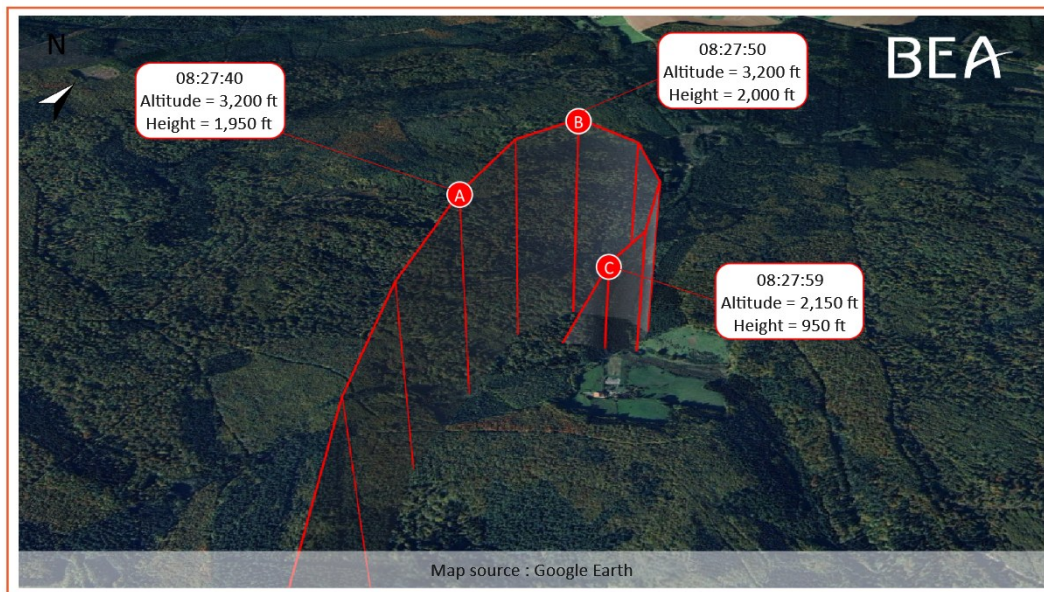
Figure 3: end of flight path of 88SY

- at the start of the right-hand turn, the airspeed, estimated using the flight path and Météo-France wind data, was of the order of 85 to 90 kt (see **Figure 3**, Point **A**). The altitude slightly increased from 3,000 ft to 3,200 ft;
- the altitude stayed globally constant for 10 s (up to Point **B**), while the estimated bank (based on the ground speed and rate of turn) increased beyond 30°;
- the altitude then rapidly decreased, passing from 3,200 ft to 2,100 ft (Point **C**, last recorded point considered as valid) in 9 s, while the estimated bank reached 70°. The flight path indicated a tightening of the right-hand turn. The average vertical speed was around – 8,000 ft/min during the descent. It was estimated that the impact occurred around 5 s later.

The start of a turn, the high vertical speed and the increasing bank led to the hypothesis of entry into a spiral dive being considered. A spiral dive is a steep banked turn, in descent and at high speed.

The flight path data for 88SY, specifically an increase in bank from 30° to 70° in 9 s, a U-turn in around 20 s and a vertical speed of the order of 8,000 ft/min, is compatible with the scenario of a controlled spiral dive with the illusion of holding level flight. In this case, the increase in load factor linked to the speed is cancelled by a reduction in pitch attitude. The altitude then rapidly drops. There is an important difference between the airspeed and ground speed: the ground speed is practically constant while the airspeed increases, essentially due to the vertical component. The bank effect compensates the effect of the increase in speed. The flight path is, in this case, centred on a single point.

The actions to recover from a spiral dive are, in the following order, completely reduce power, adopt 0° bank and smoothly pull out to level flight.
