**Accident** to the CESSNA 150L  
registered **F-HTFS**  
on 3 July 2024  
at Vern-sur-Seiche

**Fuel exhaustion, forced off-field landing, overturn<sup>2</sup>**

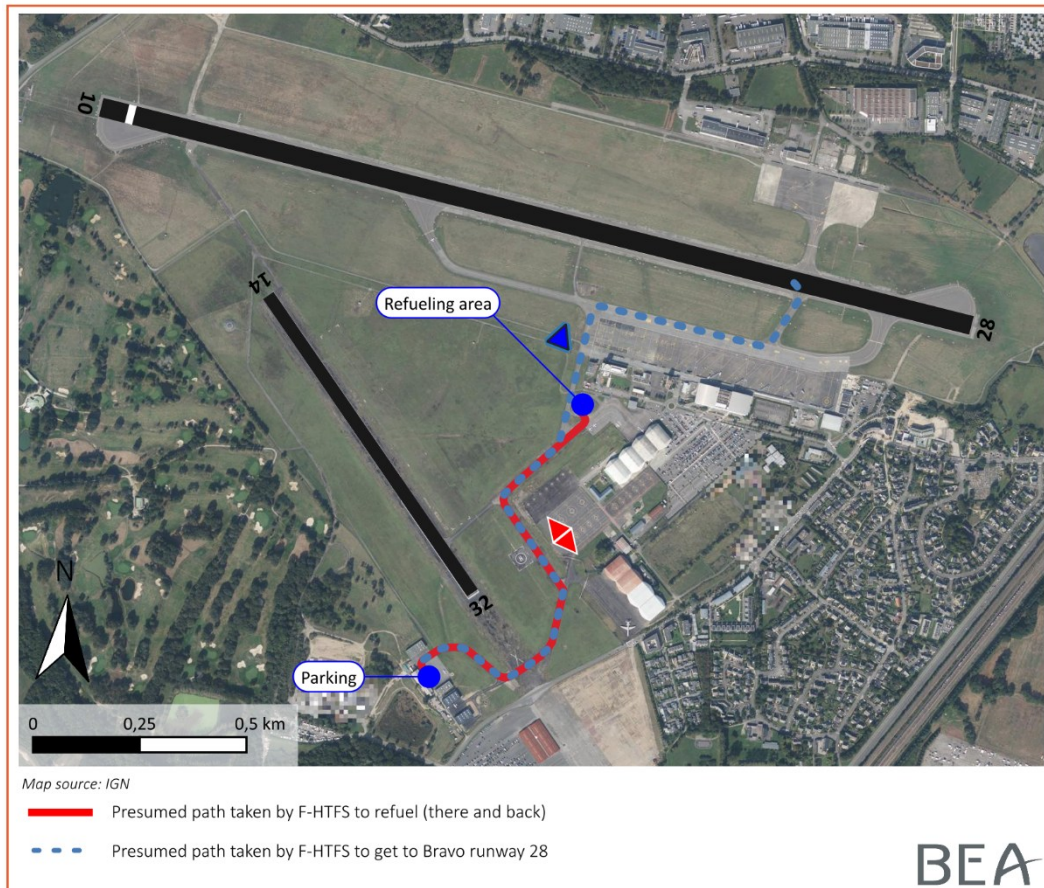
As the passenger had not yet arrived, he decided to go to the refuelling station to top up the fuel and then return to the parking. On arriving at the station, he saw that he had forgotten his payment card and returned to the parking<sup>4</sup>.

Figure 1: presumed path on ground

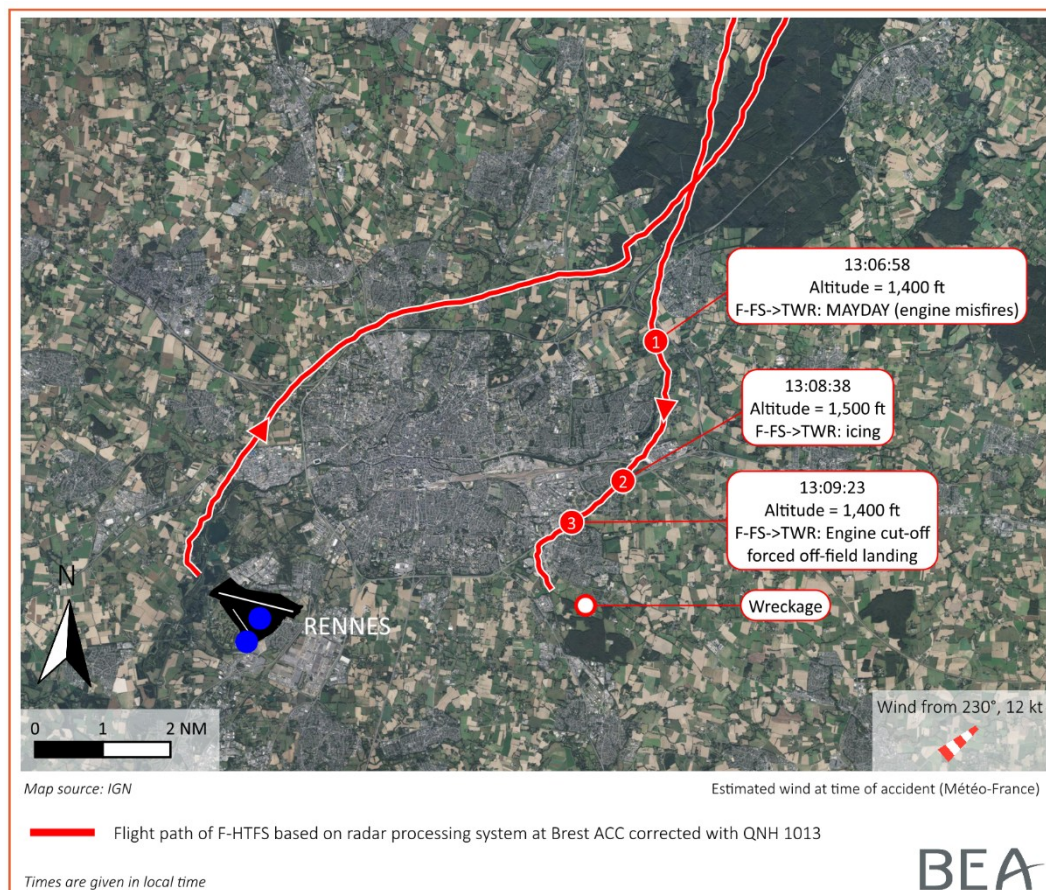
At 13:06, the pilot transmitted a “Mayday” message (see **Figure 2**, point ①), indicating to the control tower that the engine was misfiring and asking for priority to land. The engine power increased again and then decreased again after three to four minutes.

At 13:08, the pilot indicated to the control tower possible carburettor icing and engine misfires (point ②).

Figure 2: Rennes-Saint Jacques airport outbound and inbound flight path of F-HTFS

At 13:09, the pilot reported to the control tower that the engine was “cut-off” and that he was going to carry out an off-field landing (point ③). He identified a field and carried out the approach. He indicated that the engine picked up speed on short final. He pulled out to pass over a hedge. The engine stopped again. The pilot flared in a field of rapeseed. During the run, the aeroplane overturned. The pilot and passenger extracted themselves from the aeroplane unaided. Then the pilot contacted the tower to indicate their position.

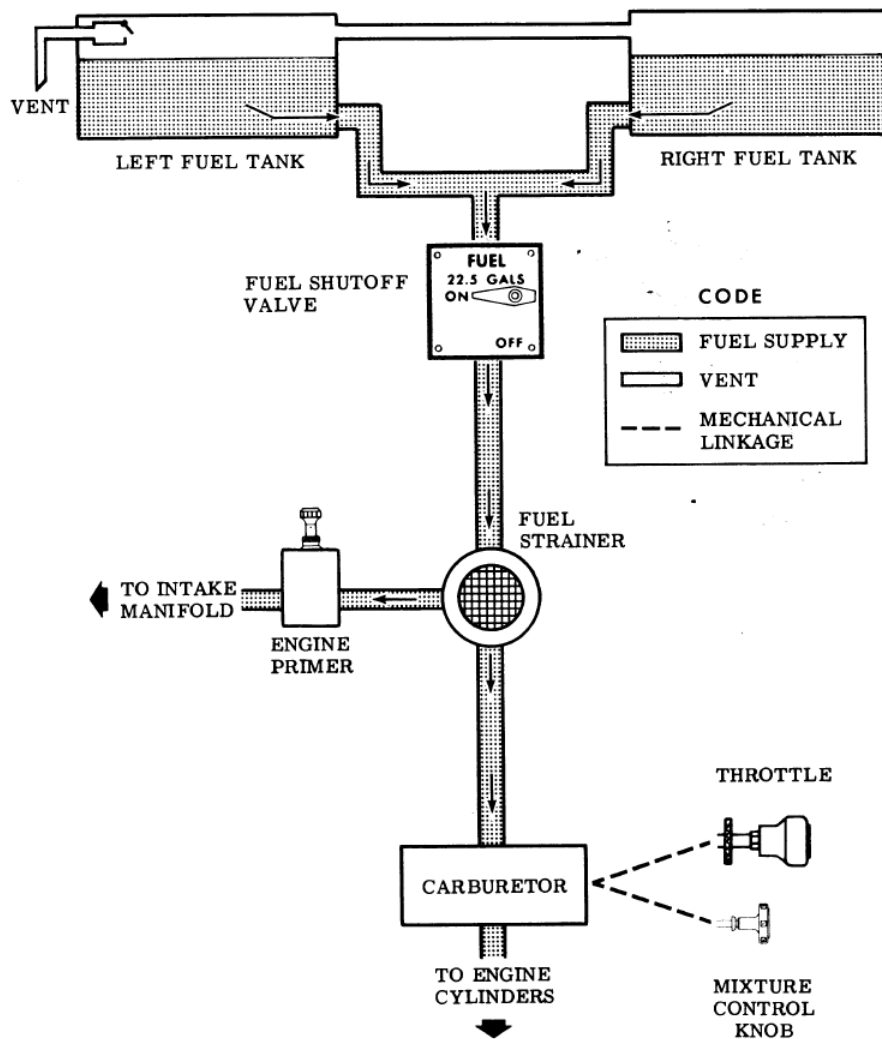
**Figure 4** shows the composition of the aeroplane's fuel system. The diagram is taken from the 1971 flight manual, transmitted to the BEA by the R.L.A. director. The aeroplane is equipped with two fuel tanks, one in each wing, for a total quantity of 26 US gal, i.e. 98.4 l. The total quantity of unusable fuel according to the flight manual is 3.5 US gal, i.e. around 13.2 l. The system is open or closed; it is not possible to select one of the fuel tanks. Fuel is gravity-fed to the carburettor, the aeroplane is not equipped with a pump.

Figure 4: schematic diagram of fuel system (source: C150 flight manual)

During the examinations carried out by the BEA, ten millilitres of fuel were collected only from the carburettor bowl. No other sign of fuel was identified in the rest of the system.
