**Unavailability of transponder, unavailability of ACAS,  
difficulties with, or loss of radiocommunication and  
datalink, degraded approach and landing capabilities,  
dangerous loss of separation**

SERIOUS INCIDENT	INCIDENT	SERIOUS INCIDENT
AIRBUS A320-251N registered EI-NSF	AIRBUS A321-252NX registered PH-YHA	AIRBUS A321-252NX registered PH-YHC
Aer Lingus Teoranta	Transavia Airlines C.V.	Transavia Airlines C.V.
Passenger commercial air transport		
20 September 2024 around 07:30 <sup>1</sup>	13 January 2025 around 21:20	29 April 2025 around 10:30
en route

*Note: this interim report is solely based on information known to the BEA at this stage of the investigations. It does not prejudge the conclusions that the BEA may draw in the final reports relating to these three investigations.*

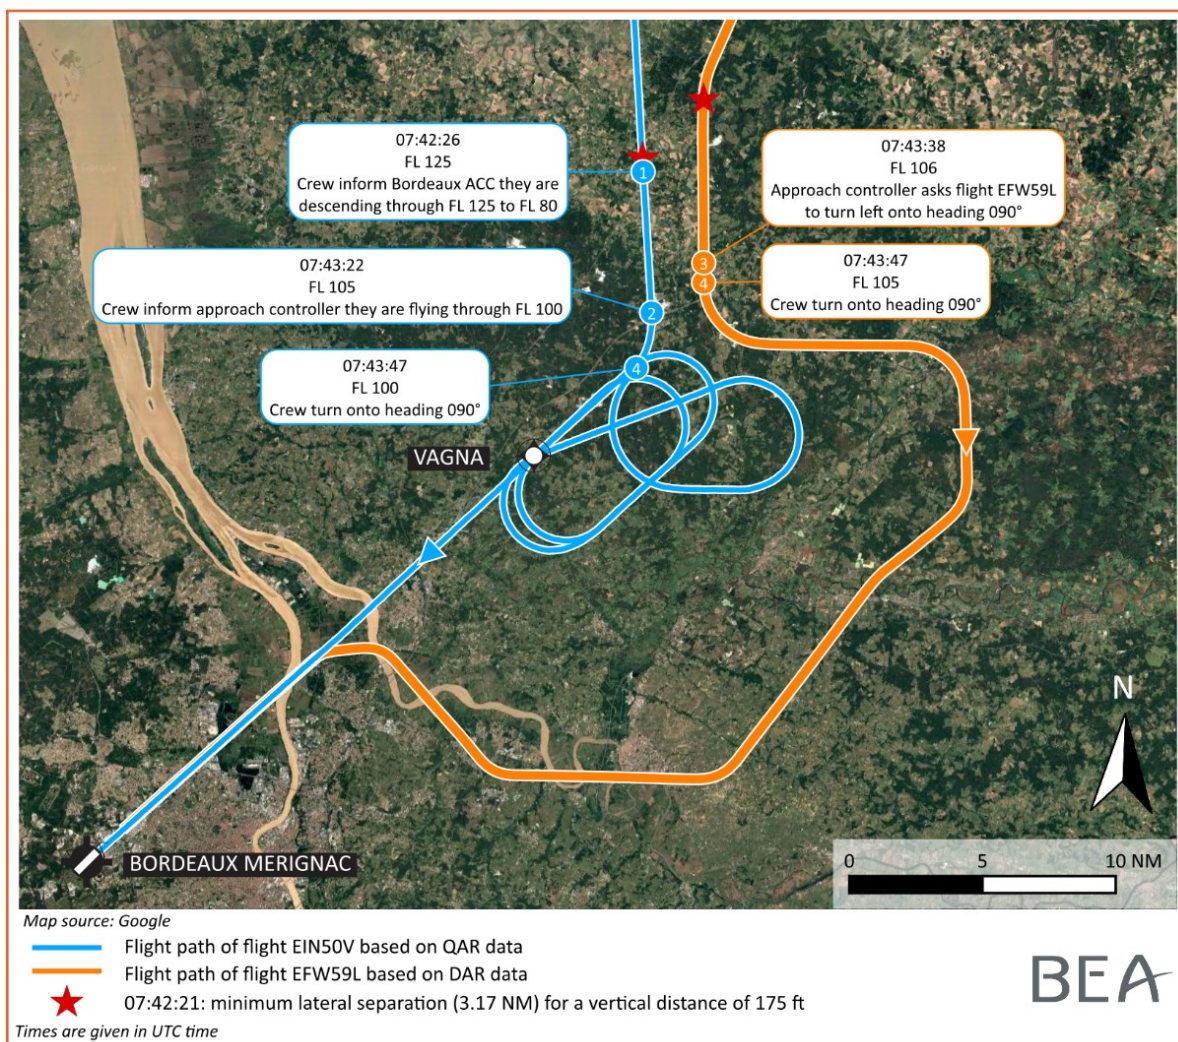
Figure 1: flight path of flight EIN50V during the loss of separation with flight EFW59L

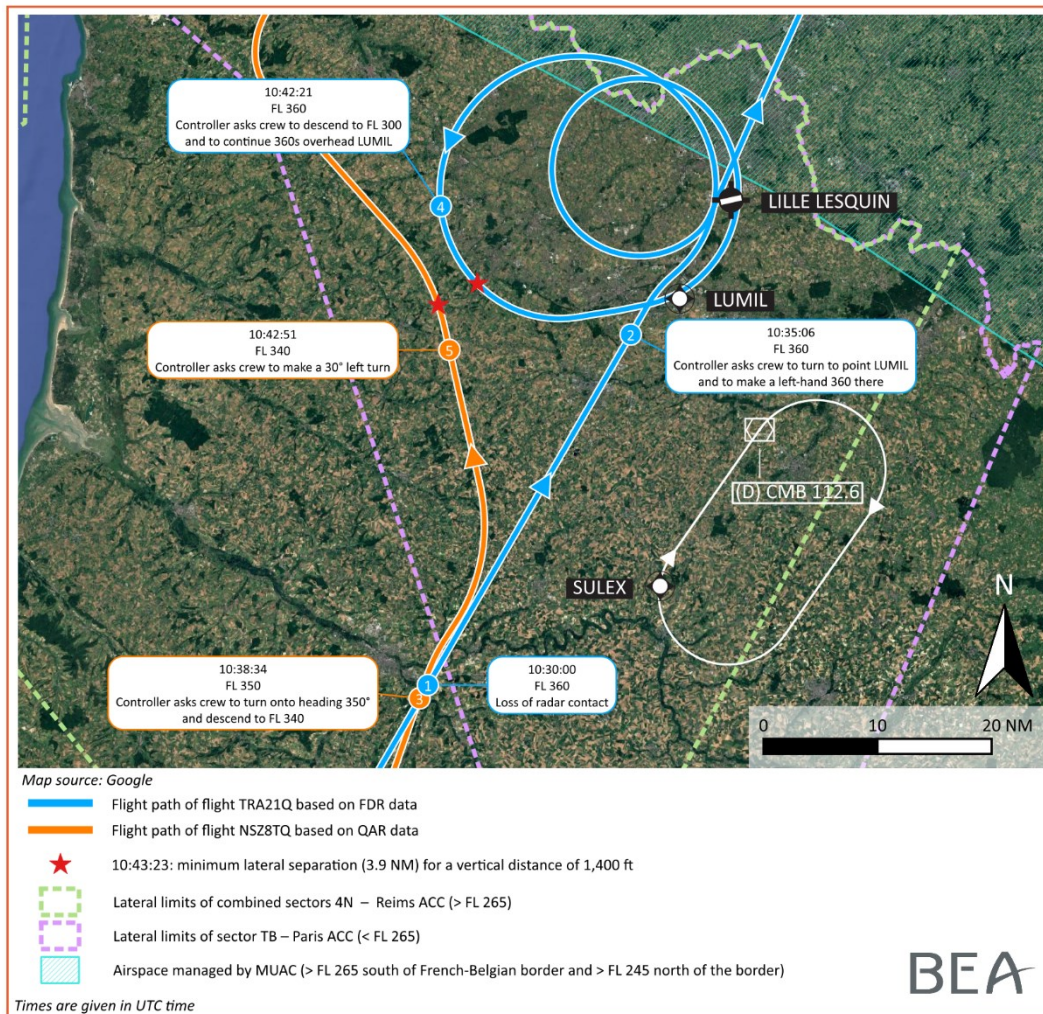
Figure 2: flight path of flight TRA21Q during the loss of separation with flight NSZ8TQ

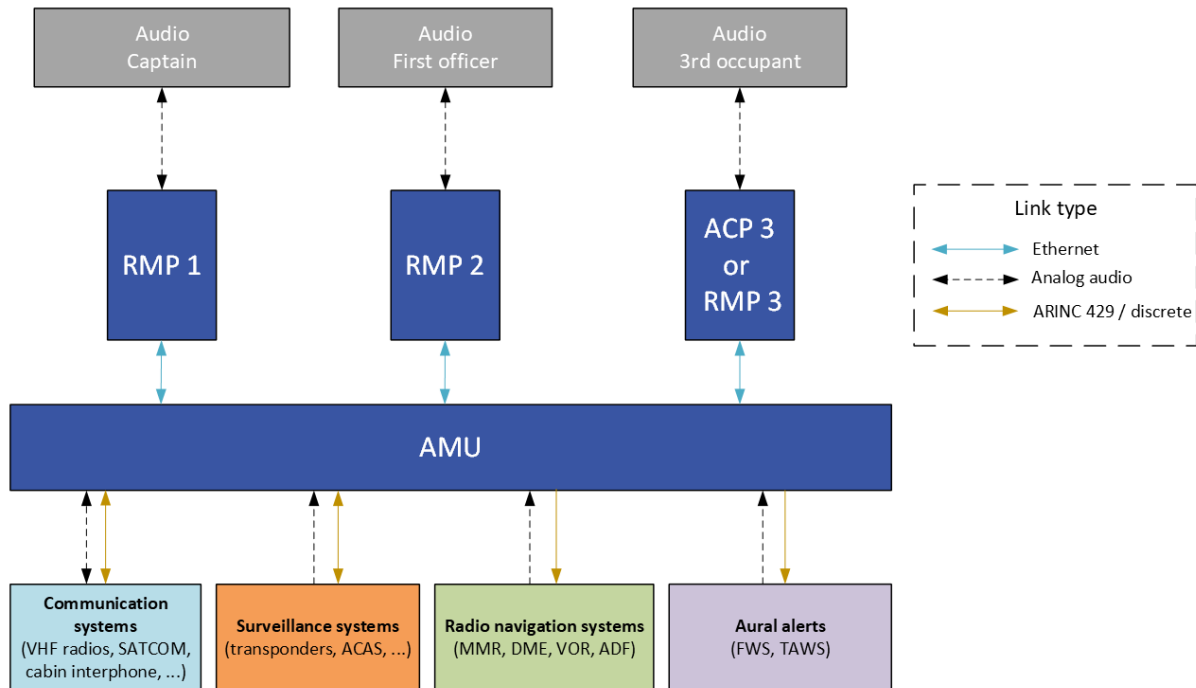
Figure 3: simplified architecture of DRAIMS (source: BEA)

Due to a lack of robustness in one of the AMU components to Ethernet micro-cuts, the AMU may switch to degraded mode, leading to erratic processing of the Ethernet data flow between the RMPs and the AMU.

A modification to the AMU software has been developed by the manufacturer (Thales) for the A320neo family and certified by EASA. This modification prevents the failure described above from having consequences on the DRAIMS and its peripheral systems. This new version of the software includes:

- internal monitoring of the component that causes the failure;
- an automatic restart mechanism for this component as soon as the failure is detected;
- additional checks performed by the AMU to prevent corrupted messages from being sent to interfaced systems.

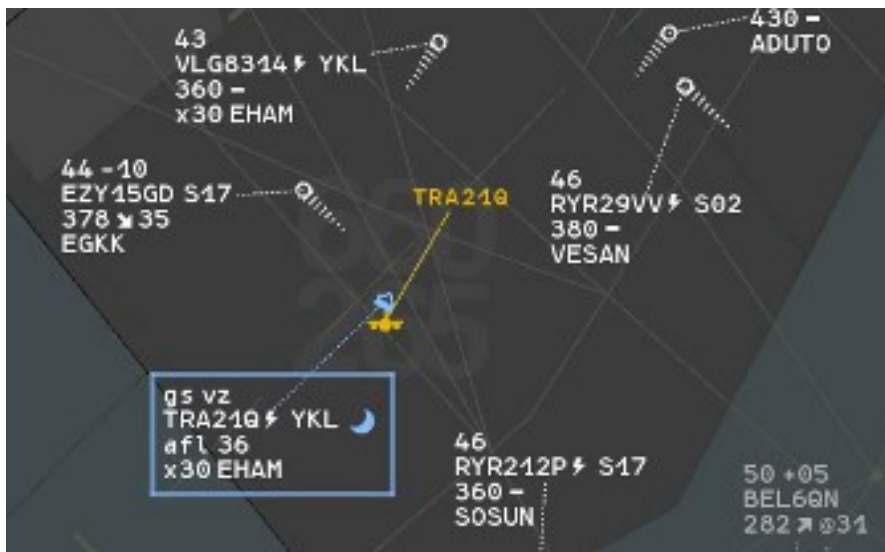
With the 4-FLIGHT system, a FPASD<sup>33</sup> is displayed which shows the position of the aircraft with a total transponder failure. This position is calculated by the system based on the flight plan data (see Figure 6).

Both systems display on the radar screen, a “track marker”, showing the last detected position and alerting controllers to the loss of detection of the flight in question.

Figure 6: illustration of track marker (in amber) and of F-PASD (in blue) displayed during the serious incident to PH-YHC (source: DSNA)

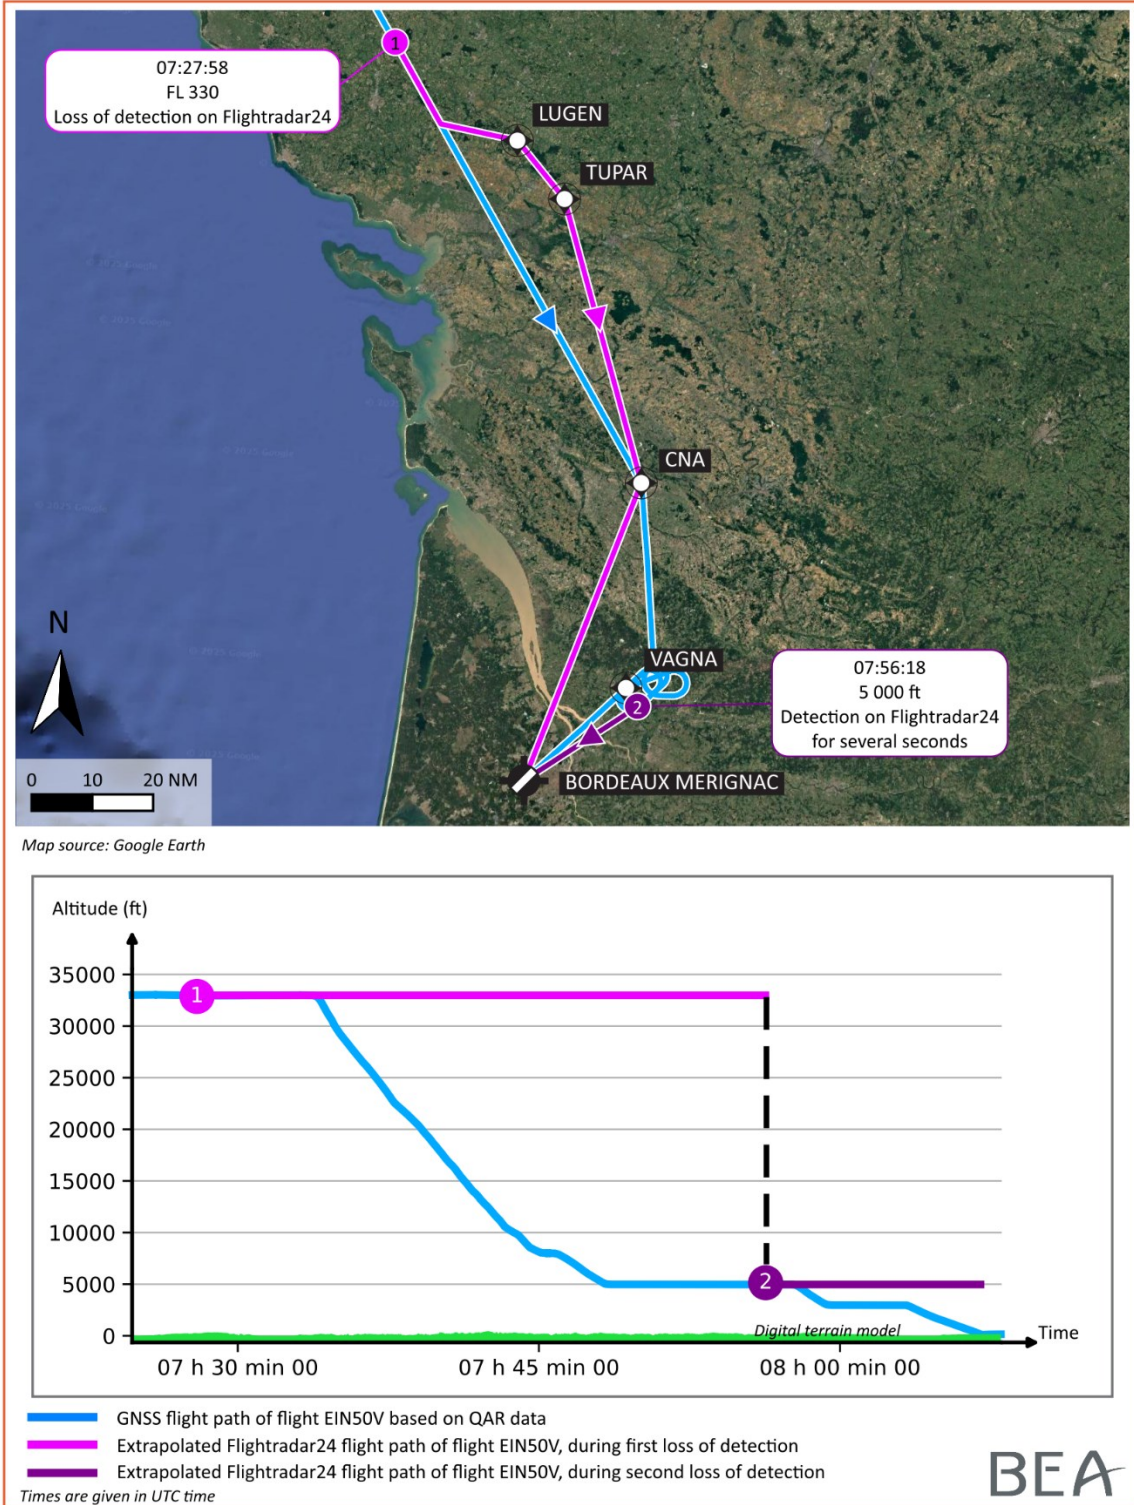
Thus, during the incident, the flight remained displayed at FL 330, on a route different from the route actually followed by the aircraft (see Figure 8). For the controllers, this information could appear consistent with the radio failure procedure then in force for flights to Bordeaux-Mérignac; this procedure indicated that the crew should report at the IAF at the last level received. The extrapolated flight level information provided by Flightradar24 may have influenced the air traffic controllers' awareness of the situation and their decision-making.

Figure 8: comparison of GNSS flight path with Flightradar24 estimations for flight EIN50V
