**Accident** to the PIPER PA18  
registered **F-BAYP** with a paraglider  
on Tuesday 21 January 2025  
at Les Allues

| This is a courtesy translation by the BEA of the Final Report on the Safety Investigation. As accurate as the translation may be, the original text in French is the work of reference. | |

**Collision with a paraglider during approach to mountain  
airfield, loss of control, collision with a house**

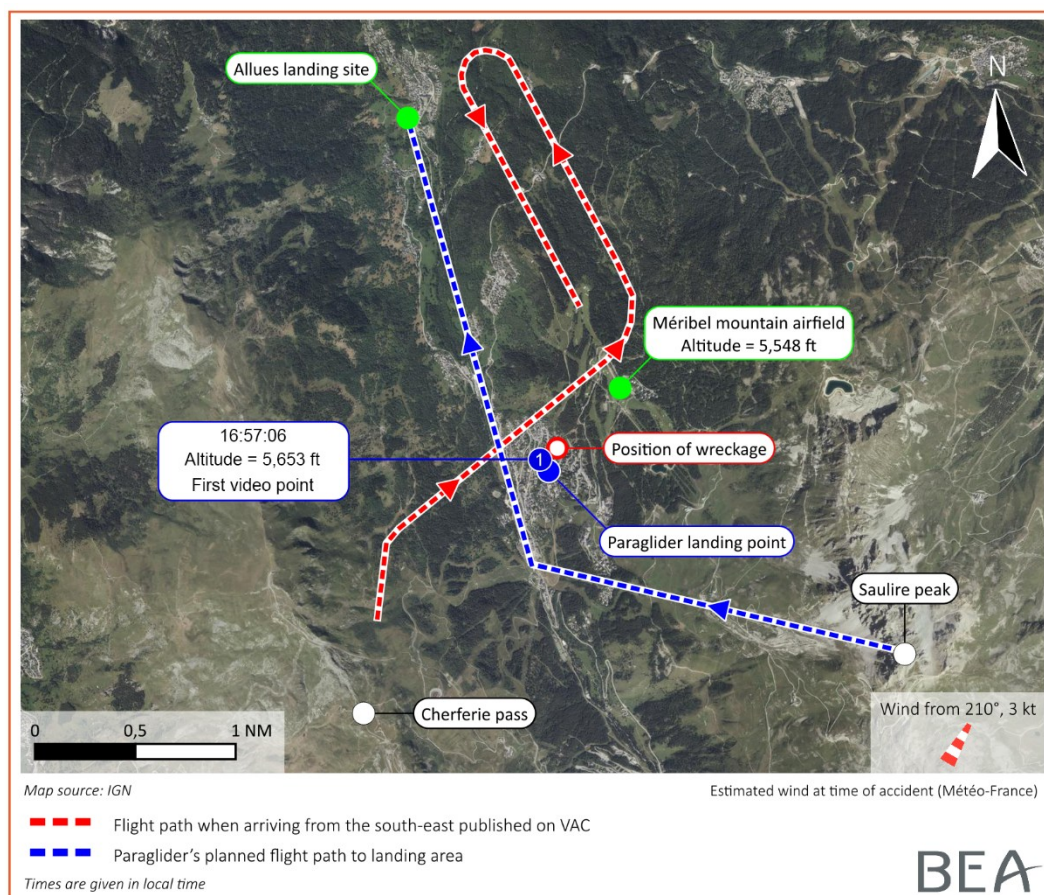
The pilot of the aeroplane, accompanied by a passenger, was carrying out a local flight from Méribel Robert Merloz mountain airfield. On flying back, he flew over the village of Méribel and continued his route to pass overhead the mountain airfield which has to be flown over at 6,500 ft<sup>2</sup>. The pilot of the paraglider took off from the top of Saulire (Alt. 8,800 ft) for a tandem flight. He indicated that he then flew away from the terrain, flew over the ski front of Méribel ski station and then headed towards the village of Les Allues (Alt. 3,600 ft) in the north to land on the officially designated landing site<sup>3</sup> for free flight. The paraglider was at a distance of around one kilometre from the mountain airfield when the pilot and his passenger indicated that they perceived the aeroplane heading towards them in the front left sector, at a distance that they estimated as being around fifty metres, and at the same altitude. The paraglider pilot immediately started an evasive manoeuvre during which the wing collided with the aeroplane. Witnesses saw the aeroplane fall to the ground in a steep nose-down attitude. The aeroplane collided with an unoccupied chalet. The paraglider pilot opened his emergency parachute and landed in a tree.

Figure 1: estimated flight paths of paraglider and F-BAYP

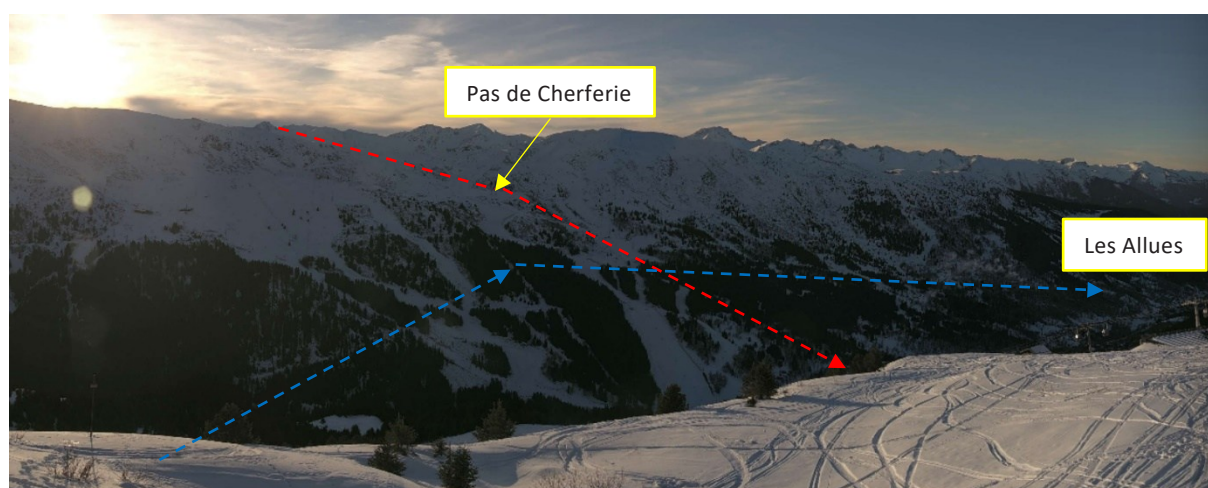
Figure 2: image dated 21 January at 16:45 taken from the webcam situated on Saulire slope.

On the day of the accident, the sun set at 17:25. At 16:45, as shown by the station's webcams (see **Figure 2**), the sun was about to pass behind the terrain, the Pas de Cherferie slopes and Méribel valley were in shadows with little luminosity.

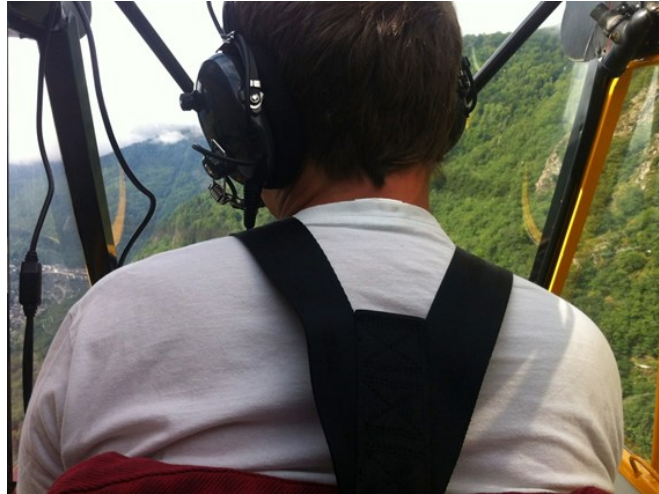
*Figure 3: photo illustrating forward visibility from rear seat of a PA18 (source: BEA)*

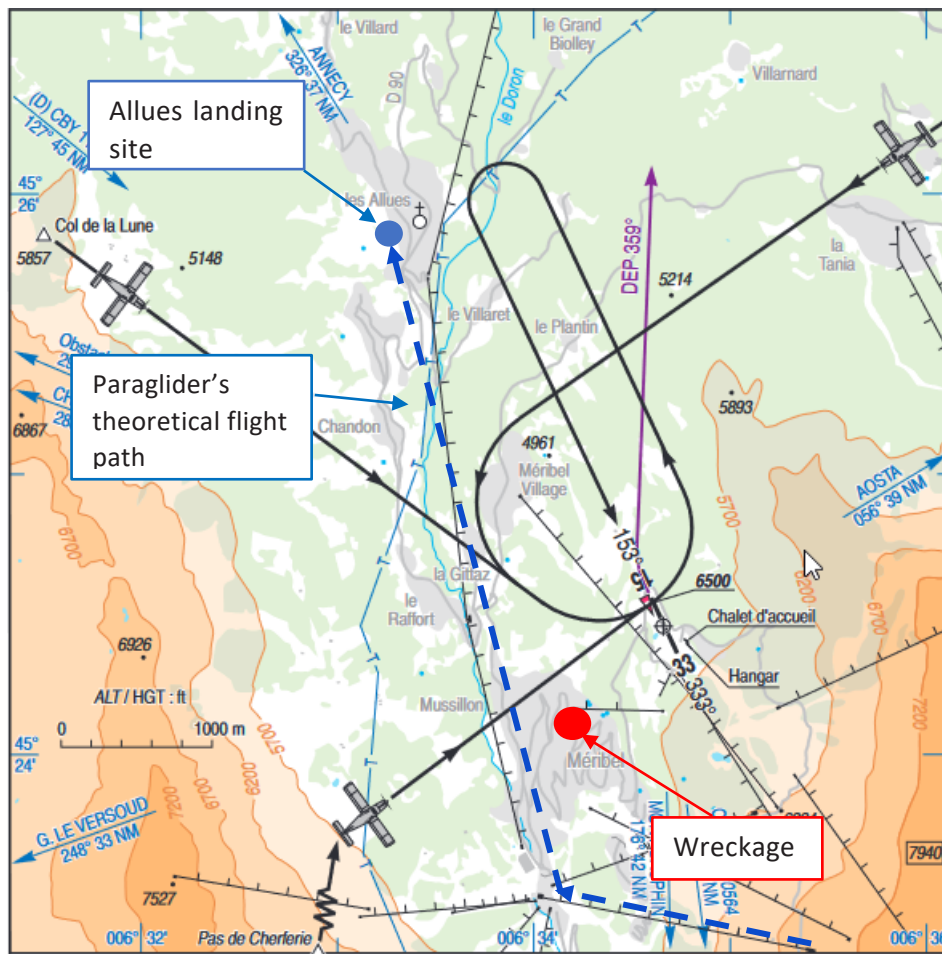
The VAC chart special instructions and procedures indicate that it is compulsory to transmit all position messages on the mountain airfield A/A frequency. The entry (optional indicated by a white triangle) points mentioned are the following:

Usual practice when landing on a mountain airfield where there is no air traffic unit is to fly overhead the airfield before joining the circuit. The Méribel VAC chart recommends doing this at 6,500 ft.

Figure 4: excerpt from Méribel mountain airfield VAC chart (source: SIA, annotations BEA)

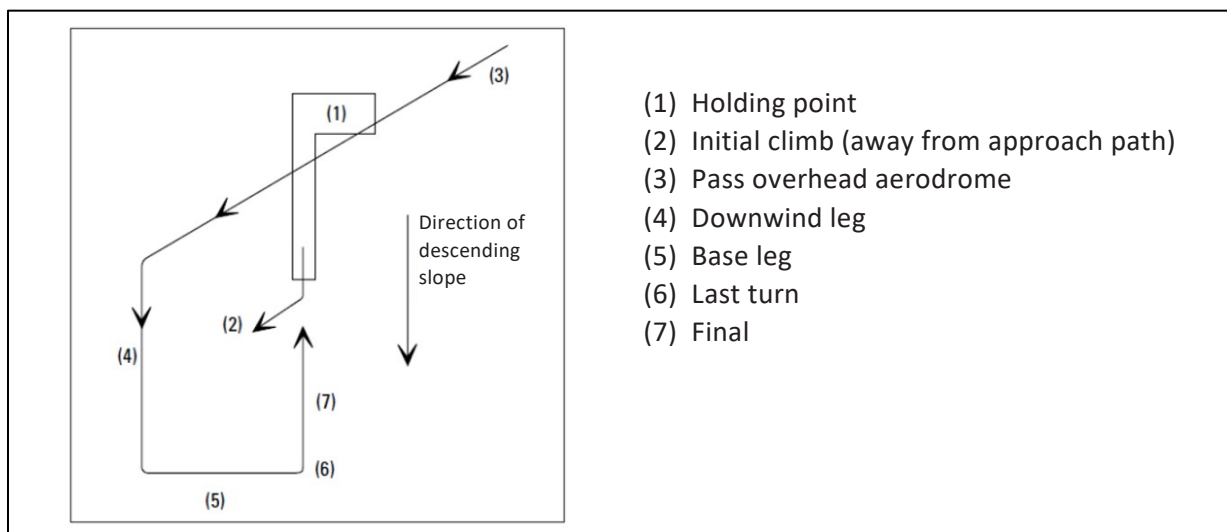
In France, the order of 12 July 2019 relating to general air traffic procedures for the use of aerodromes by aircraft, sets out the rules relating to aircraft<sup>5</sup> joining and operating in the aerodrome traffic circuit. The order describes, as follows (see Figure 5), the characteristic positions of a traffic pattern for a typical surface and a typical aerodrome traffic pattern for a mountain airfield.

Figure 5: excerpt from French order of 12 July 2019 relating to general air traffic procedures for the use of aerodromes by aircraft

As described in the order, the "traffic pattern" does not include incoming flight paths as they may be referenced on a VAC chart.
