**Accident** to the PIPER PA18 SuperCub  
registered **HB-OKB**  
on Monday 26 May 2025  
at Mens

**Windsock strike during go-around on mountain airstrip,  
in instruction**

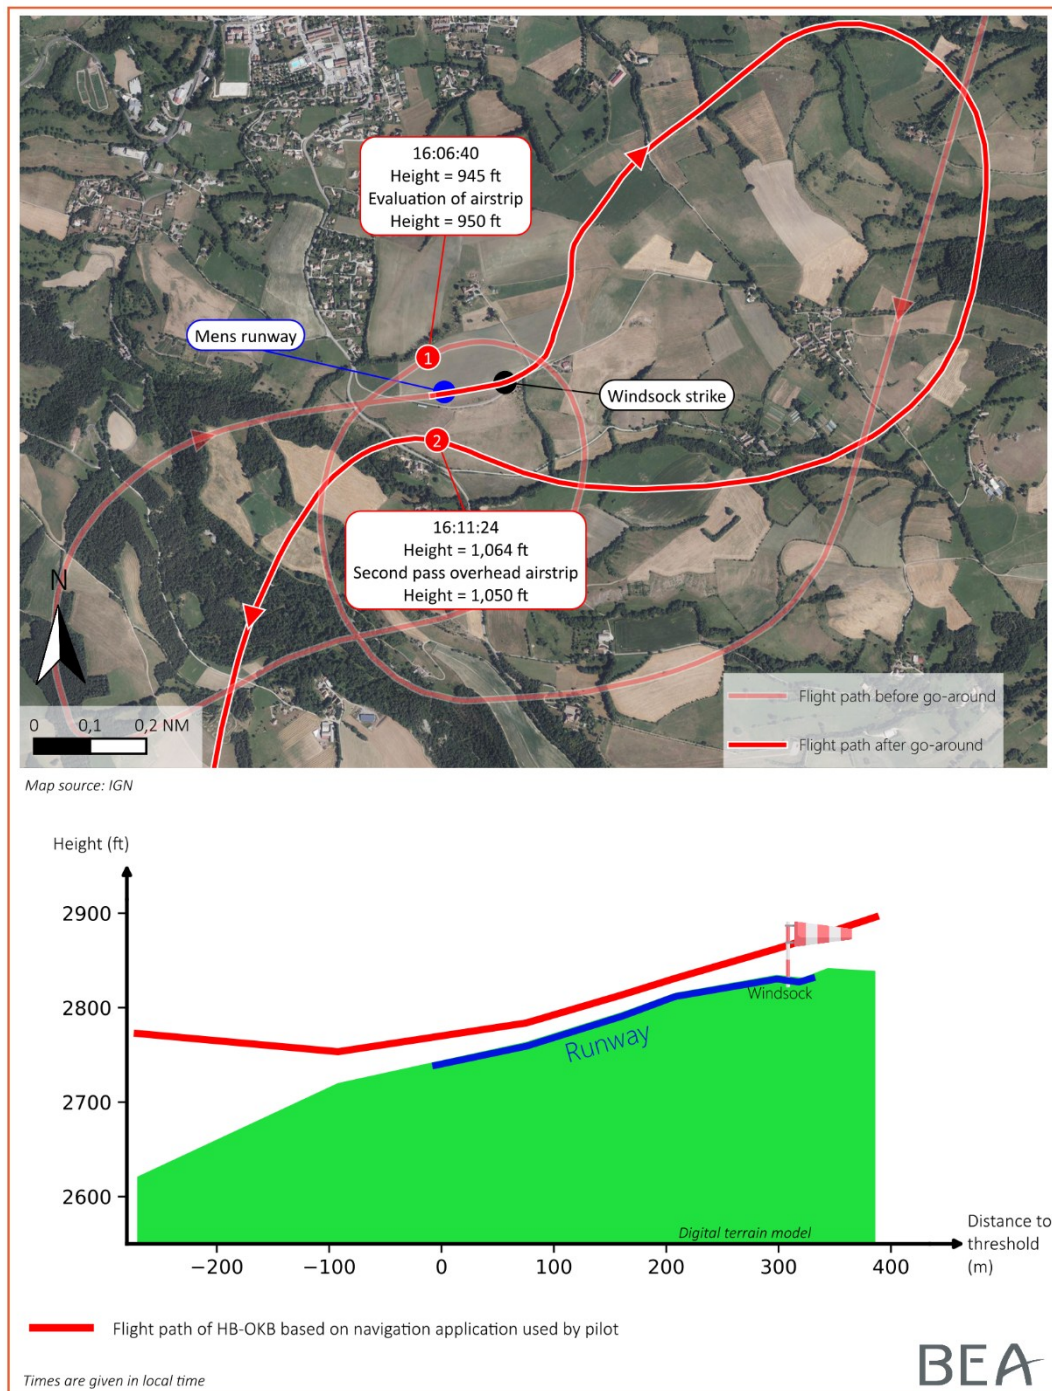
Figure 1: flight path of HB-OKB

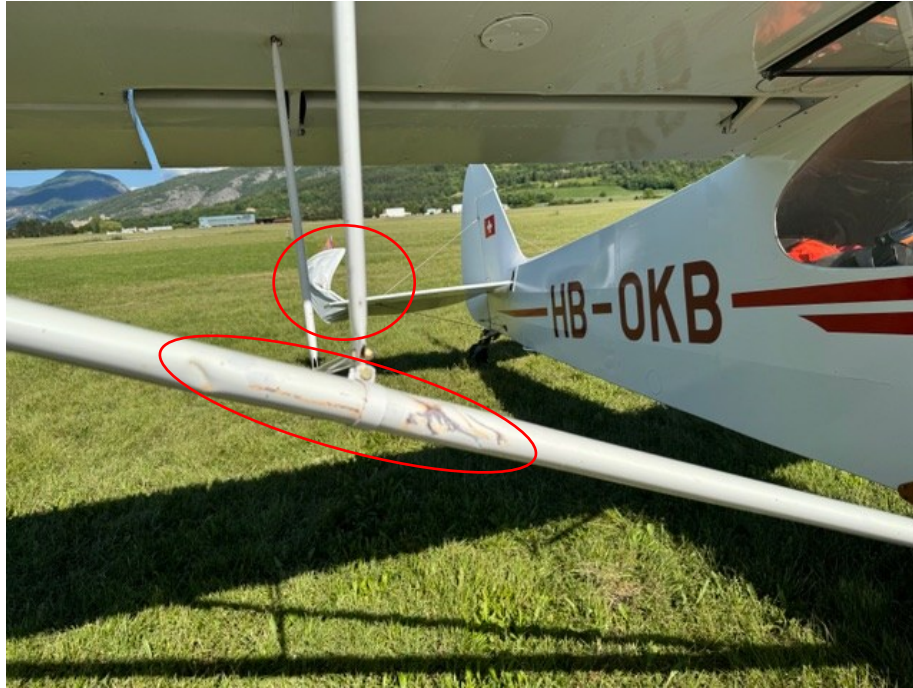
Once on the ground, the instructor and student pilot observed a dent on the right-hand strut of the aeroplane as well as substantial damage to the right-hand part of the elevator (see **Figure 2**).

Figure 2: damage observed on aeroplane (source: instructor, annotations BEA)

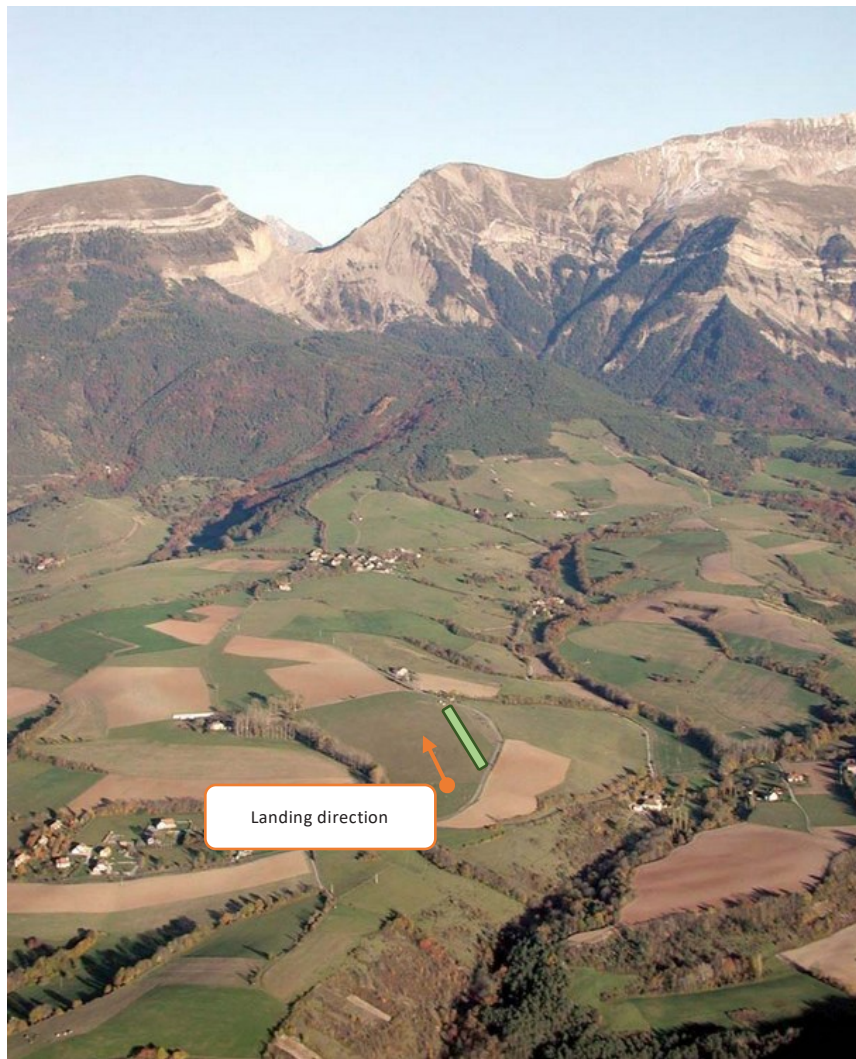
The Mens mountain airstrip is situated at an altitude of 2,790 ft and has an unpaved runway 08/26 measuring 345 m x 17 m. The mountain airstrip information sheet published by [BASULM](#) and available on the AFPM site<sup>4</sup> indicates that landings must be performed on runway 08 and take-offs from runway 26. The runway circuit is joined from the right-hand side at a height of 210 ft. The Mens mountain airstrip is situated in a valley (see **Figure 3**). Runway 08 has a smooth upward gradient of 8.2%.

*Figure 3: Mens mountain airstrip (source: AFPM, annotations BEA)*

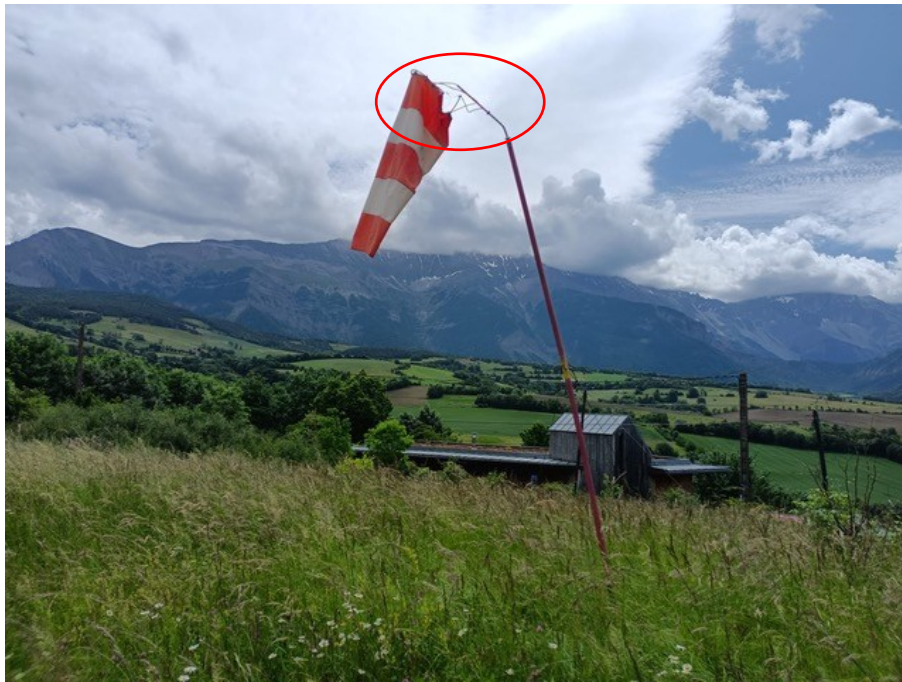
Following the accident, the airstrip operator checked for possible signs of a strike with objects close to the runway, he observed that the windsock was damaged (see **Figure 4**).

Figure 4: damage to the windsock (source: operator, annotation BEA)

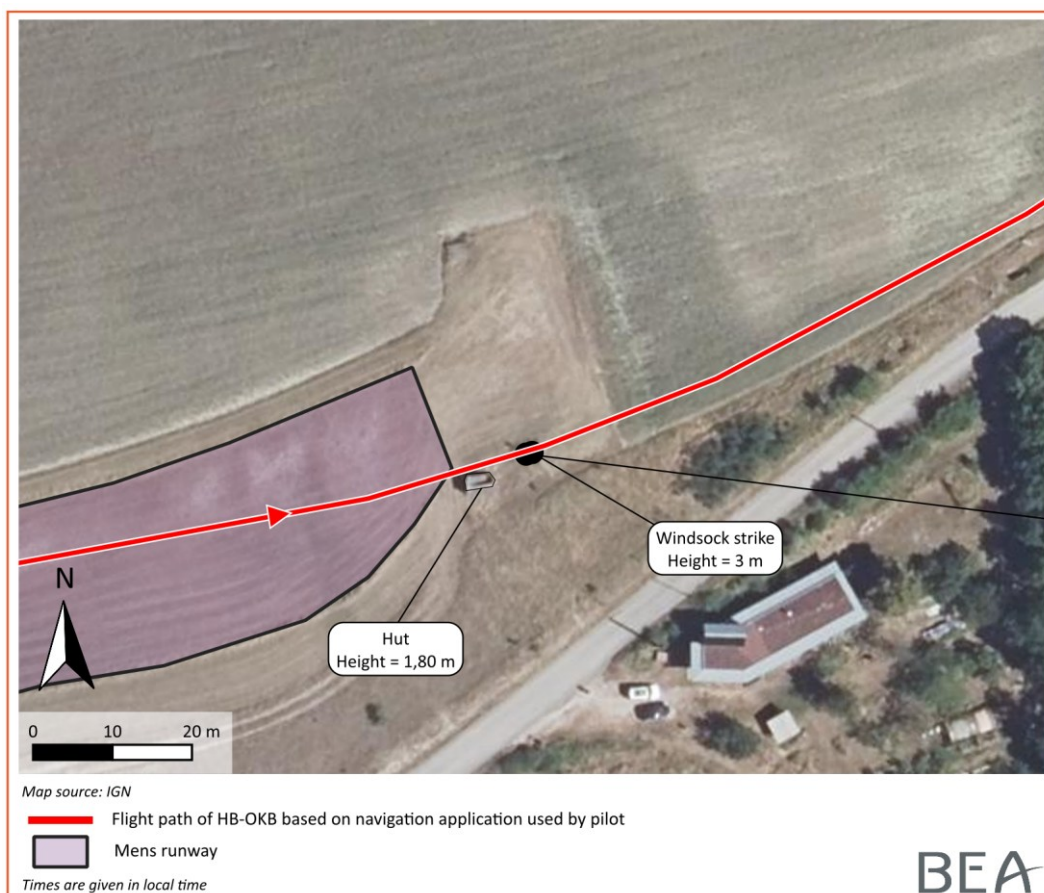
Figure 5: flight path of aeroplane during go-around

The airstrip information sheet indicates in the comments part, that the runway curves in on the left-hand side on landing. In **Figure 5**, it can be seen that the windsock and hut are more or less on the extended centreline of runway 08.

On final, at a very low height, close to the runway threshold, the instructor considered that the length of the grass compromised landing and take-off. He decided to carry out a go-around. During this manoeuvre, the aeroplane collided with the windsock situated on the runway's extended centreline, after the end of the runway.
