**Accident** to the CENTRAIR – 101A Pégase  
registered **F-CHEL**  
on Tuesday 10 June 2025  
at Valavoire

## Collision with terrain, slope soaring<sup>2</sup>

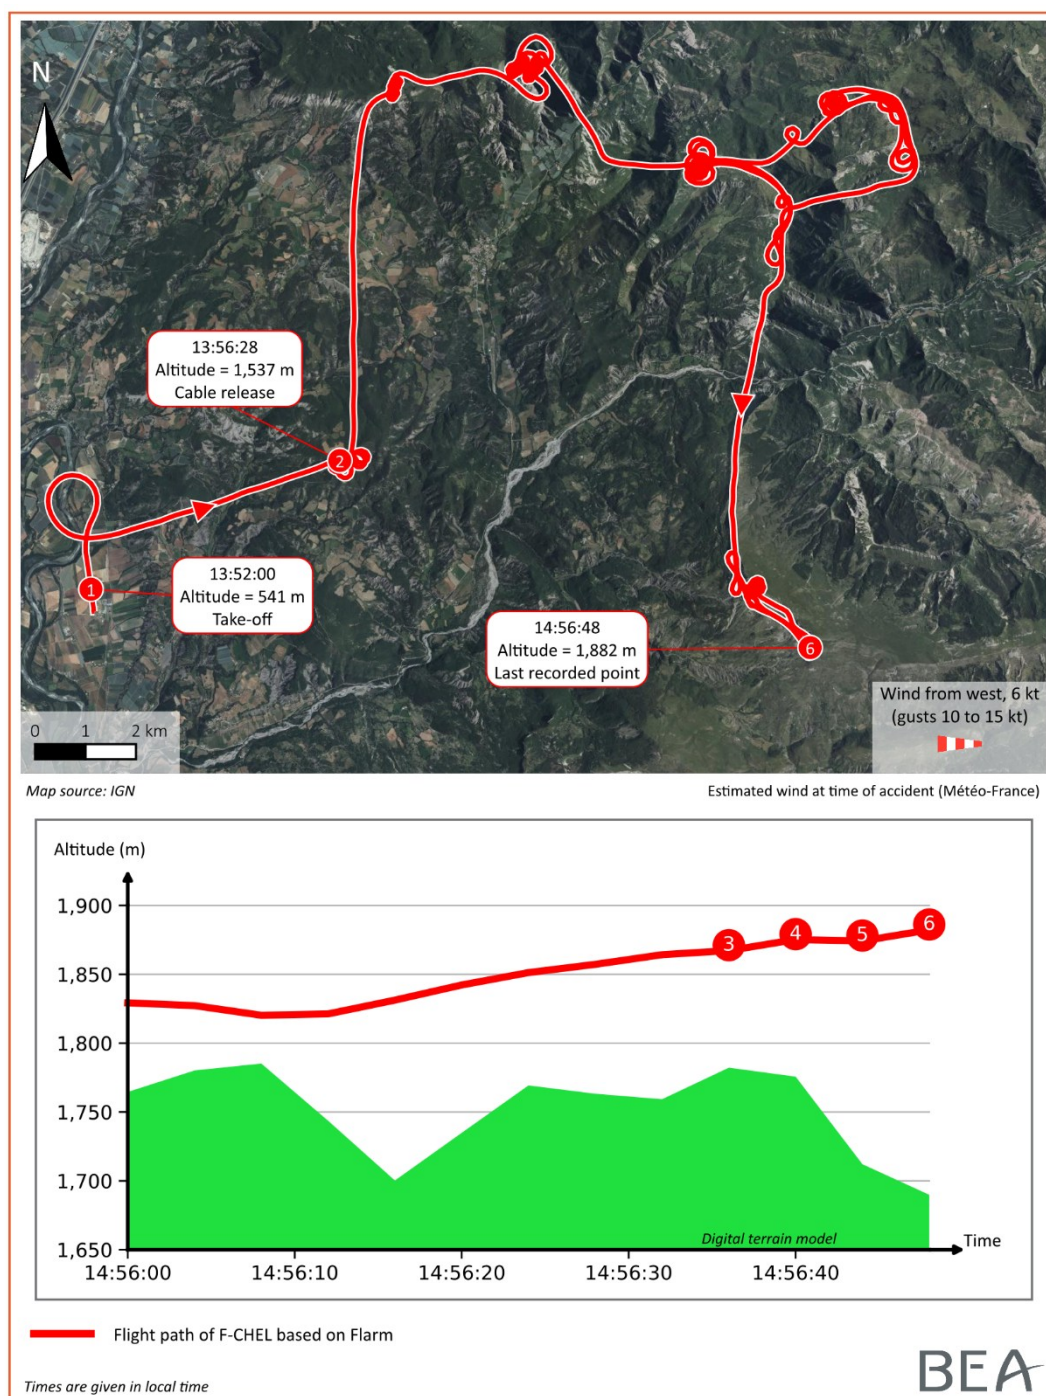
The pilot helped several gliders take off from Sisteron Vaumeilh aerodrome. He then carried out a towed take-off at 13:52 (see **Figure 1**, point **1**). He released the cable at an altitude of around 1,500 m four minutes later (point **2**).

Figure 1: flight path of F-CHEL

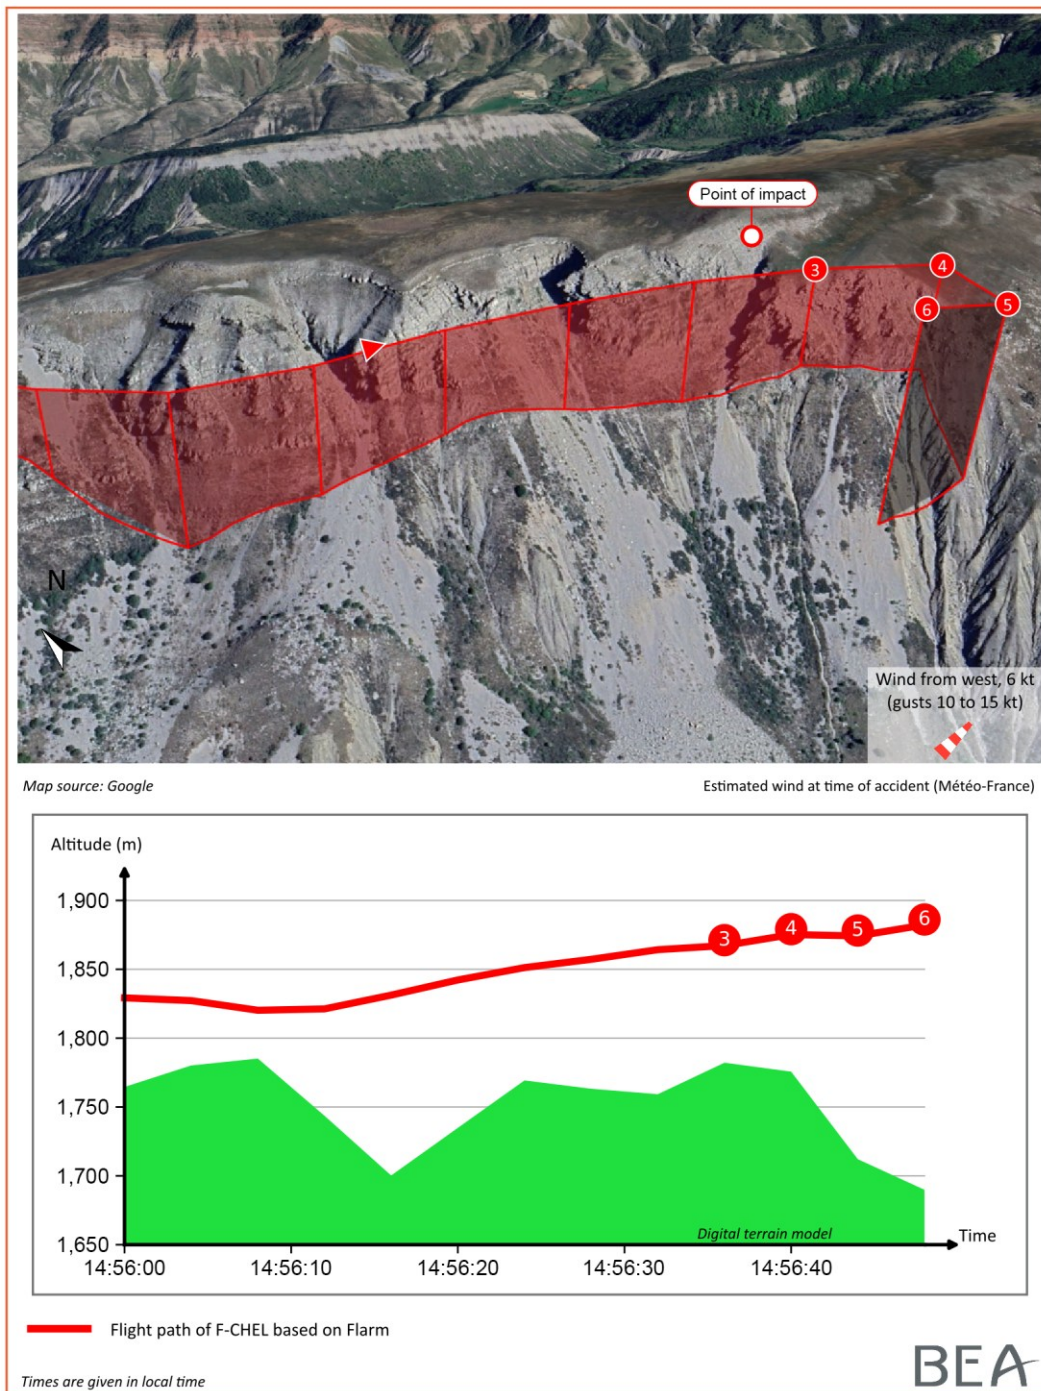
He next headed again to the south-east slope of Jouère mountain and carried out a right-hand turn (see **Figure 2**, points **3**, **4**, **5** and **6**).

The glider collided with the terrain close to the last point recorded by the on-board computer (point **6**).

Figure 2: end of flight path of F-CHEL

The recorded flight path showed that a right-hand turn was carried out while slightly gaining altitude. The glider then collided with the terrain at a point twenty metres lower than the last recorded position.

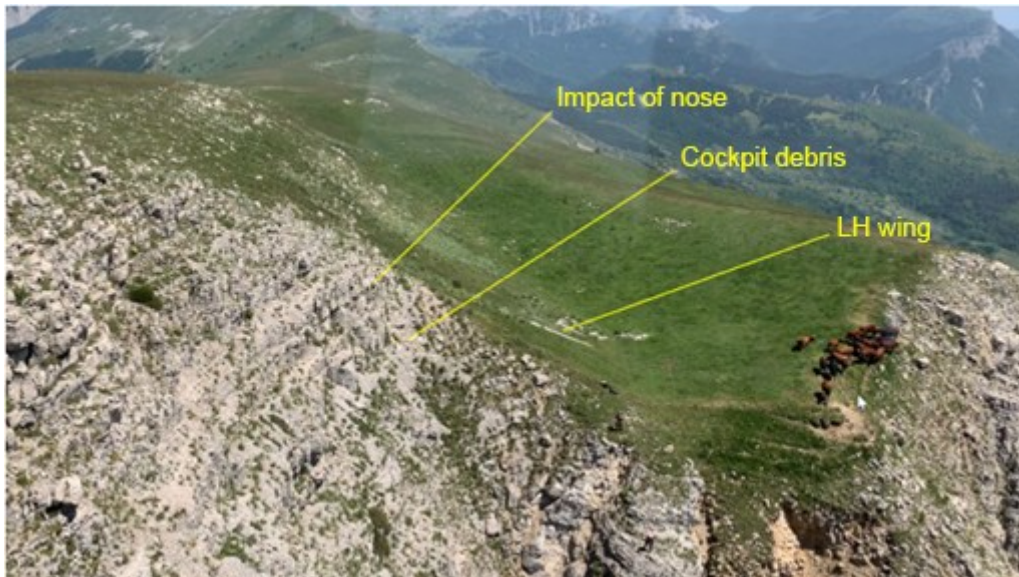
The glider wreckage was found close to Dormeilleuse ridge; the point of impact was at an altitude of around 1,860 m at the top of a slope of scree. The rear section of the fuselage, the tail plane and the root and tip of the right-hand wing were found on the scree. The complete left-hand wing was found on the grass plateau.

Figure 3: overall view of accident site (source: BEA)

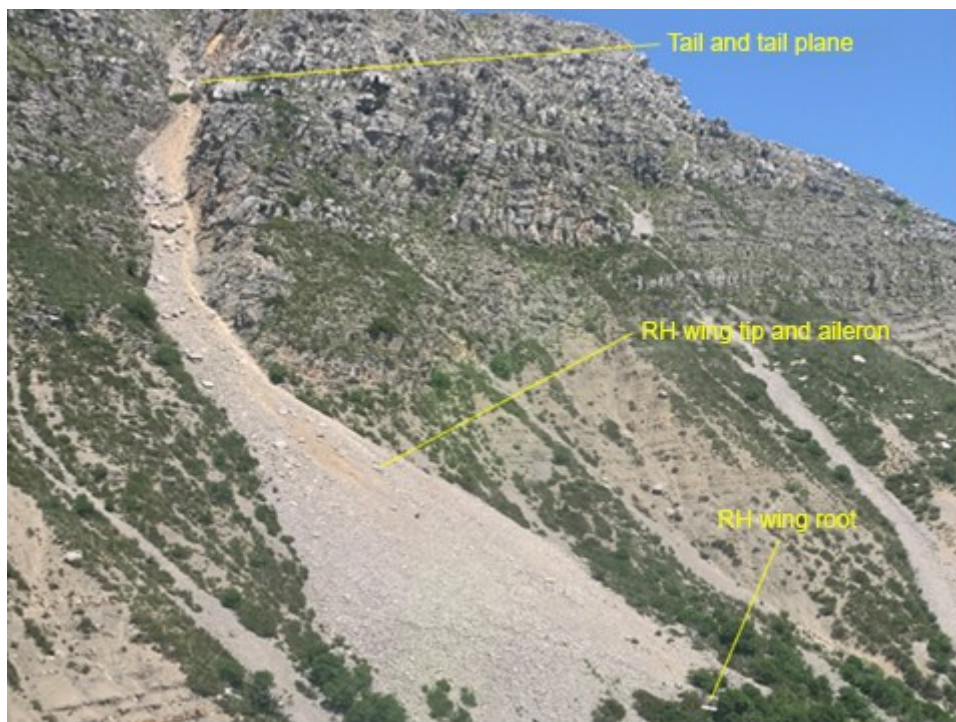
Figure 4: partial view of accident site (source: BEA)

- the glider was complete and all the controls were continuous;
- the glider collided with the terrain with high energy;
- it is probable that the nose and the right-hand wing collided with the terrain before the left-hand wing;
- the canopy closing system was in the closed position;
- the pilot had at least his lap belt fastened;
- a bottle of oxygen was installed in the glider, however no supplemental oxygen delivery device was found on board.

The examination of the wreckage did not reveal any technical failure which could explain the accident.
