**Accident** to the GLASFLÜGEL 304  
registered **F-CEBU**  
on Thursday 31 July 2025  
at Sainte Marie de Cuines

## Collision with a tree then the ground during an off-field landing

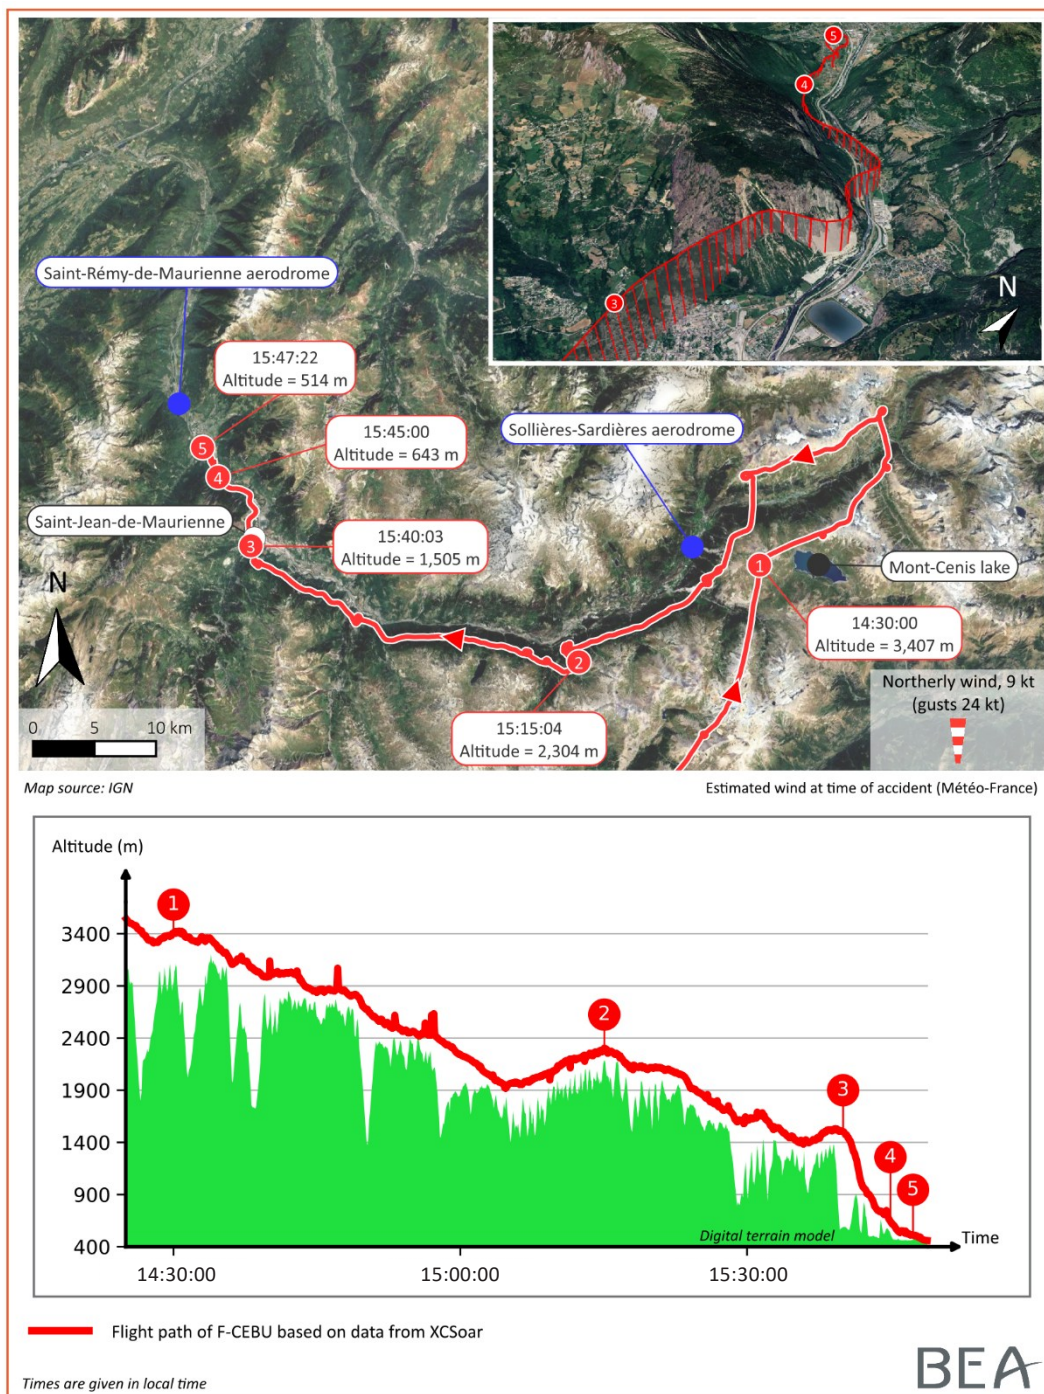
Figure 1: flight path

At 11:30, the pilot carried out a towed take-off from runway 10 at Fayence aerodrome. He headed north, crossed the southern Alps and entered Maurienne valley by passing over the ridge at a height of around 300 m (see **Figure** , point **1**). He intended to then turn around and head back south. The pilot tried to find uplifts but the glider's altitude progressively decreased. In a very short interval, the altitude was such that it was no longer possible to safely exit the valley. The pilot decided to fly in the valley in a westerly direction to search for more favourable air conditions while being aware of the probable need to carry out an off-field landing. At around 15:05, he was able to use uplifts and gain 300 m in altitude which enabled him to reach around 2,300 m (point **2**). The pilot decided to carry out a precautionary landing at Saint-Rémy-de-Maurienne aerodrome situated at a distance of around 30 km at an altitude of 430 m.

He reached the town of Saint-Jean-de-Maurienne at 15:35, at an altitude of 1,500 m, and was at this point only 12 km from the aerodrome. On continuing northwards, he found himself on the lee side of steep ground (point **3**) which resulted in a sudden, quick loss of altitude (around 430 m in 1 min 15 s, i.e. a mean rate of sink of 5.7 m/s). The pilot flew around the high ground to reach flat land to search for a favourable area for an off-field landing. The valley was initially narrow and did not offer a suitable field for landing. The glider was at a height of around 160 m when the pilot

reached a more favourable sector (point 4). He selected a field and then carried out a U-turn at a height of 70 m to reach it (point 5). At a height of a few metres, the pilot perceived and avoided a power line. The glider struck a tree and then collided with the ground.

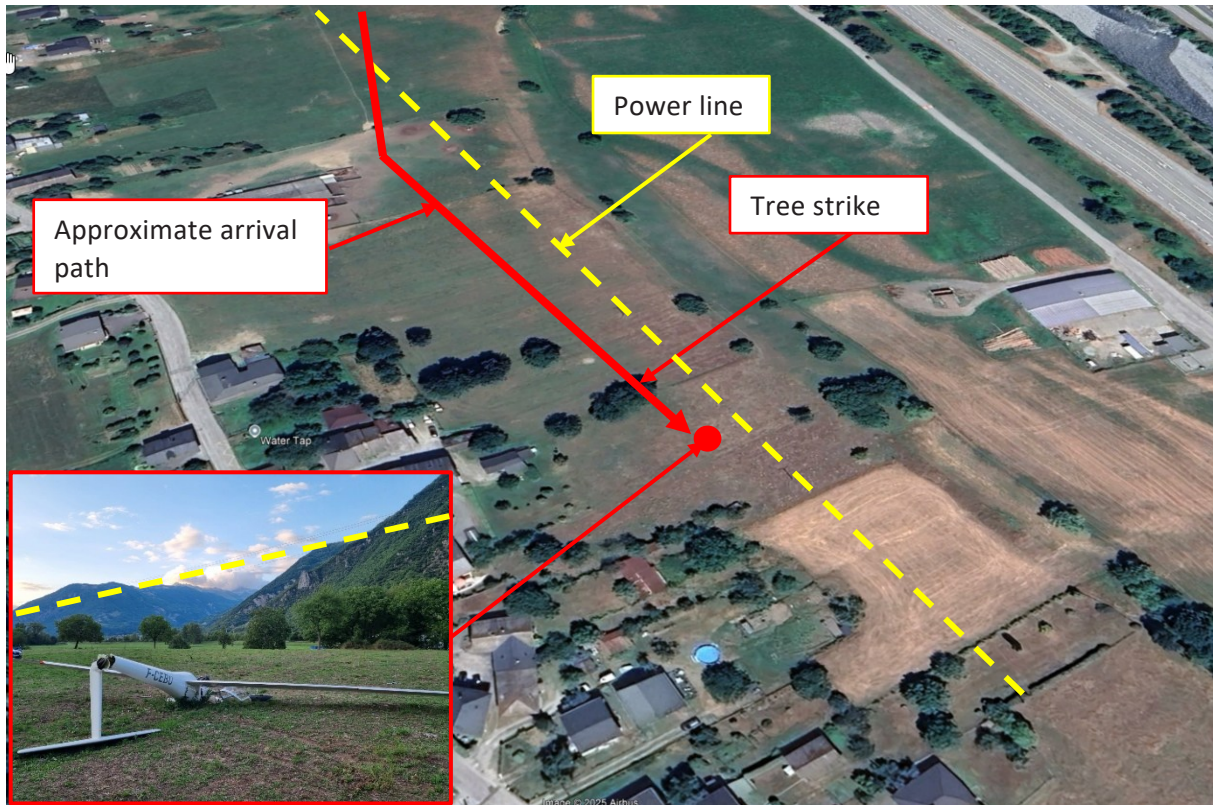
Figure 2: accident site (source: Google Earth and BEA, annotations BEA)

The glider was on a south-easterly flight path when it struck the trees and then collided with the ground. The wreckage was situated approximately ten metres from the power line.

Numerous power lines were present in the sector. To the north of the sector was a built-up area. To the south, over around 4 km, the very narrow valley, along which runs a road and river, offered no landing possibilities.
