**Accident** to the EVEKTOR AEROTECHNIK TeamEurostar  
identified **59CXR**  
on Sunday 3 August 2025  
at Thézac

## **Collision with ground, post-impact fire**

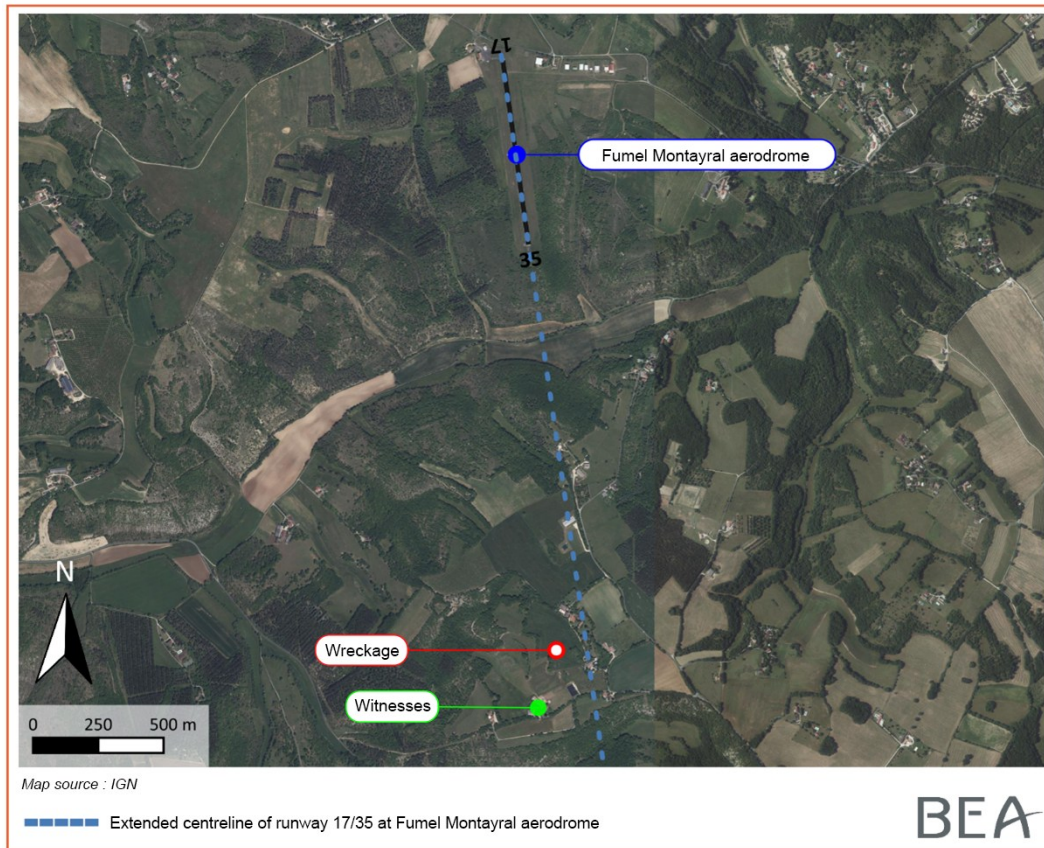
A field investigator went to the accident site. The wreckage was grouped together, seemed to be complete and was lying upside down on the ground. There were few marks on the ground. The observations indicated that the microlight had a steep nose-down attitude and a left bank when it collided with the ground.

Figure 1: overall view

The damage resulting from the fire meant that it was not possible to draw any conclusions about the condition of the microlight before the accident. The damage observed on the propulsion system was the result of the collision with the ground. The ground fire destroyed the components of the ignition, lubrication and fuel systems making it impossible to be conclusive about these systems.
