**Accident** to the Best-Off Nynja 912 UL  
identified **67BYO**  
on Wednesday 6 August 2025  
at Royan – Médis aerodrome

**Loss of control in initial climb, collision with ground, fire**

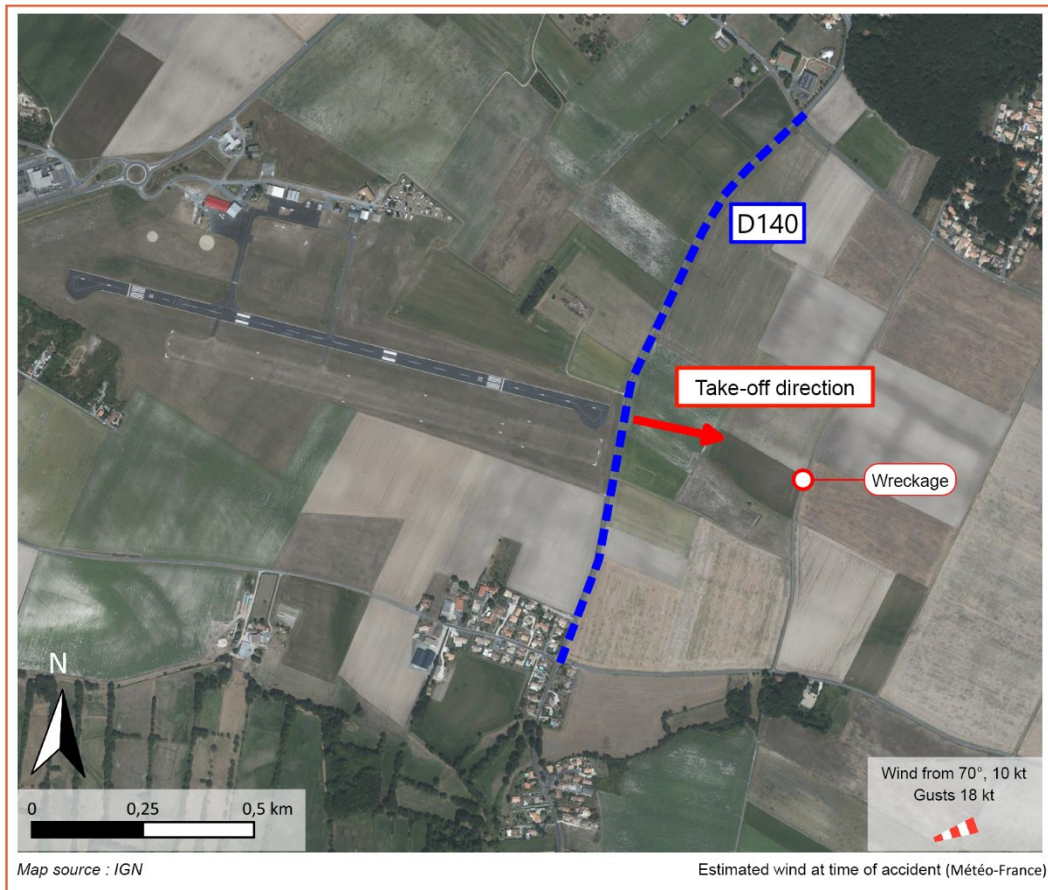
The pilot took off from paved runway 10<sup>2</sup> of Royan – Médis aerodrome to carry out aerodrome circuits. While the microlight was in its initial climb, a witness on the ground<sup>3</sup> indicated that the microlight seemed to be flying slowly before suddenly taking a steep roll angle and rapidly losing altitude. The microlight collided with the ground 460 m after the end of runway 10 on its extended centreline and then caught fire.

<sup>3</sup> The witness was a passenger in a car travelling along the D1740 road adjacent to the end of runway 10 and perpendicular to the runway extended centreline (see **Figure 1**). He had no particular aeronautical experience.

Figure 1: aerial view of Royan aerodrome and areas flown over in initial climb after taking off from runway 10 (source: BEA)

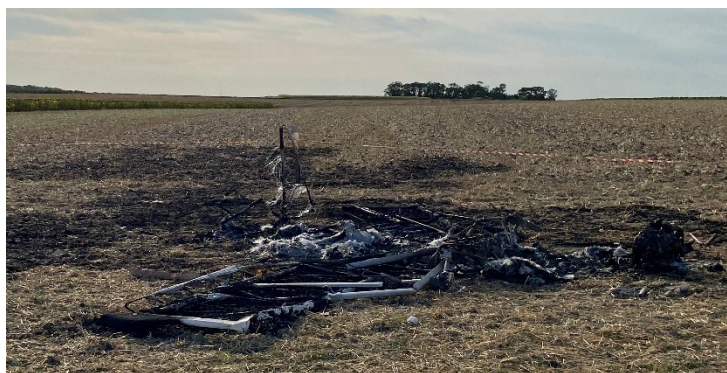
The wreckage was situated 460 m after the end of runway 10. It was found complete, grouped together and burnt.

The initial information collected at the accident site did not reveal any aspect of the structure or flight controls that might have contributed to the accident.

*Figure 2: wreckage of 67BYO (source: BEA)*

The powerplant was examined at the BEA. However, due to the extent of the damage, it was not possible to carry out exhaustive examinations. No anomaly which could have contributed to an engine malfunction was observed.

The examination of the propeller debris revealed no indication of engine torque at the time of the impact with the ground. It was not possible to determine if this apparent lack of torque was the result of a pilot action or a failure of the powerplant system.
