**Accident** to the PILATUS PC-6/B2-H4  
registered **D-FIPS**  
on Sunday 28 June 2026  
at Tomblaine

| This is a courtesy translation by the BEA of the preliminary report on the safety investigation. As accurate as the translation may be, the original text in French is the work of reference. | |

**Loss of control just after take-off, collision with ground,  
during a parachute dropping flight**

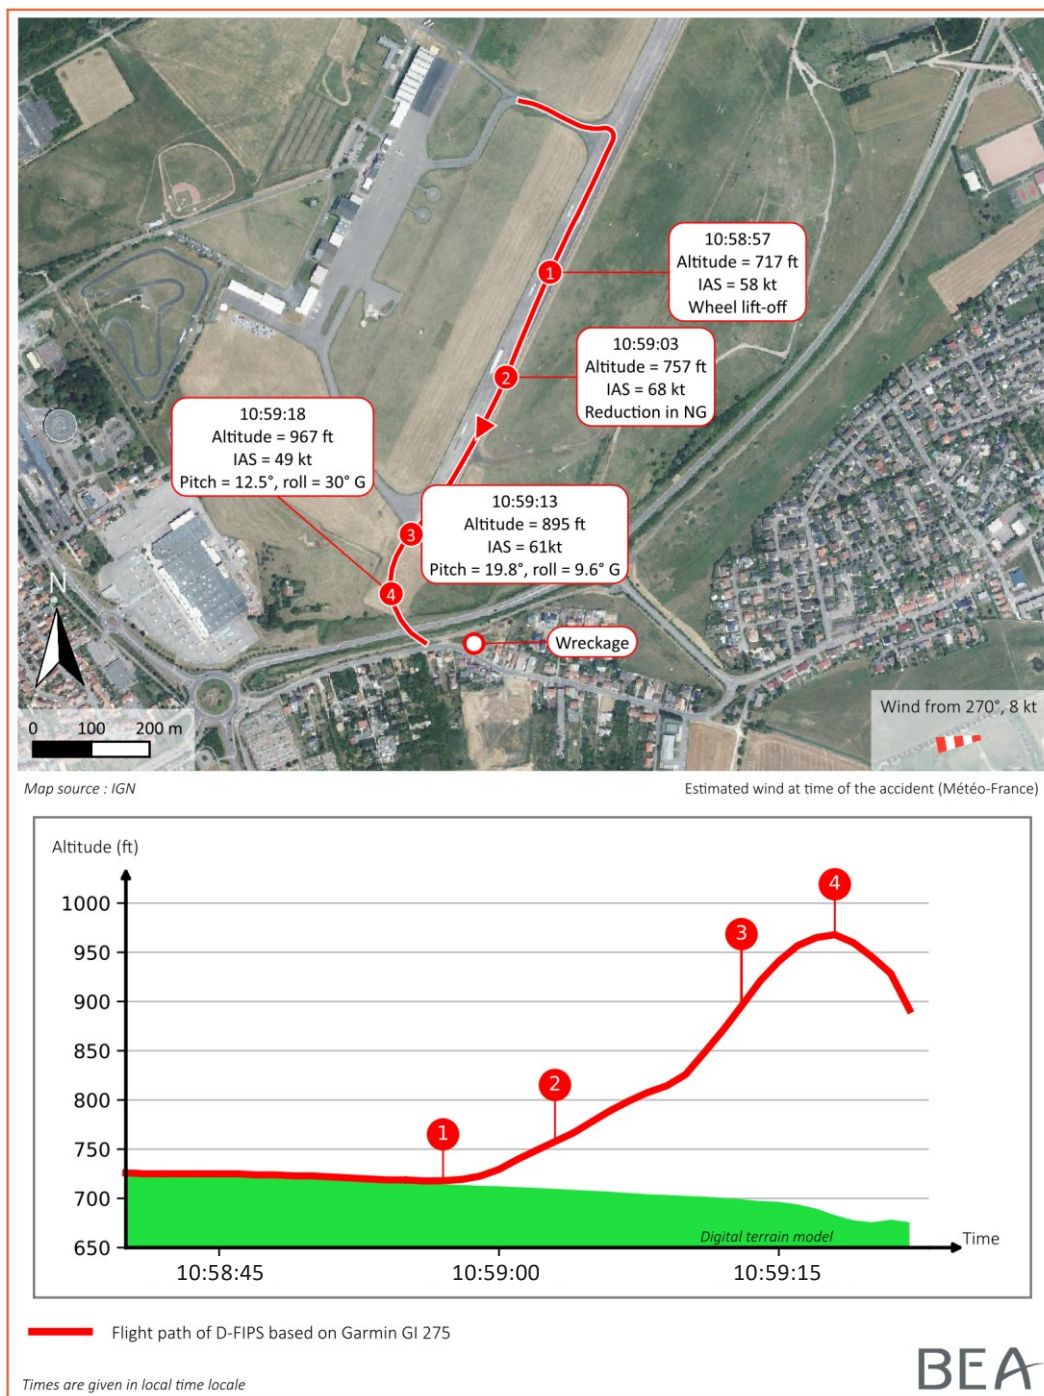
A short time later, the gas generator speed (Ng) of the turboprop engine decreased by around 10%. At the same time, the propeller speed (Np) briefly fluctuated before returning to its nominal value of 2,000 rpm<sup>4</sup>. Soon after, the pitch attitude of the aeroplane increased and the stall warning was briefly activated three times. The pilot turned left with a high pitch attitude and the stall warning continuously sounded. The aeroplane entered an asymmetric stall and collided with the ground.

Figure 1: flight path of D-FIPS based on on-board Garmin GI-275 equipment

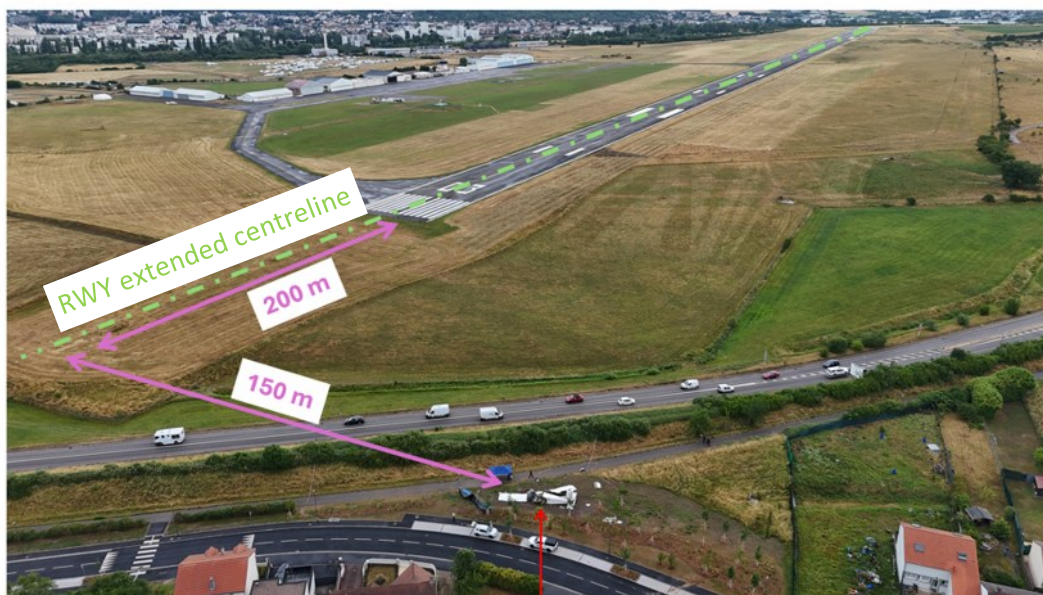
**Wreckage**

*Figure 3: accident site (source: BEA)*

The observation of the site and wreckage found that the aeroplane had struck the ground on a near-vertical flight path, with a steep nose-down attitude and left bank.

The wreckage was complete and grouped together. The flight controls were continuous at the time of the collision with the ground.

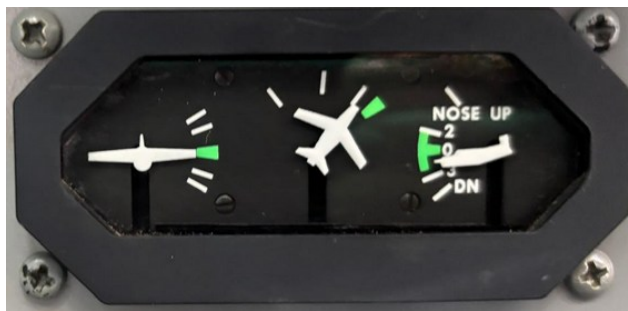
The electrical actuator controlling the THS was nominally installed on the aeroplane structure (lower attachment of actuator) and on the THS (upper attachment of actuator). No anomaly was observed during its disassembly. An X-ray radioscopic examination was also carried out which did not reveal any particularity. The actuator is operated by an irreversible screw-nut system. The position in which the actuator was found on the wreckage is therefore representative of its position during the collision with the ground. The measurement of this position indicates that the THS was in a position consistent with the manufacturer's recommendations for take-off.

- the actuators were correctly installed on the aeroplane structure;
- no anomaly was observed when they were disassembled and underwent a tomographic examination;
- measurements of the screw-nut systems indicated that both trims were in positions consistent with the manufacturer's recommendations for take-off.

*Figure 6: recreation of display in cockpit of trim positions at time of collision with ground (source: BEA)*

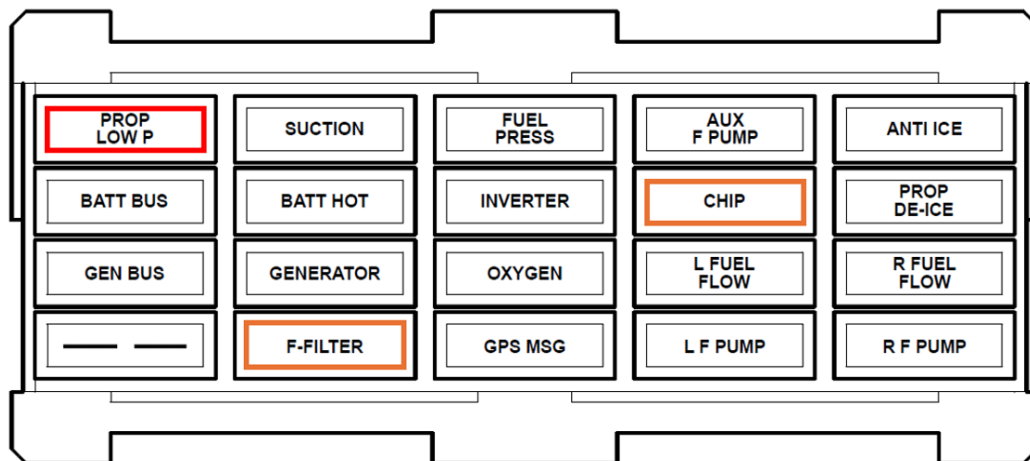
All of the lights on the annunciator panel underwent an X-ray radioscopic examination. Three lights had bulbs with a filament deformed in a more or less homogeneous manner and which had uncoiled. These were the PROP LOW P, CHIP and F-FILTER lights. The filaments of the other bulbs showed no uncoiling. Some of them had broken without deformation, other were intact. It is therefore very likely that the PROP LOW P, CHIP and F-FILTER lights were lit at the time of the collision with the ground.

Figure 7: annunciator panel (source: Pilatus, annotations BEA)

- **PROP LOW P**: warning indicating that the propeller has reached a low pitch in flight;
- **CHIP**: caution indicating that the contamination of the turboprop engine oil by metal particles has been detected;
- **F-FILTER**: caution indicating that the fuel filter is clogged.

The analysis is continuing to determine if these lights were activated before or after the loss of control.
