SAFETY INVESTIGATION INTO THE SERIOUS INCIDENT TO THE BOEING 777 REGISTERED F-GSQJ OPERATED BY AIR FRANCE ON 5 APRIL 2022 AT CHARLES DE GAULLE AIRPORT - INVESTIGATION UPDATE -

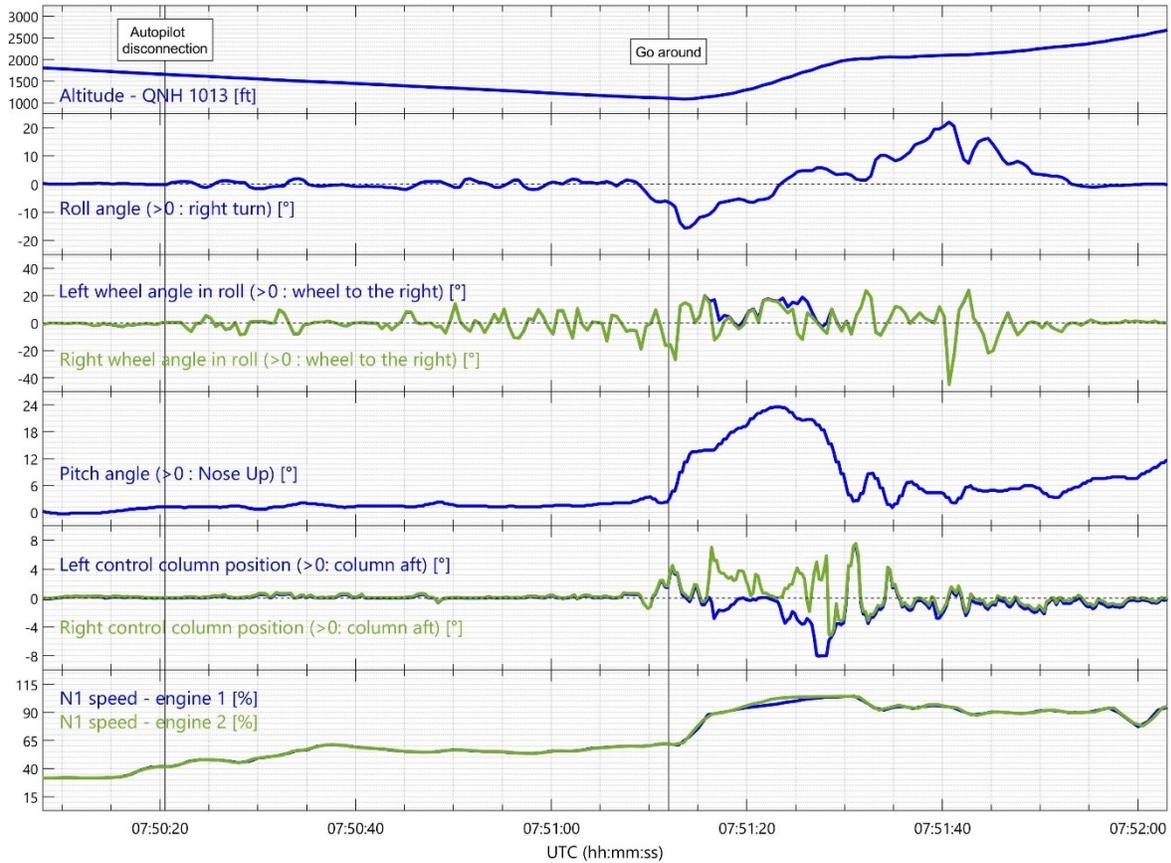
2. Flight parameters from 07:50:08 to 07:52:03 :

At 07:51:16, the captain commented that the plane was going left. The control columns were then desynchronized⁸ for 14 seconds due to opposing forces. The captain held the control column in a slightly nose-down position while the co-pilot made several, more pronounced, nose-up inputs. Two brief episodes of wheel desynchronization were also observed.

At 07:51:25, the co-pilot called out “Positive climb” and retracted the landing gear. The configuration warning was displayed⁹ and the associated aural warning (siren) sounded. The two pilots continued to simultaneously make inputs on the controls. The captain made more pronounced nose down inputs for a few seconds.

The crew analysed the situation without perceiving the antagonistic inputs made on the controls and the desynchronizations of the control channels. They considered that they could use the AP again and carry out a new approach.
