Accident to the Schleicher K8B
registered **D-3036**
on Friday 2 August 2024
at Percey

Time	Around 12:50 ¹
Operator	Gliding Adventures Europe (Netherlands)
Type of flight	Instruction
Persons on board	Student pilot
Consequences and damage	Student pilot injured, glider destroyed
This is a courtesy translation by the BEA of the Final Report on the Safety Investigation. As accurate as the translation may be, the original text in French is the work of reference.

Late precautionary landing, collision with trees during off-airfield landing, in solo instruction

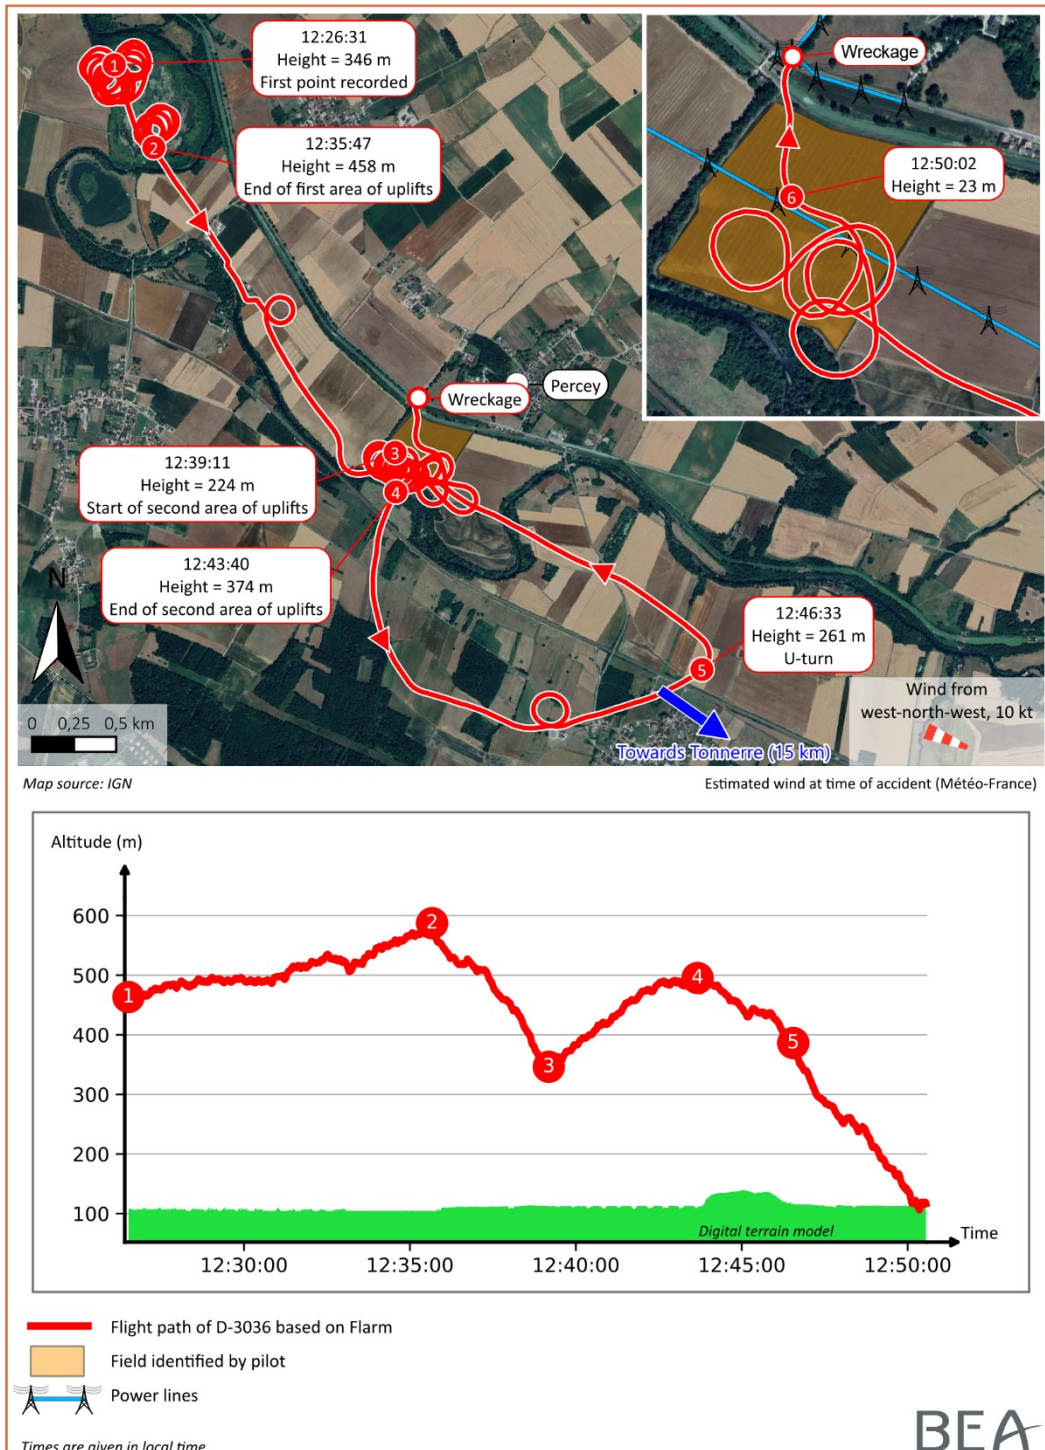
He carried out a winch take-off from LH runway 25 at 12:22. After releasing the cable at a height of 350 m, he found several uplifts close to the aerodrome which allowed him to reach a height of 450 m at around 12:35 (see **Figure 1**, points **1** and **2**). He continued the flight heading towards Tonnerre, but rapidly lost height in the following minutes.

Between 12:39 (point **3**) and 12:43 (point **4**), he found an area of uplifts close to the town of Percey which enabled him to climb from a height of 220 m to 380 m. On perceiving a line of clouds stretching out in the desired direction and thinking that he would be able to reach this potential zone of uplifts, he continued in this direction. He then realised that he was losing altitude faster than he had anticipated.

At 12:46, at a height of around 260 m, he carried out a U-turn (point **5**) to return to the previous area of uplifts and look for a suitable field. He identified a field of harvested wheat bordered by trees, with a power line situated in the middle of it. He flew figures of eight to lose altitude and observe the field. After flying over the power line which corresponded to his base leg, he observed that his speed was too high to land in the chosen field.

He then identified another field to the north-north-east on the other side of the river and turned right (point 6). He nosed up to clear another power line and trees and the left wing struck a tree. The glider turned over and came to a stop in a ditch at the edge of the road.

Figure 1: flight path of D-3036

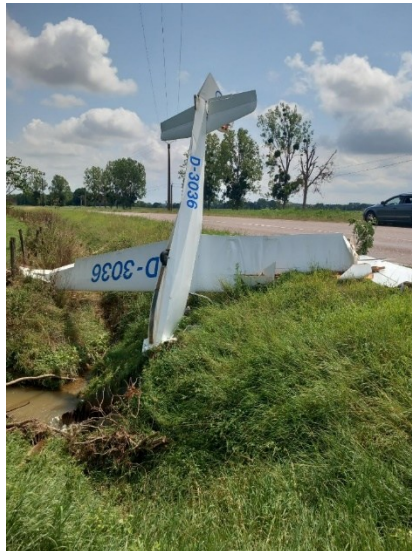
Figure 2: D-3036 after coming to a stop in ditch (source: student pilot)

He tried to gain some speed by pitching down and retracting the airbrakes in order to land in the other field (letter B and red arrow). He flew over another power line and a few trees to reach the chosen field. He then realised that he was going to strike a house (letter C). He managed to avoid the house but the left wing of the glider struck a tree. He touched down in the grass next to the road and the glider finished its run in a deep ditch.

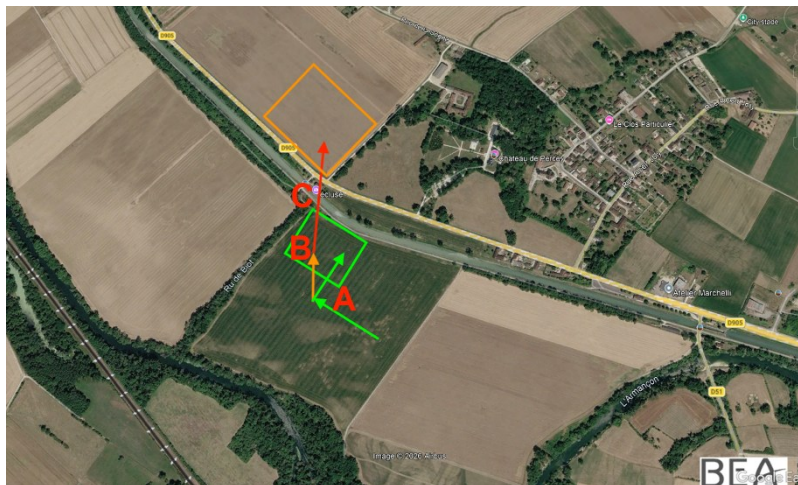
He added that at a distance that he considered would still allow him to return to the departure aerodrome, he found an uplift overhead Percey and climbed to a height of 400 m. He then saw a line of clouds in the desired direction (east-south-east) and thought he could reach it. En route, he rapidly lost altitude. On arriving below the clouds that he had spotted, he descended even more quickly (around -2 m/s). He then carried out a U-turn. He specified that he had been concentrating on climbing towards the clouds and that he had not anticipated an off-airfield landing. At a height of around 280 m, he started looking for a field and decided to return to the last area where there had been uplifts. He added that, stressed and in a hurry, he got the wind direction wrong, believing it was coming from the east instead of the west. He looked for a field, preferably a field where the wheat had been harvested, which was flat, free of obstacles and quite long. He hesitated between irregular shaped meadows and a field of harvested wheat with trees on each side, a river and a power line in the middle. He considered that the areas either side of the power line were sufficient (see green square in **Figure 3**).

Figure 3: initial field (in green) then final field (in orange) chosen by the pilot. The green arrows indicate the initially planned base leg and final approach.

He decided not to carry out a complete 90° turn but to use the diagonal length of the field (see **Figure 1**, point 6 and **Figure 3**, letter A). He then chose to fly over the river and land in the second field chosen (see **Figure 3**, arrow and orange square).
