Serious incident to the ROLLADEN SCHNEIDER - LS8-18 registered D-4776 and to the SCHEMPP HIRTH Ventus 1A registered D-5063

on 05 August 2021
at Montluçon Guéret (Creuse)

Mid-air collision between two gliders, emergency landing, during a training flight for a competition

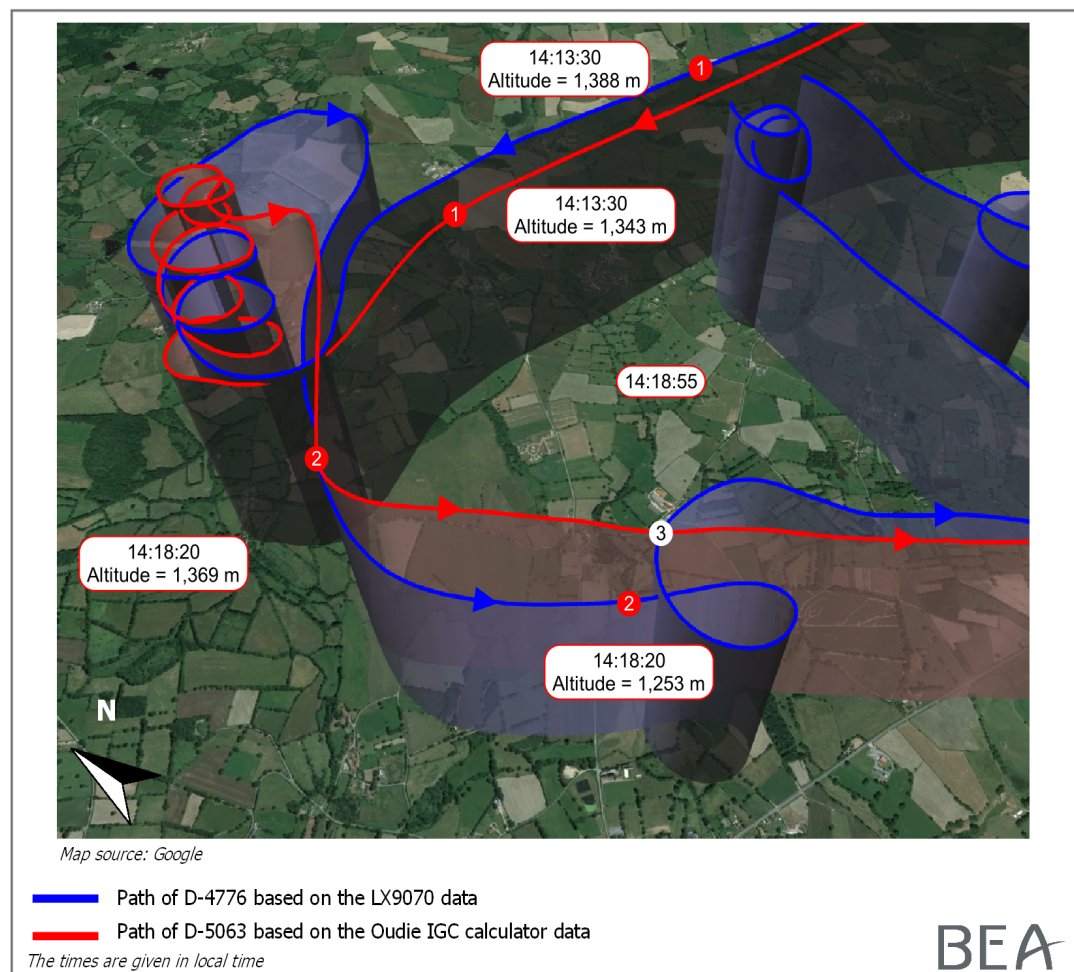
Gliders' path

The map below shows the manoeuvres around the collision.

At the time of the collision, the estimated ground speeds based on the GNSS data were 116 km/h for both gliders.
