**Accident** to the ROLLADEN SCHNEIDER LS8  
registered **D-7488**  
on Saturday 9 August 2025  
at La Mure-Argens

**Collision with vegetation and then ground, while searching for uplifts in mountainous area**

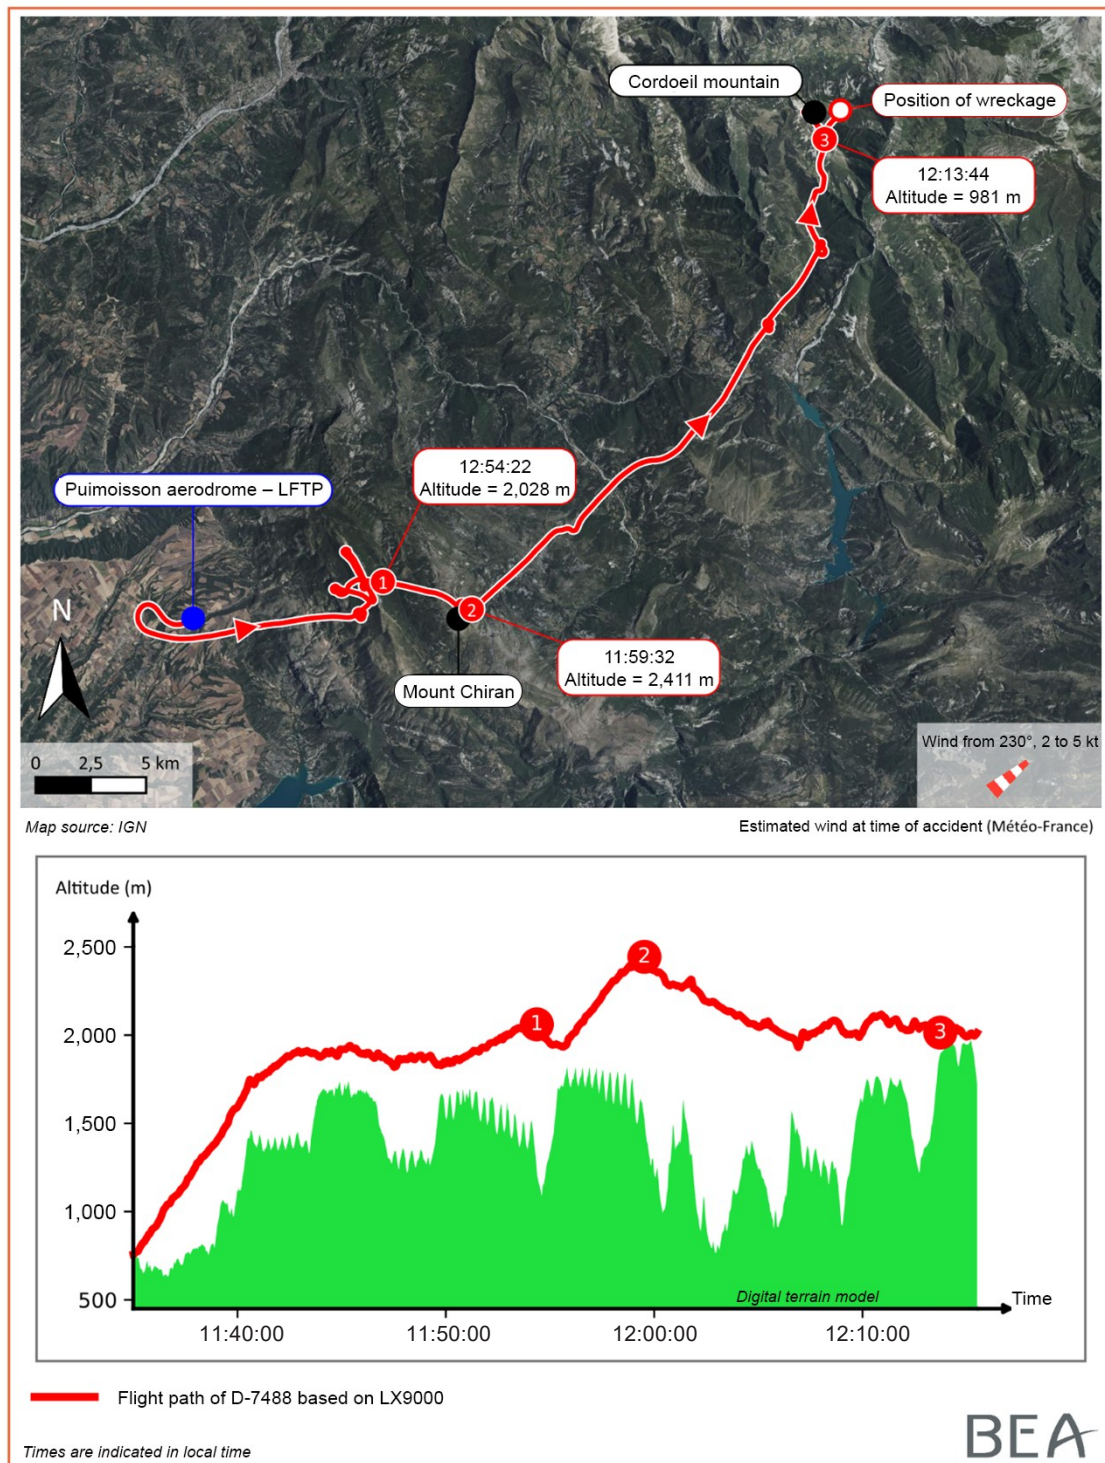
Figure 1: overall flight path of accident flight

After the cable release at an altitude of 1,600 m near Serre de Montdenier, the pilot used the first uplifts and was able to reach an altitude of around 2,000 m (see **Figure 1**, point **①**). He joined two team members who had taken off a few minutes earlier and they continued together to mount Chiran where they reached an altitude of around 2,500 m (point **②**) before continuing north.

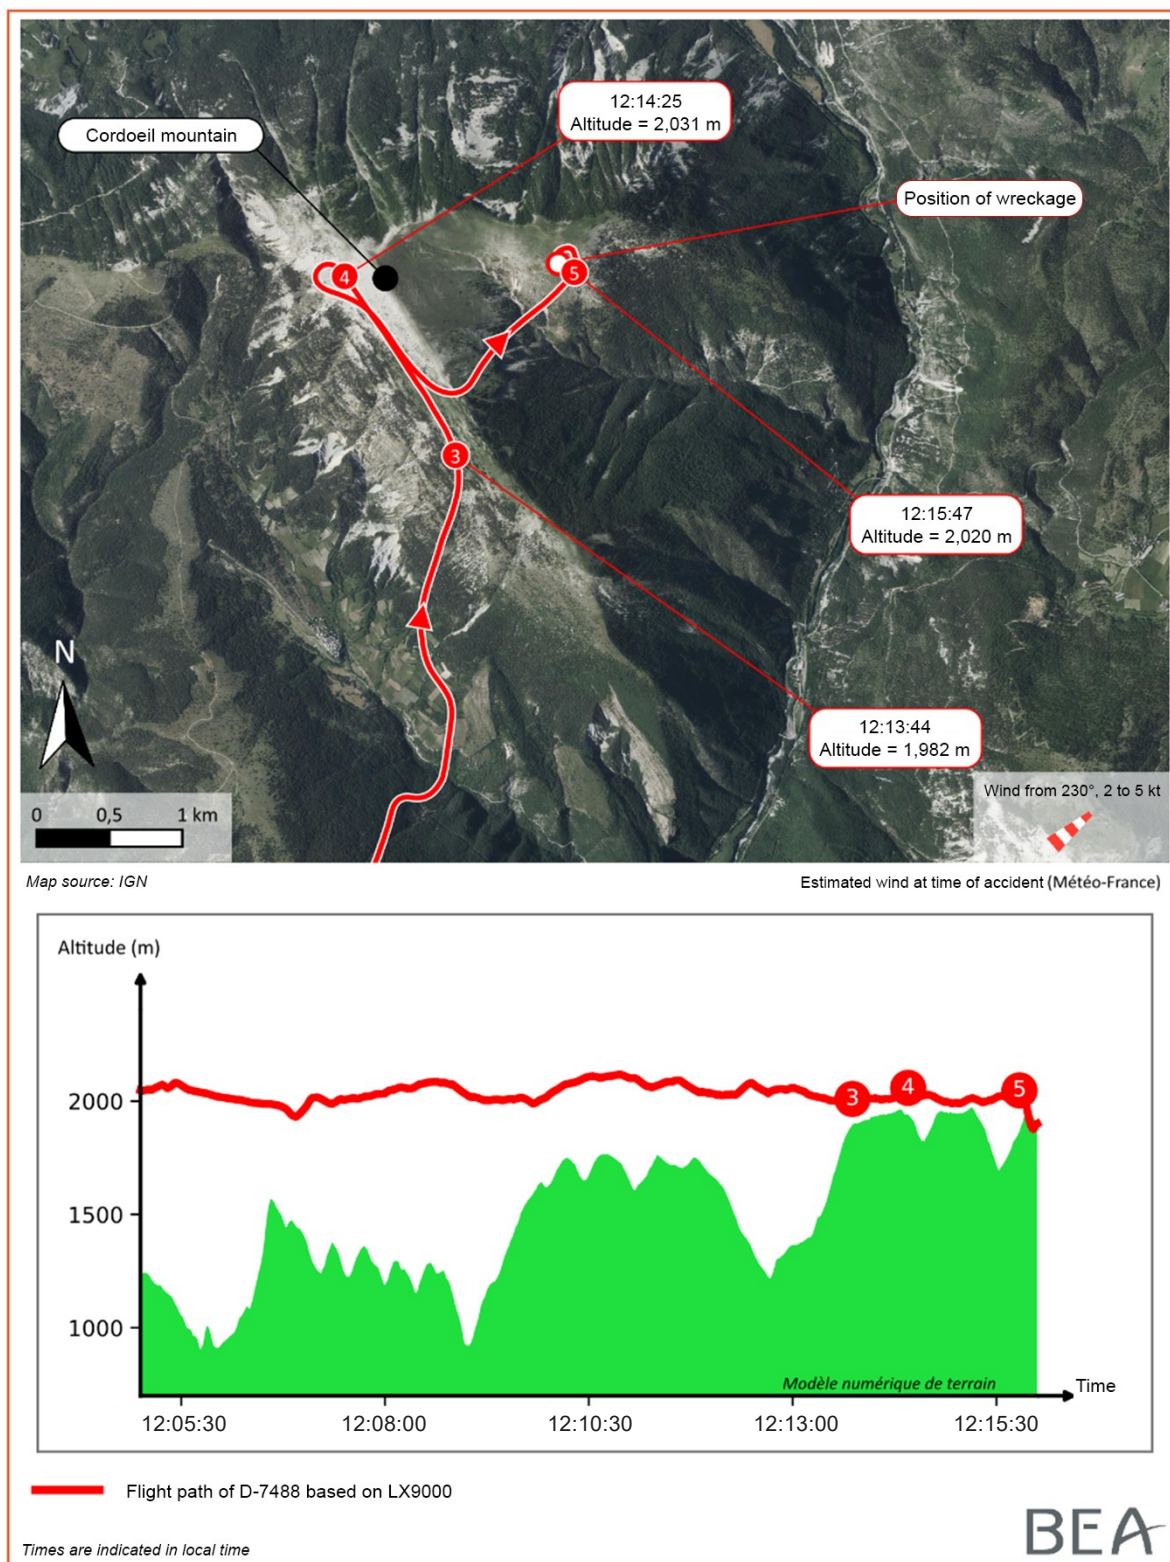
Figure 2: end of flight path of accident flight

Once at Cordœil mountain, they observed a cumulus around 500 m above the summit, a sign of possible thermal uplifts. They separated to look for them more effectively. The pilot headed west of the summit (see **Figure 1** and **Figure 2**, point **③**), another pilot headed north and the third, south-east. As the pilot did not find any uplifts, he turned around (see **Figure 2**, point **④**) to head east to where his teammate indicated he had found one.

Believing that he was at a sufficient height, the pilot carried out a left-hand turn (point 5) towards the terrain in order to join his teammate and the uplift. At this point, the altitude of the glider was around 2,070 m and the terrain ahead, around 2,000 m. A few seconds later, the pilot felt the glider sink under the influence of a downdraft. He was unable to turn right due to the high ground and thus continued his left-hand turn while monitoring his speed in order not to stall.

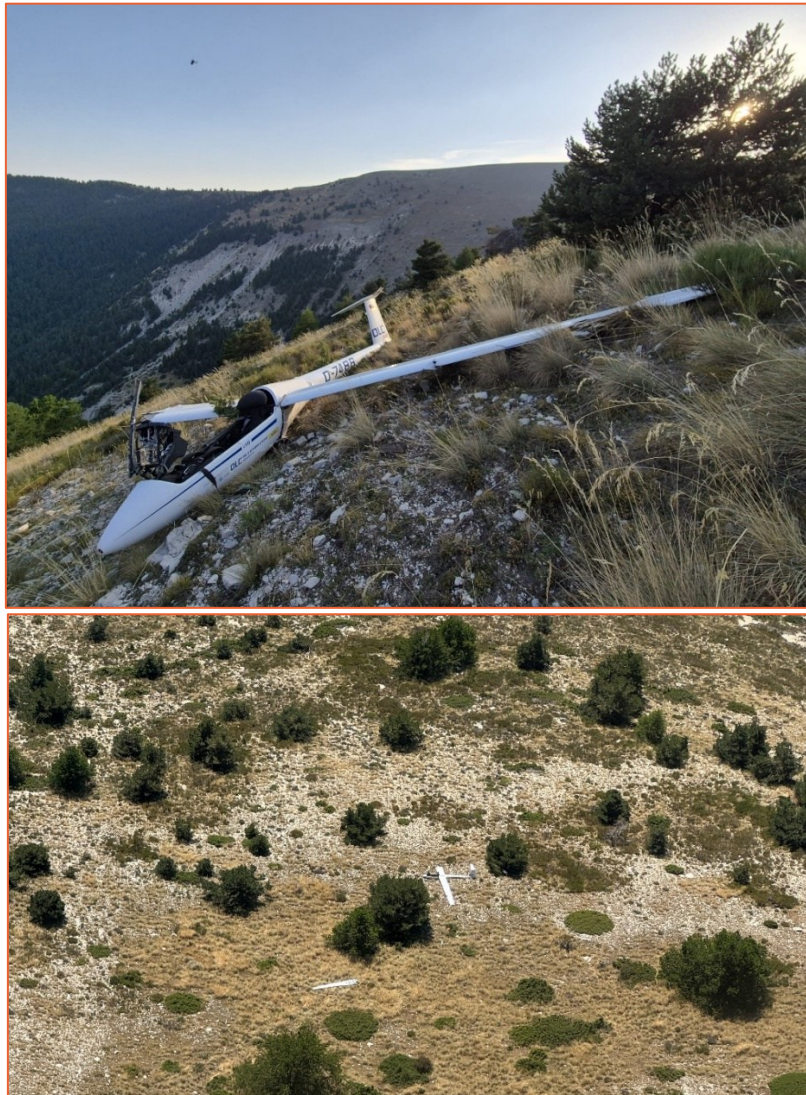
Figure 4: position of wreckage (source: pilot and team member in flight)

The glider wreckage was lying on a mountain side with a roughly 20° slope. The BEA did not go to the accident site.

The glider had sustained substantial damage, including the failure of the right-hand wing and left-hand wing tip, the failure of the left-hand horizontal stabilizer and bending failures level with the cockpit and tail.

All of the damage was the result of the collision with the vegetation and the ground.
