## **Accident** to the SCHLEICHER ASW20 registered **D-8631** on Saturday 5 April 2025 at Saint-Geniez

### **Collision with a power line during an off-field landing**

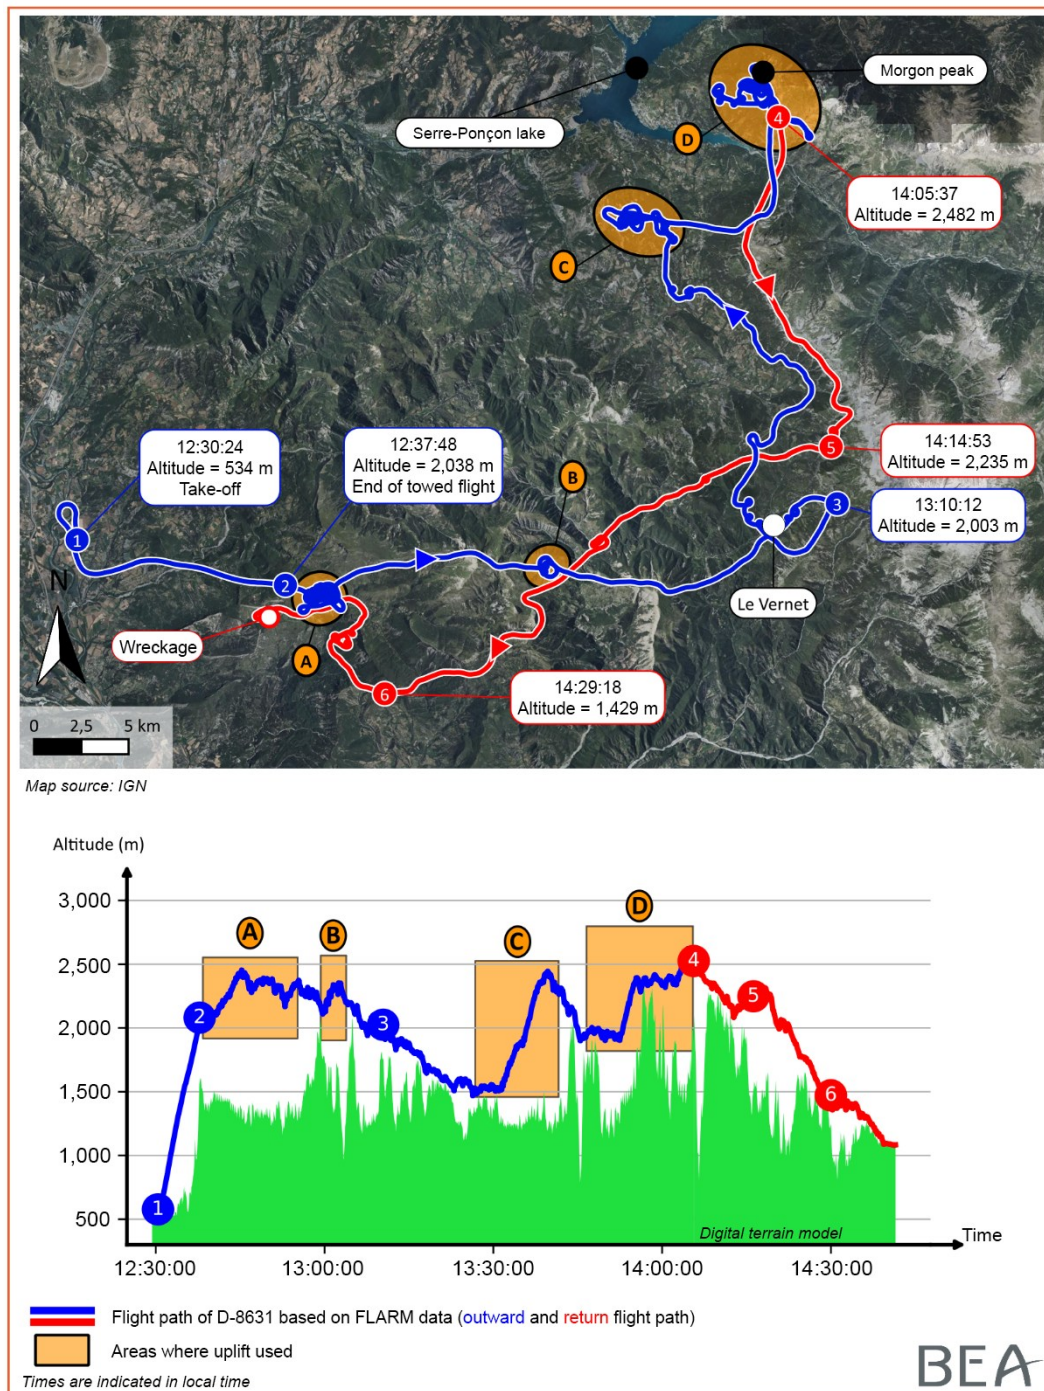
Figure 1: overall flight path

At 12:30, the pilot carried out a towed take-off from unpaved runway 35 at Sisteron - Vaumeilh aerodrome. After being towed for seven minutes (see **Figure 1**, point ②), the pilot released the cable. He then headed east using the uplifts (zones ① ②), until reaching the region of Vernet (point ③), and then north to Morgon peak (south of Serre-Ponçon lake) that he reached after a flight time of 1 h and 15 min.

He again used the uplifts to gain altitude (zone ④) for approximately 15 min. The pilot decided to return home and left the area (point ⑤) taking south (point ⑥) and then south-west headings. While navigating towards the south-west, he observed that the glider was rapidly losing altitude. He decided (point ⑦) to head to the departure aerodrome. However, he was unable to gain sufficient height to cross the ridgeline on his course. He chose to carry out a precautionary landing in a field (see **Figure 2**, point ⑧).

For the accident flight, the analysis of the flight path found that given the high ground between points ③ and ⑤ (see **Figure 1**) and the flight path followed, the pilot was no longer within glide distance to Sisteron - Vaumeilh aerodrome<sup>2</sup>, but was within glide distance to the private Seyne-les-Alpes aerodrome and to several listed fields for off-field landings. The pilot did not know of these fallback areas.

For the part of the flight between points ⑤ and ⑥, the pilot was limited by the orientation and altitude of the ridgelines and had to follow a south-westerly course which extended his flight. At point ⑥, the pilot theoretically had sufficient altitude to get back to the aerodrome on a direct course given the glider's performance but in practice, it was insufficient to fly over the high ground separating him from the aerodrome.

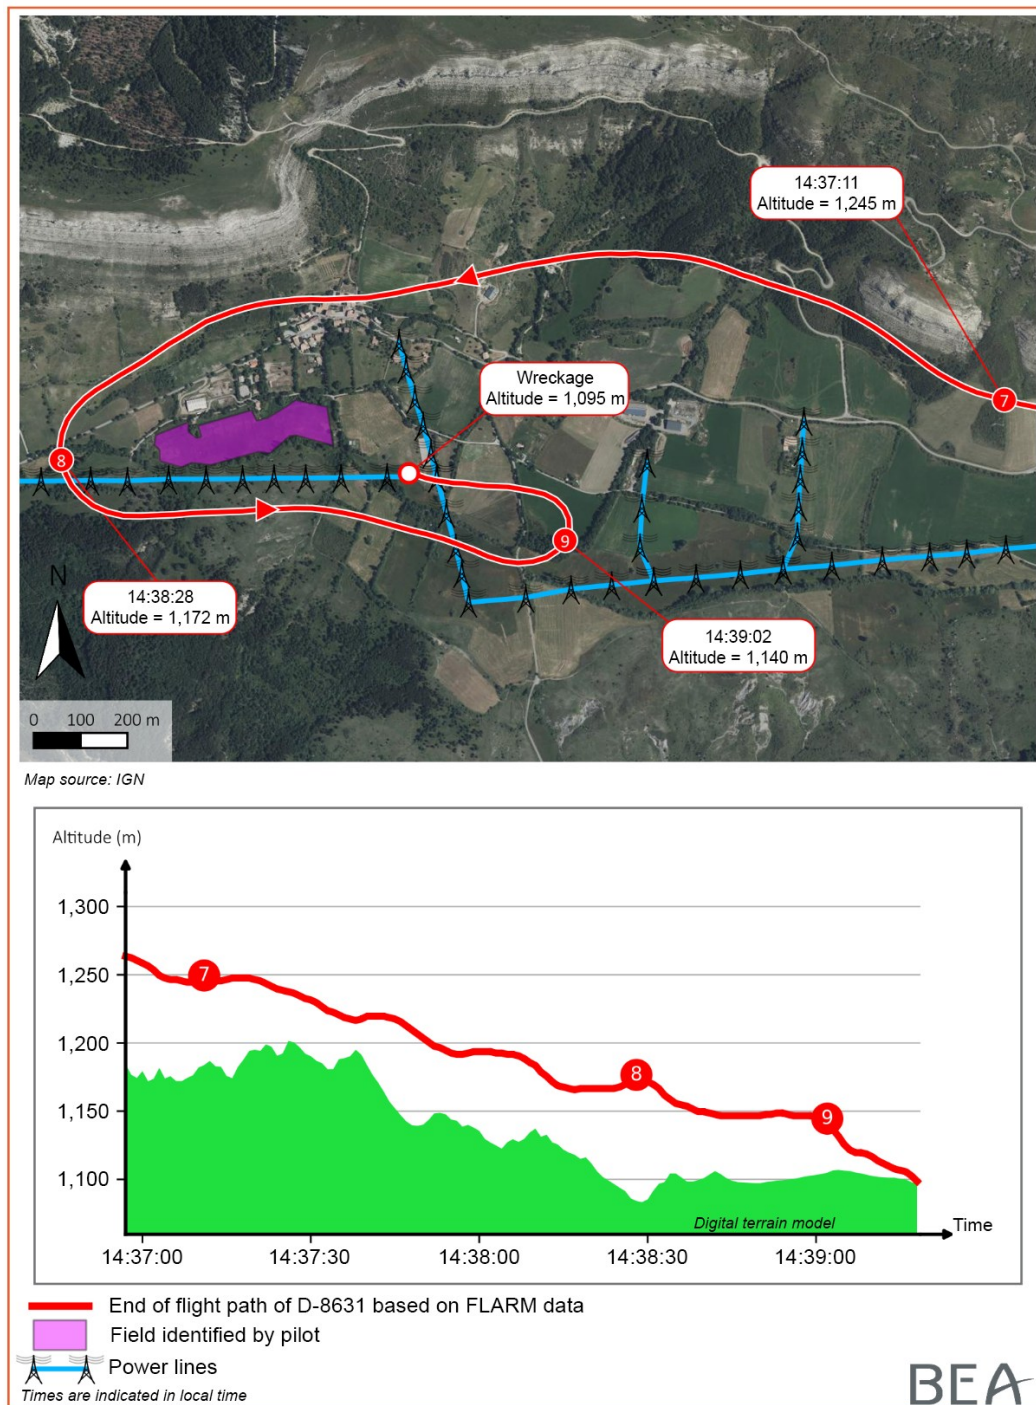
Figure 2: final flight path

After passing close to the field that he had identified, the pilot started his landing pattern (point ⑧). In the last turn (point ⑨), the glider quickly lost altitude. On final, the tail of the glider struck the cable of a low voltage power line situated at the beginning of the field which caused an electric arc. The glider was destabilized and collided with the ground before coming to a stop a few metres further on.

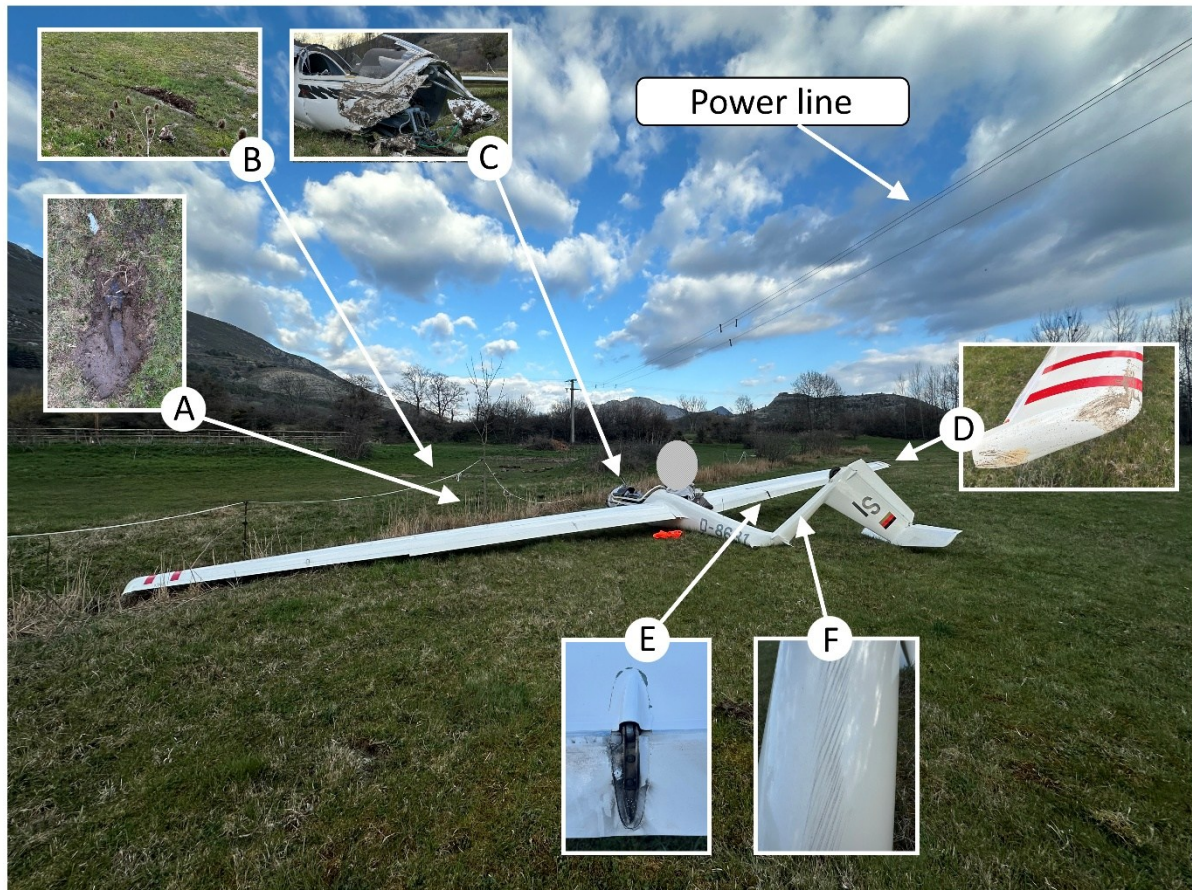
Figure 3: detail view of site and damage (source: BEA)

The accident site was situated at an altitude of 1,100 m and approximately 11 km south-east of Sisteron aerodrome. The glider wreckage was complete and lying on its belly in a field of soft ground, near the power line. Two marks were visible in the ground, one corresponding to the nose of the glider (see **Figure 3**, detail ①) and the other, to the leading edge and tip of the right wing (detail ②).

The nose of the glider was destroyed (detail ©) and the canopy broken. The right-wing tip showed signs of contact with the ground (detail Ⓓ). The tail of the glider had ruptured and rub marks with the power line were observed (detail Ⓔ). Burn marks (detail Ⓔ) level with the metal hinge of the wing flap were visible, confirming the electric arc.

The flight controls were continuous. The landing gear was extended and the flaps deflected downwards without it being possible to determine their exact position.
