Accidents

1 - to the CIRRUS SR20 registered **D-EFCD**

2 - to the REIMS Aviation CESSNA FR172H registered **D-EFTP**

on 22 August 2021

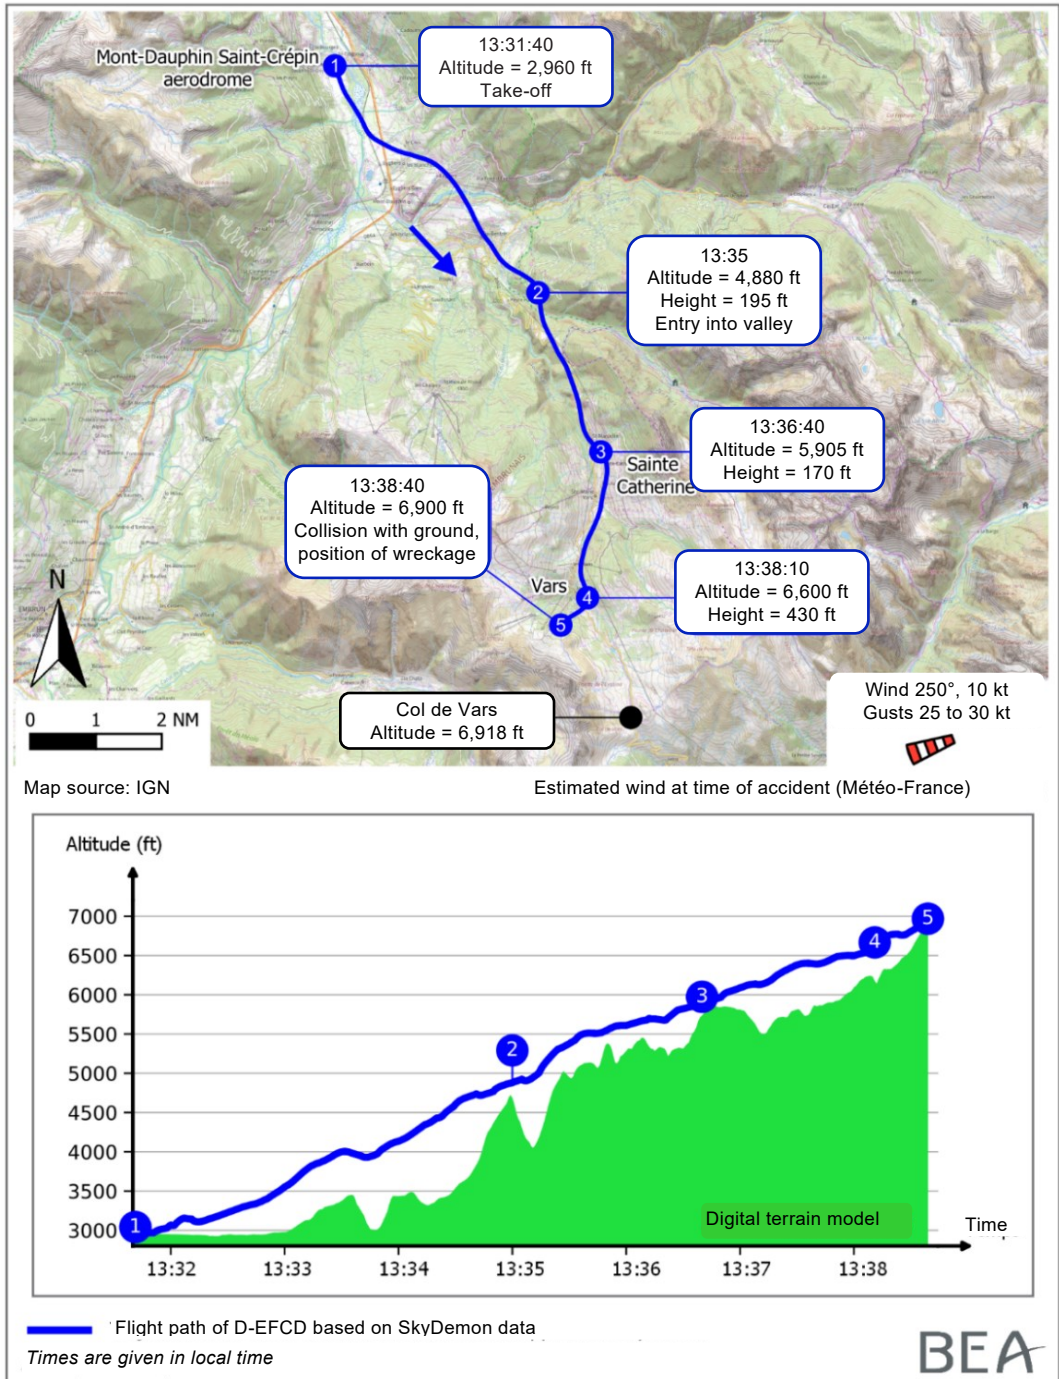
Figure 1: flight path of Cirrus SR20 registered D-EFCD

The pilot of the Cirrus SR20, accompanied by one passenger, took off at 13:31 from Mont-Dauphin Saint-Crépin aerodrome (Hautes-Alpes) (see Figure 1, point ①) bound for Barcelonnette aerodrome (Alpes-de-Haute-Provence). At 13:35, he was heading in climb at an altitude of approximately 4,880 ft (1,487 m) (point ②) towards the valley leading to Col de Vars mountain pass located at an altitude of 6,918 ft (2,108 m). The height of the aeroplane at this point was around 195 ft². At 13:35:21, he was flying at an altitude of 5,233 ft (1,595 m) and passed over the top of a very high voltage power line and close to one of the power line pylons situated at an

altitude of around 4,723 ft (1,440 m) before entering the valley. He then continued to climb, flying along the left side of the valley.

At 13:36:40 (point 3), he flew close to the hamlet of Sainte-Catherine at a height of around 170 ft. At 13:38:10, the aeroplane climbed to an altitude of 6,600 ft (2,010 m) abeam the village of Vars, situated at 3.6 km from the pass. The height of the aeroplane at this point was around 430 ft. The pilot then turned roughly 90° to the right, facing the terrain (point 4). He continued to climb in a straight south-westerly line, up to an altitude of 6,900 ft (2,105 m), while the height of the aeroplane quickly decreased. Several witnesses on the ground and in flight saw the aeroplane, on a straight path at low height, collide with the trees, facing the slope (point 5).

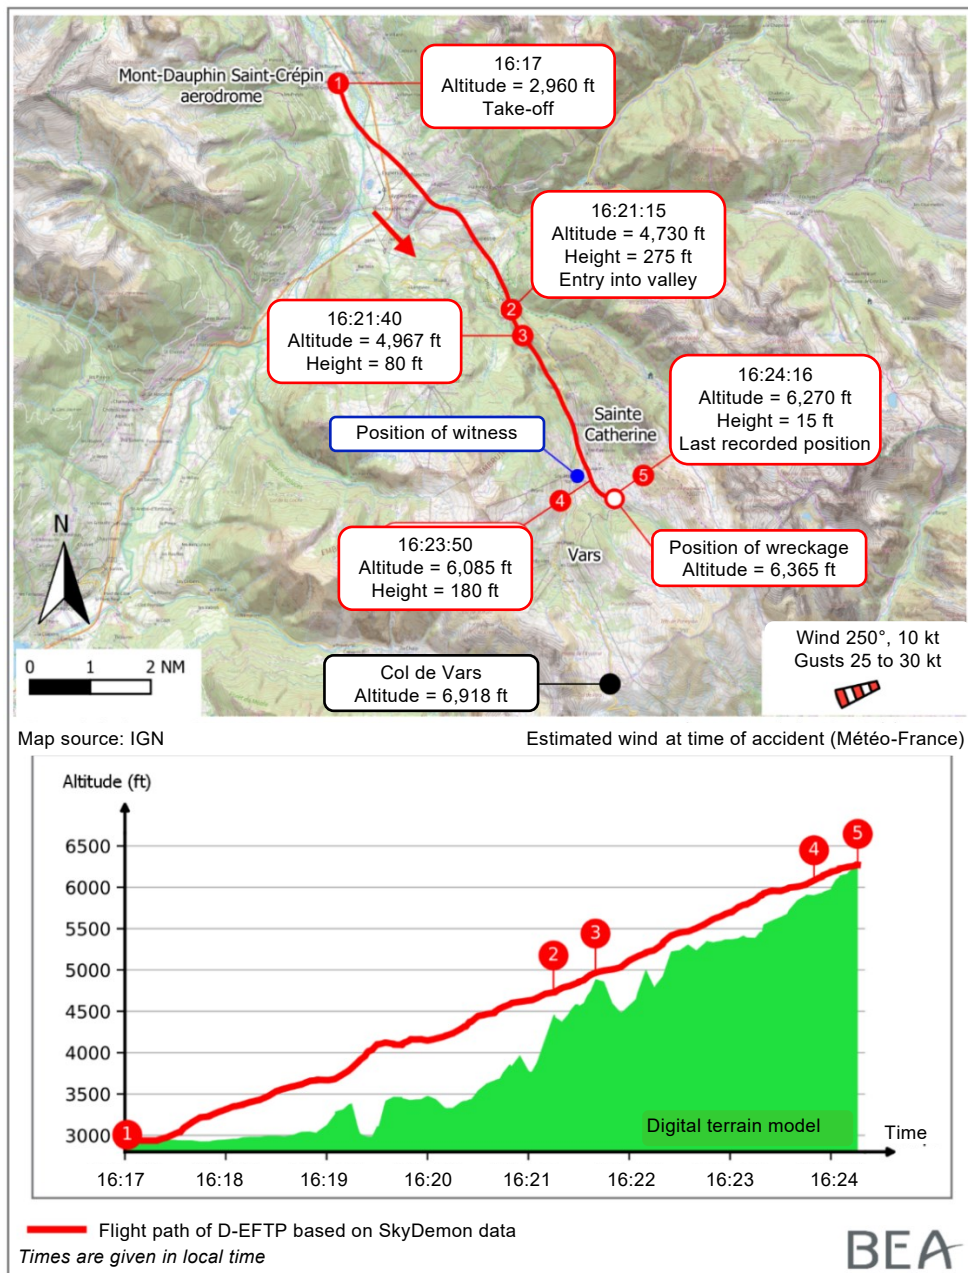
Figure 2: flight path of Cessna 172 registered D-EFTP

At 16:17, the pilot of the Cessna 172, accompanied by two passengers, then took off and headed in the same direction as the SR20 (see Figure 2, point ❶). At 16:21:15, at an altitude of around 4,730 ft (1,440 m), he flew in climb over the same very high voltage line situated on a ridge and entered the valley leading to the pass. At this point, the aircraft was at a height of around 275ft (point ❷). Around 30 s later, at 16:21:40 (point ❸), the aeroplane was at a height of approximately 80 ft. The pilot continued climbing, flying along the left side of the valley. A witness on the ground said he saw the aeroplane at a low height between the hamlets of Sainte-Marie and Sainte-Catherine, with a steep nose-up attitude and a fairly low speed. At 16:23:50, when the valley split into two after the hamlet of Sainte-Marie, the pilot turned 60° to the left instead of keeping to the right and continuing in the valley leading to Col de Vars mountain pass. The aircraft was at a height of around 180 ft (point ❹). The aeroplane's altitude continued to increase, reaching 6,270 ft (1,910 m) (point ❺) while its height quickly decreased. The pilot turned left towards the terrain. The aeroplane touched down in a grass field, facing the slope and performed a ground loop.

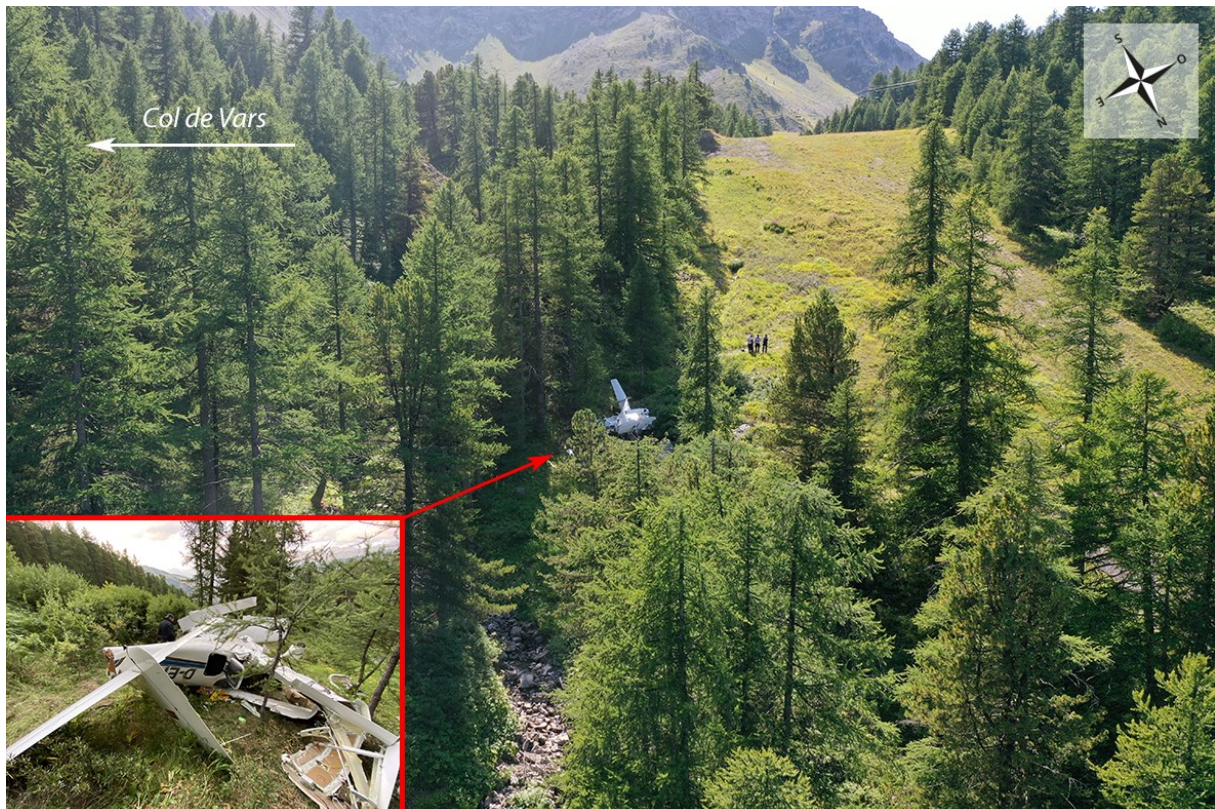
Figure 3: drone aerial view of the site and the wreckage of D-EFCD (source: BEA)

The wreckage was found at an altitude of 6,905 ft (2,105 m), in a forest located on the right-hand side of the valley rising towards Col de Vars mountain pass, at approximately three kilometres from the pass (see Figure 3). The aeroplane had struck three trees, with its wings horizontal, before colliding with the ground and turning over. The examination of the wreckage indicated that the flaps were retracted at the time of the accident. The engine was producing power at the time of the impact and no anomaly was observed during the examination.

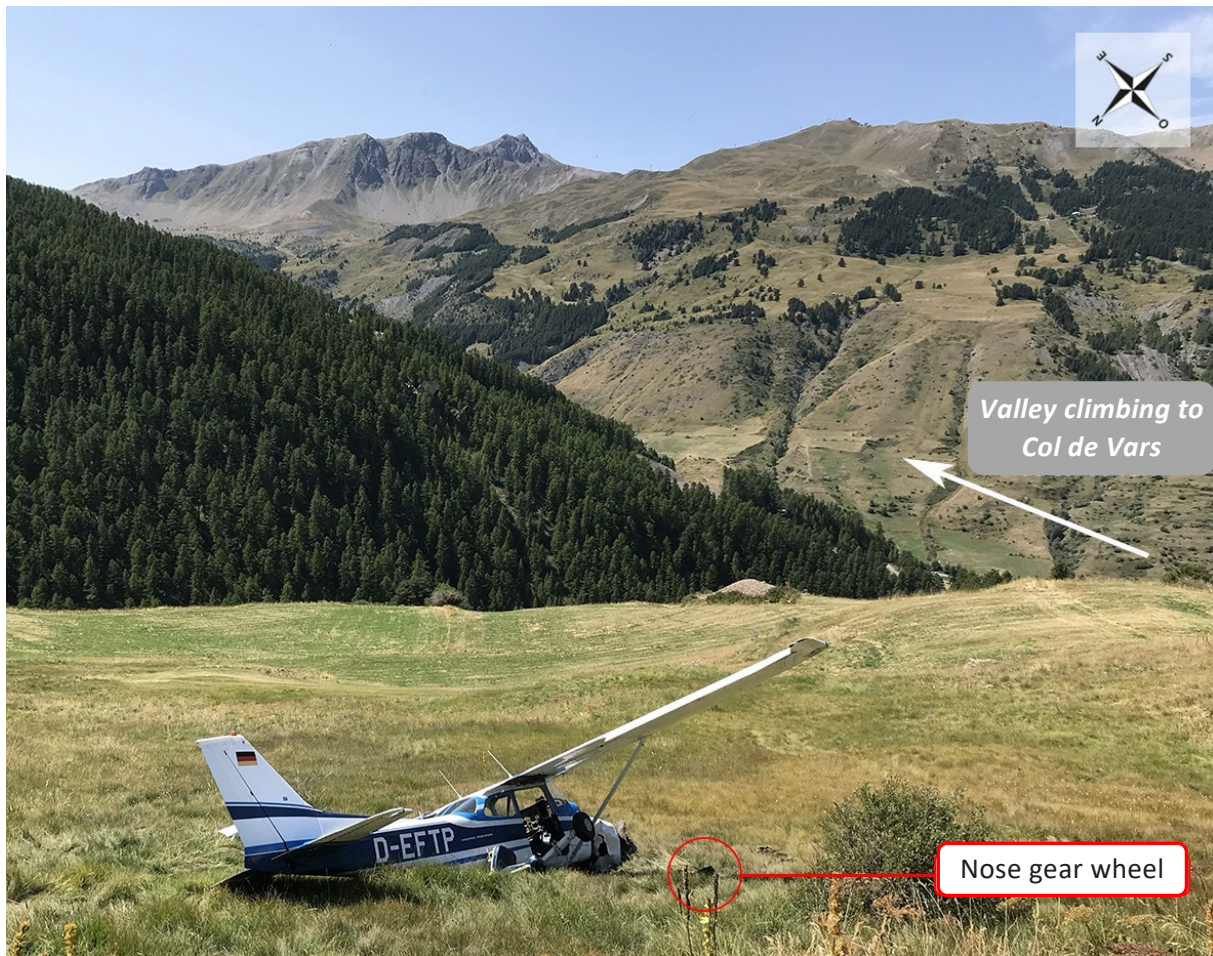
Figure 4: position of wreckage of D-EFTP (source: BEA)

The wreckage was located at an altitude of 6,365 ft (1,940 m), in a field clear of obstacles, with an average slope of 21%. The field, 5.6 km north of the Col de Vars mountain pass, was in another valley that did not lead to the pass. Marks in the grass over a distance of around 10 m showed that the aeroplane had collided with the ground facing the slope, wings level and with a slight nose-down attitude. The left main landing gear was torn off, then the left wing touched the ground. The aeroplane next spun 180° and came to a stop with the nose facing down the slope (see Figure 4), which caused major damage to the front section of the aeroplane, and the collapse of the right main landing gear and nose gear. The flaps were retracted at the time of the accident. The engine was producing power at the time of the impact and no anomaly was observed during the examination of the wreckage.
