Accident to the CESSNA TR182 (RG)
registered **D-ELXC**
on Friday 19 July 2024
close to Vichy - Charmeil aerodrome

**Collision with vegetation during an off-field
emergency landing**

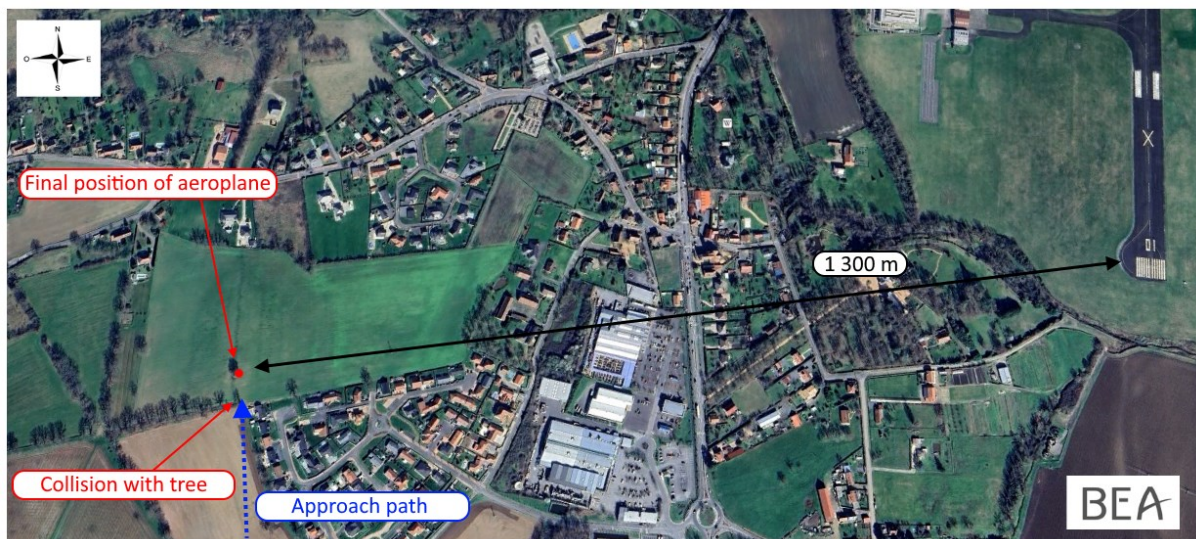
Figure 1: overview (map source: Google Earth)

The aeroplane was situated in a field at 1,300 m from and to the west of the threshold of runway 01 of the aerodrome at an altitude of 870 ft. Marks from the main landing gear run were visible and showed a slight leftward deviation before the aeroplane pivoted 180°. The aeroplane travelled approximately 40 m between the collision with the tree at the beginning of the field and its final position.

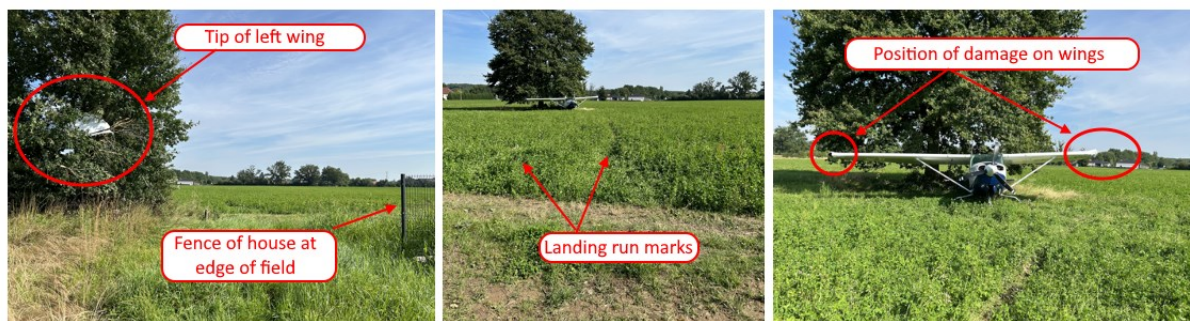
Figure 2: damage and marks (source: BEA)

The tip of the left-hand wing was torn off and found in the tree at the beginning of the field. Distortions were visible at the left-hand wing root and on the upper surface of the wing.

The front of the right-hand wing tip was dented, corresponding to the point of contact with the tree when the aeroplane pivoted.

The three metal blades of the propeller were bent backward, indicating that the engine was not delivering power at the time of landing.

The aeroplane's tail was slightly damaged and folds were visible on the moving part of the elevator.

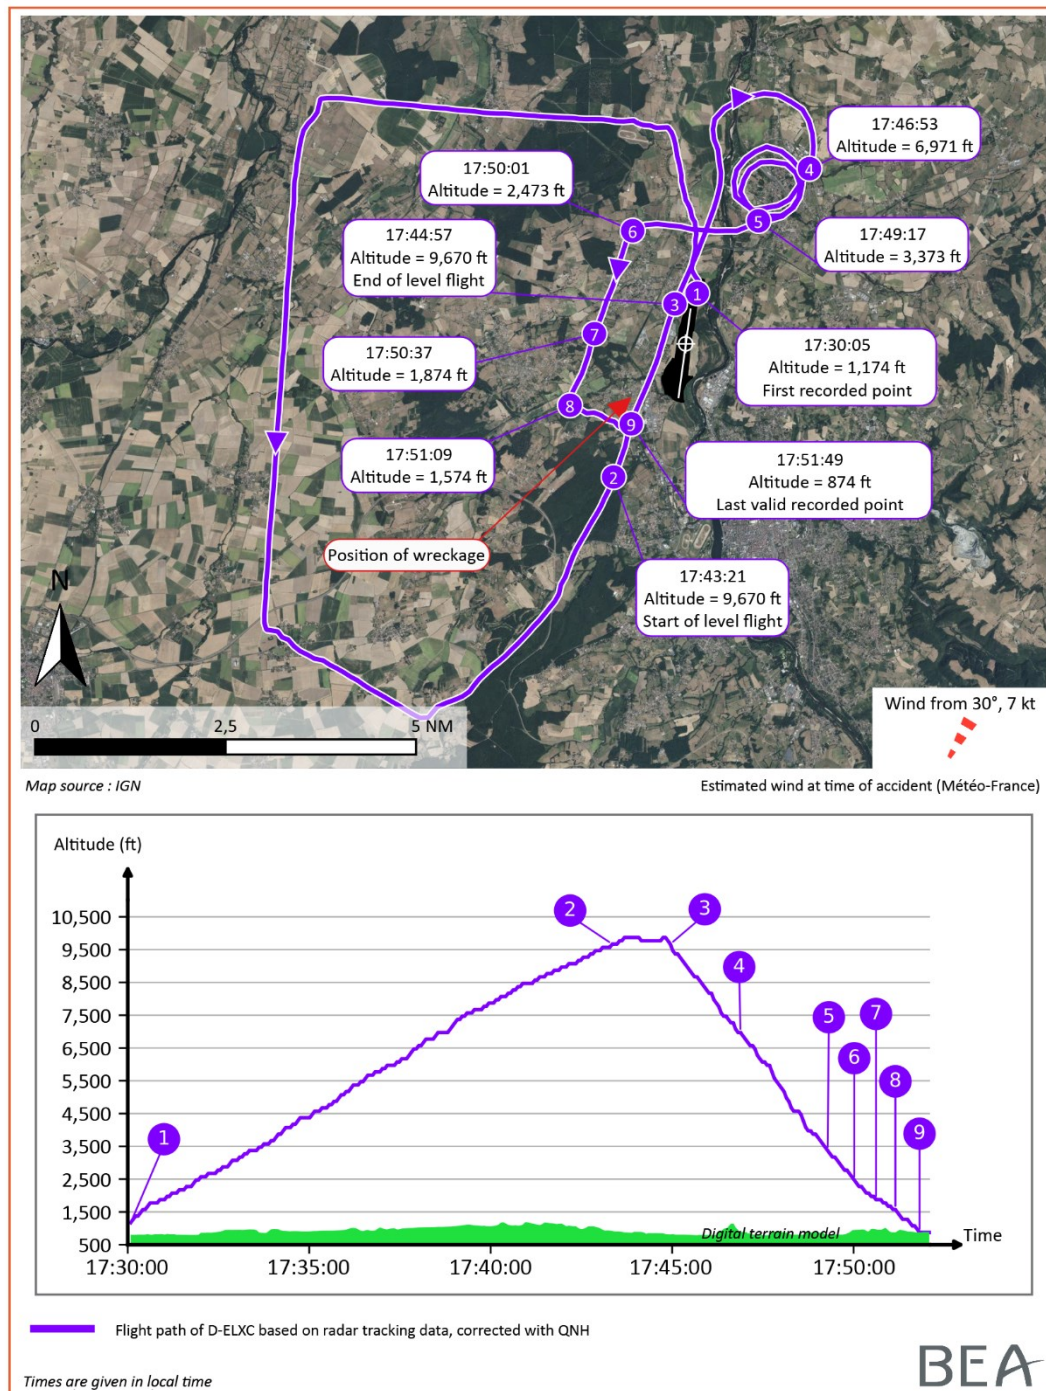
Figure 5: flight path followed during last flight

The radar track shows that after the jump at FL 100, the pilot descended by making a series of right-hand turns at an average rate of descent of approximately 1,500 ft/min. He joined the aerodrome circuit (see point 6 of Figure 5) while continuing his descent in the downwind leg at an average rate of descent of 1,000 ft/min. This reduction in the rate of descent probably corresponds to the speed reduction phase in preparation for landing. The descent continued until the end of the downwind leg (point 8), at which point the pilot most likely wanted to readjust power and realized that the engine was no longer delivering power. Up to the last valid (point 9), the average rate of descent was approximately 1,000 ft/min.

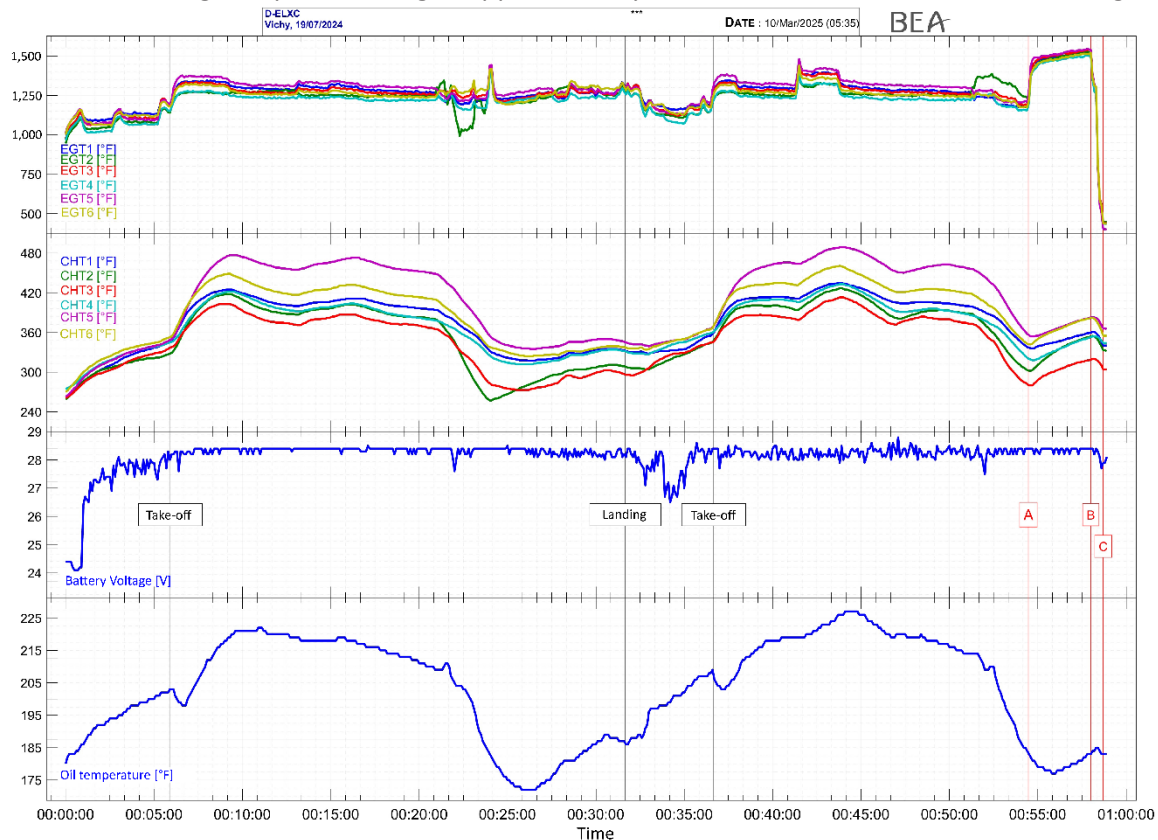
Figure 6: EDM parameter chart (source: BEA)

The parameter chart below shows the last two flights. At the end of the second rotation, the increase in EGT temperatures in a 3 min 2 s interval (see Figure 6, between points A and B) appears to indicate a lean air/fuel mixture until the engine shut down in flight (see point B).

The end of the flight corresponds to the parameter recording stopping (see point C) and occurs approximately 40 s after the engine shut down in flight, which is confirmed by the sharp drop in EGT temperatures (between points B and C).

This abnormal engine operation began approximately four minutes before the end of the flight.
