Accident to the DIAMOND DA62
registered **D-IRAY**
on Thursday 21 September 2023
at Seichamps

**Engine failure in climb, emergency landing,
collision with vegetation**

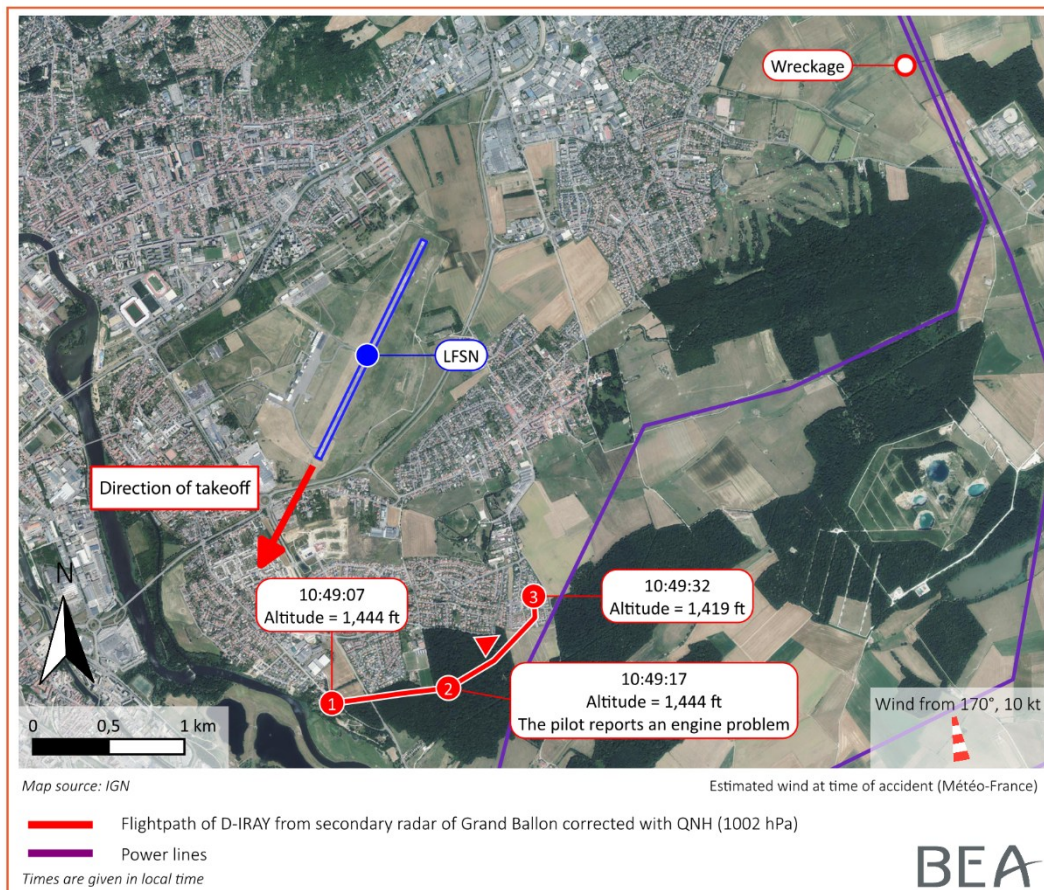
Figure 1: flight path of DA62 registered D-IRAY

While in climb, at an altitude of around 1,400 ft (i.e. a height of around 700 ft) and in a left-hand (LH) turn, the pilot reported on the AFIS frequency that he was “Coming back to field having engine problem” (see Figure 1, point 2).

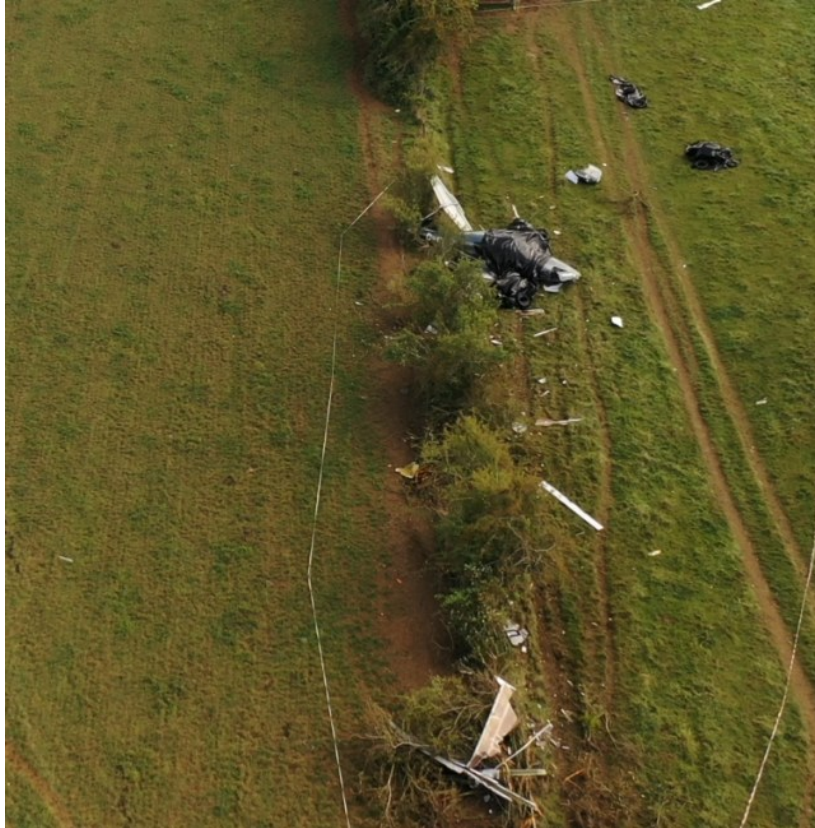
The accident site was situated to the north-east of Nancy - Essey airport, at around 2 NM from the threshold of runway 21. The examination of the site found that the aeroplane's LH wing had separated from the airframe on coming into contact with a hedge. The main wreckage of the aeroplane was found at around 30 m from this impact zone.

Figure 4: photo of accident site (source: BEA)

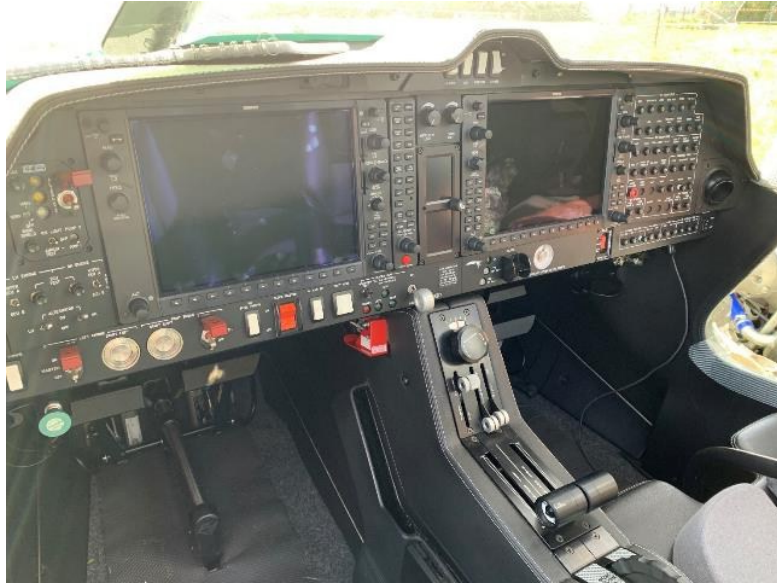
The cockpit was in good condition. The following points were observed:

- one of the engine control switches had been moved by the emergency services. The emergency services could no longer remember which one;
- the two LH and RH (right-hand) fuel pumps were set to ON;
- the yaw trim was centred and slightly to the right;
- the flap control was in the "Take-off" position;
- the elevator trim was in the "Nose-up" position;
- no SD card was present in the slots of the avionics suite³.

Figure 5: view of cockpit (source: BEA)

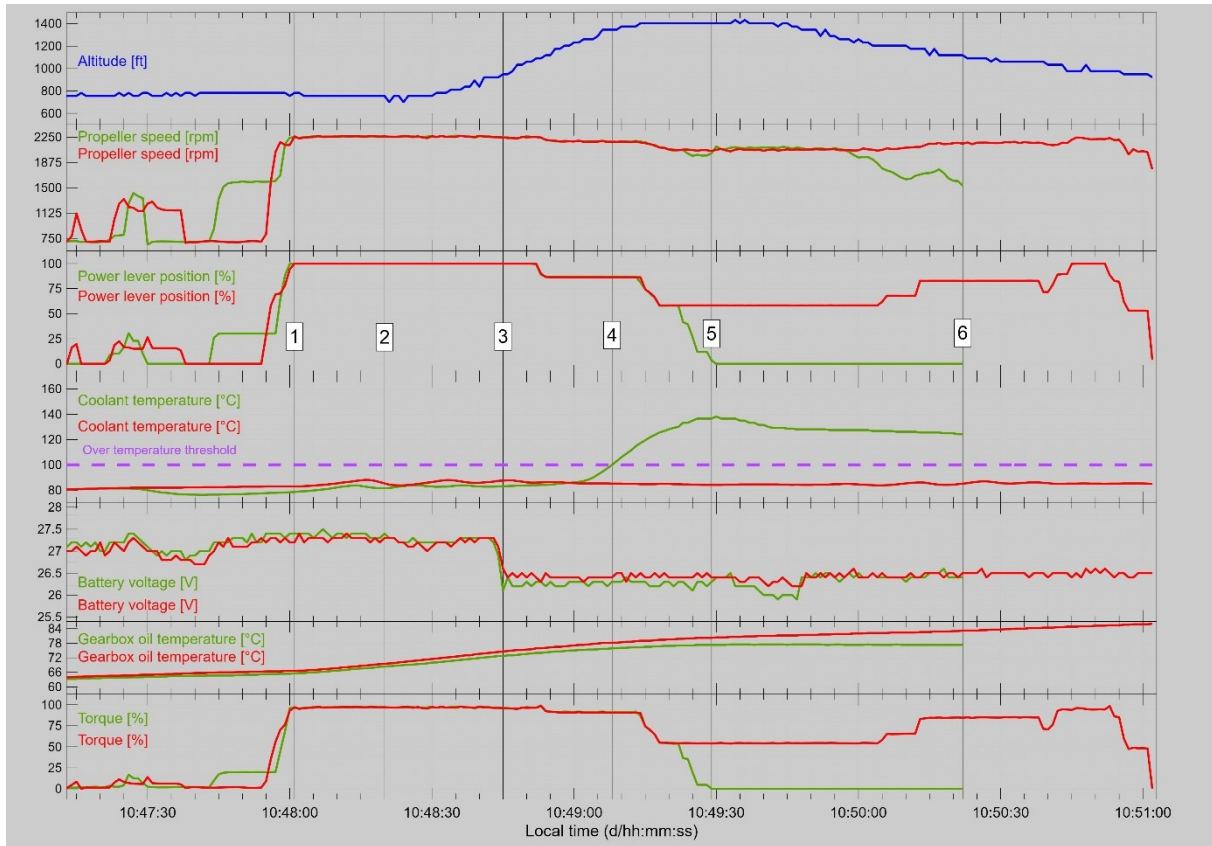
Figure 6: data from the EECU for the last four recorded minutes
In red: LH engine, in green: RH engine

Engine power was increased at 10:48 (see **Figure 6**, point 1) and the aeroplane took off 20 s later (point 2). Around thirty seconds after taking off, when the power levers were set to 100%, the battery voltages of the LH and RH engines went from 27.2 V to 26.5 V and 26.1 V respectively (point 3). Twenty seconds later, the temperature of the coolant in the RH engine started to increase in an abnormal manner. The power levers were moved back to 90% during the climb.

In a ten-second period, the temperature of the coolant in the RH engine exceeded 100°C, the limit which activates the **R ENG TEMP** warning (point 4).

The maximum temperature of the coolant in the RH engine was 138° (point 5).

The RH engine was shut down fifty seconds after reducing power to 0%, i.e. one minute fourteen seconds after the warning appeared (point 6). Once the engine was shut down, the propeller probably feathered⁴.

The temperature of the gearboxes of both engines remained below 85°C throughout the flight. There was therefore an inconsistency between the warning reported by the pilot in his statement (**R GBOX TEMP**) and the warning actually activated during the flight (**R ENG TEMP**).

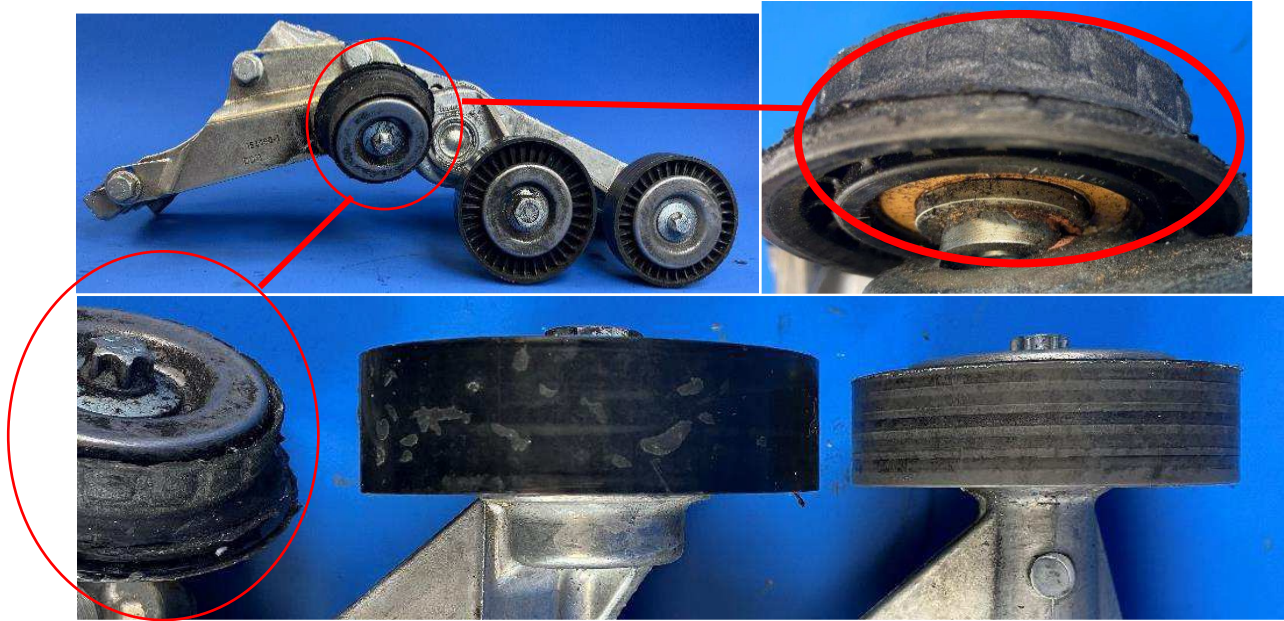
During the examination of the RH engine, it was observed that the accessory belt was absent. Numerous quantities of belt residue were present nearby.

The tensioner, alternator and water pump were inspected on Austro Engine's premises. The water pump and alternator were functional. No play or binding was observed in the various bearings. One of the belt tensioner pulleys had come out of its housing due to the deformation of the mounting bracket (see **Figure 7**).

Figure 7: RH engine tensioner - pulley in red circle out of housing (source: BEA)

It was not possible to determine with certainty the causes behind the belt's separation.

The most likely hypothesis given the deformations observed and the age of the engine and the belt, is the ingress of a foreign object in the engine unit.
