Accident to the JONKER JS-MD 3 RES “JS3”
registered **D-KPWZ**
on Saturday 22 June 2024
at La Motte-du-Caire

Non-stabilized approach, runway overshoot, vegetation strike, collision with ground

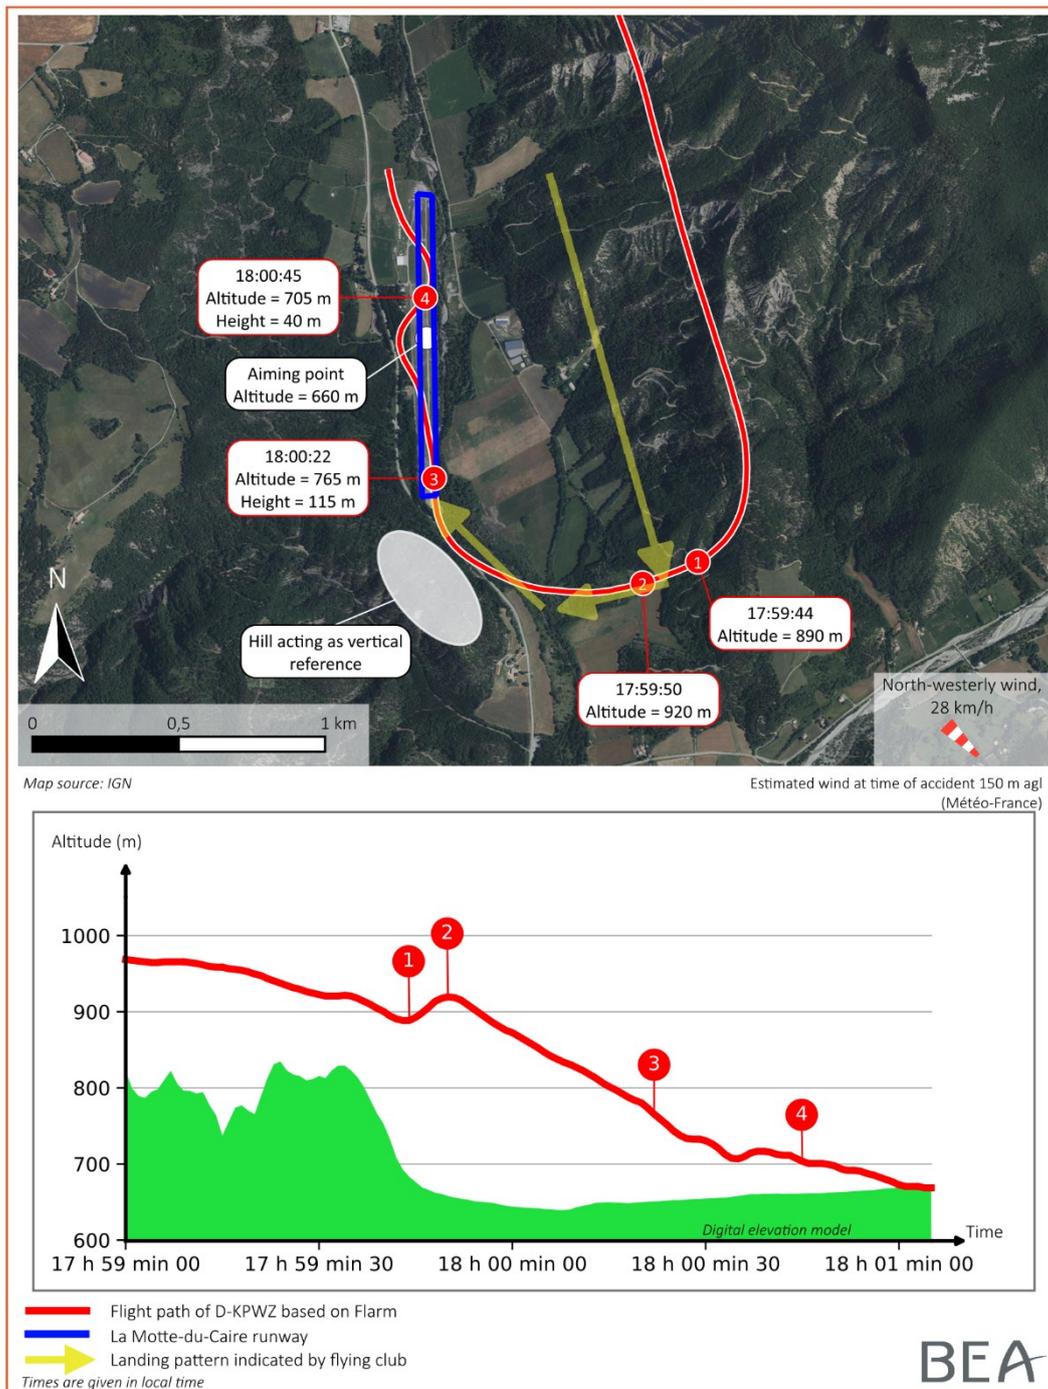
Figure 1: final flight path of glider (source: BEA)

On coming out of the turn onto the base leg (see **Figure 1**, point **1**), the indicated airspeed increased from 120 to 155 km/h and the glider rose around 30 m (point **2**). On the base leg, the pilot detected that he was too fast and too high on the slope. He fully extended the flaps and airbrakes. He came out of the last turn at a height of 115 m (point **3**) at around 600 m from the aiming point. His indicated airspeed was 120 km/h. He wanted to slightly reduce the speed in order to have more time to take a decision. The rate of descent and the speed progressively decreased as he flew over the runway.

One third of the way along the runway, he was still at a height of 75 m and offset the glider to the left-hand side with the intention of carrying out a 180° right-hand turn in order to land on the reciprocal QFU. He abandoned this project in order to carry out the La Motte-du-Caire emergency

procedure. This consisted of using the parking situated on the left-hand side of the end of the runway when the landing was too long. He returned to the runway at a height of around 40 m. At this point the remaining runway distance available was 230 m (point 4). Considering that he was still too high, he decided to land in the field situated after the parking. The glider, which had still not landed, struck the vegetation separating the parking and the field. It collided with the ground approximately 40 m further on.

The glider was equipped with a Flarm flight computer, which records, among other things, GNSS tracks and the indicated airspeed. The data read out from the flight computer was used to construct the flight path shown in **Figure 1**.

The analysis of the data also showed that between the base leg and the start of the manoeuvre when flying over the runway, the average slope was 17%, which corresponds to a lift-to-drag ratio of 6 and is consistent with the data provided in the glider's manual for the full deployment of the airbrakes.

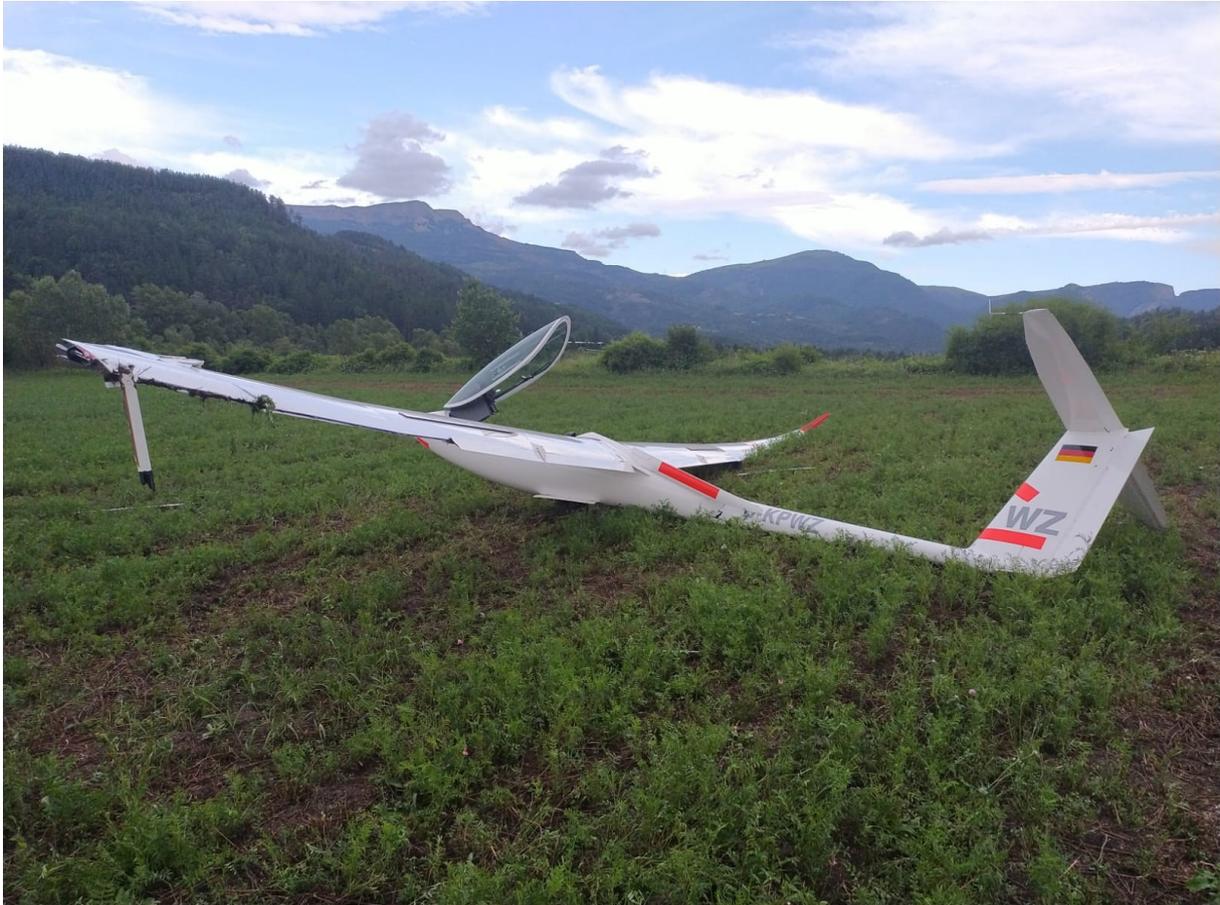
Figure 2: photograph of damaged glider (source: gendarmerie)

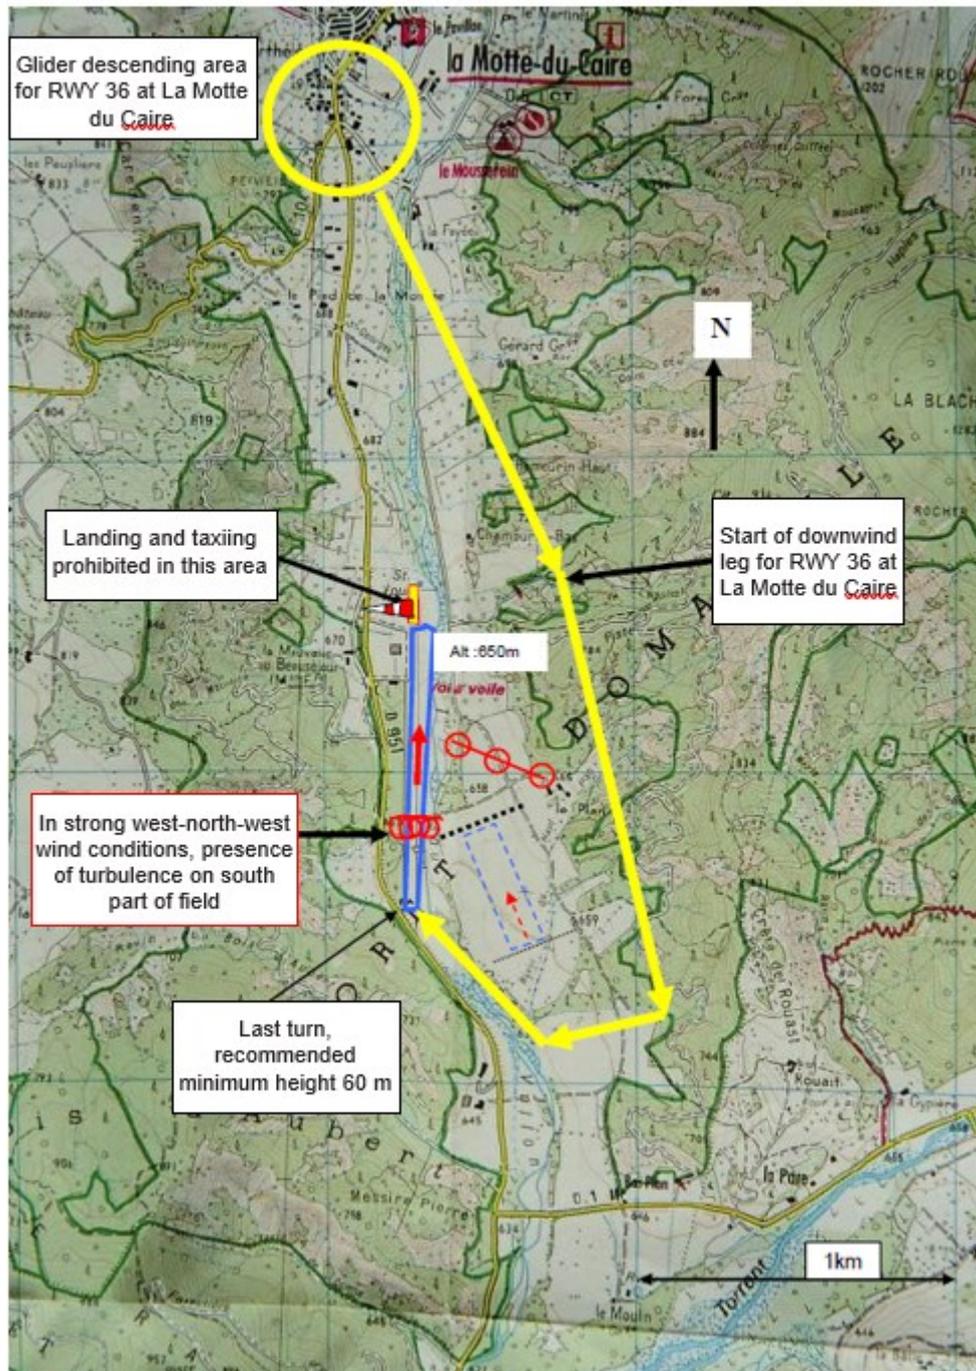
Figure 3: flying club chart for north-facing approach valid at the date of the accident (annotations BEA)

The flying club’s instructions indicate that the pilot is to leave the glider descending area between 1,000 and 1,100 m in order to join the downwind leg east of the runway.

Since the accident, the club has published changes to the instructions for a north facing approach and landing:

- the downwind leg is carried out at a greater distance from the runway, overhead the ridge, at an altitude of 900 m;
- the flight path to be followed on the base leg differs according to whether the glider is flying in the presence of a light breeze or a north wind (Mistral);
- the height for the last turn is 80 m when there is a breeze and 100 m when there is a Mistral.

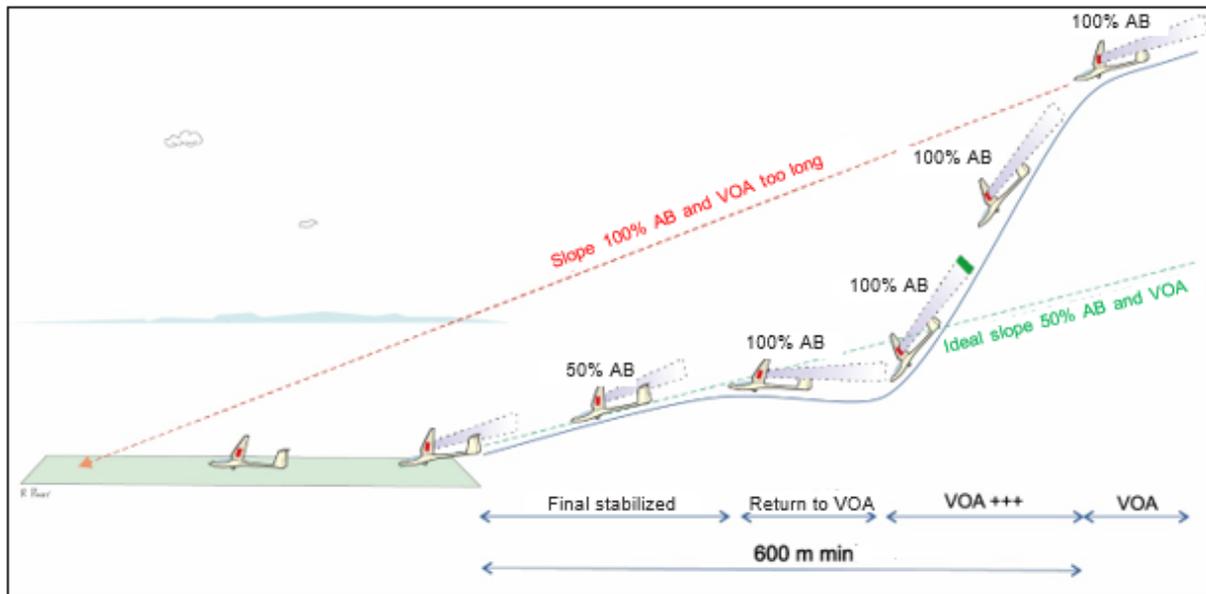
- at the very beginning of the final approach, the last resort solution is the "safety manoeuvre", which consists of intercepting the descent slope. This manoeuvre requires 600 m before the aiming point. With the airbrakes fully extended, the pilot must take a steep nose-down attitude until he passes under the nominal descent slope. During this manoeuvre, the airspeed will increase above the VOA (the manual cites a possible speed of 140 km/h as an example). When back on the approach slope, the pilot keeps the airbrakes extended until the speed is reduced to the VOA. This manoeuvre requires training and practise with an instructor.

Figure 4: intercepting the descent slope on final
 (source: Gilder pilot manual, illustration Ropert Prat, annotations BEA)

During the final approach, the pilot was particularly concentrated on reabsorbing the excess speed. Speed is a necessary but not sufficient condition for stabilizing an approach and landing safely. On the contrary, a manoeuvre to intercept the descent slope on final, in its first phase, sacrifices the holding of the optimum approach speed by taking a steep nose-down attitude.

This manoeuvre must be carried out at least 600 m before the aiming point. It must be anticipated so as to check its applicability and to determine the necessary references for its correct implementation.
