Accident to the SCHLEICHER– ASH 26 E
registered **D-KWAY**
on 25 July 2022
at Aspres-sur-Buëch

This is a courtesy translation by the BEA of the Final Report on the Safety Investigation. As accurate as the translation may be, the original text in French is the work of reference.

Deployment of engine at low height, collision with trees

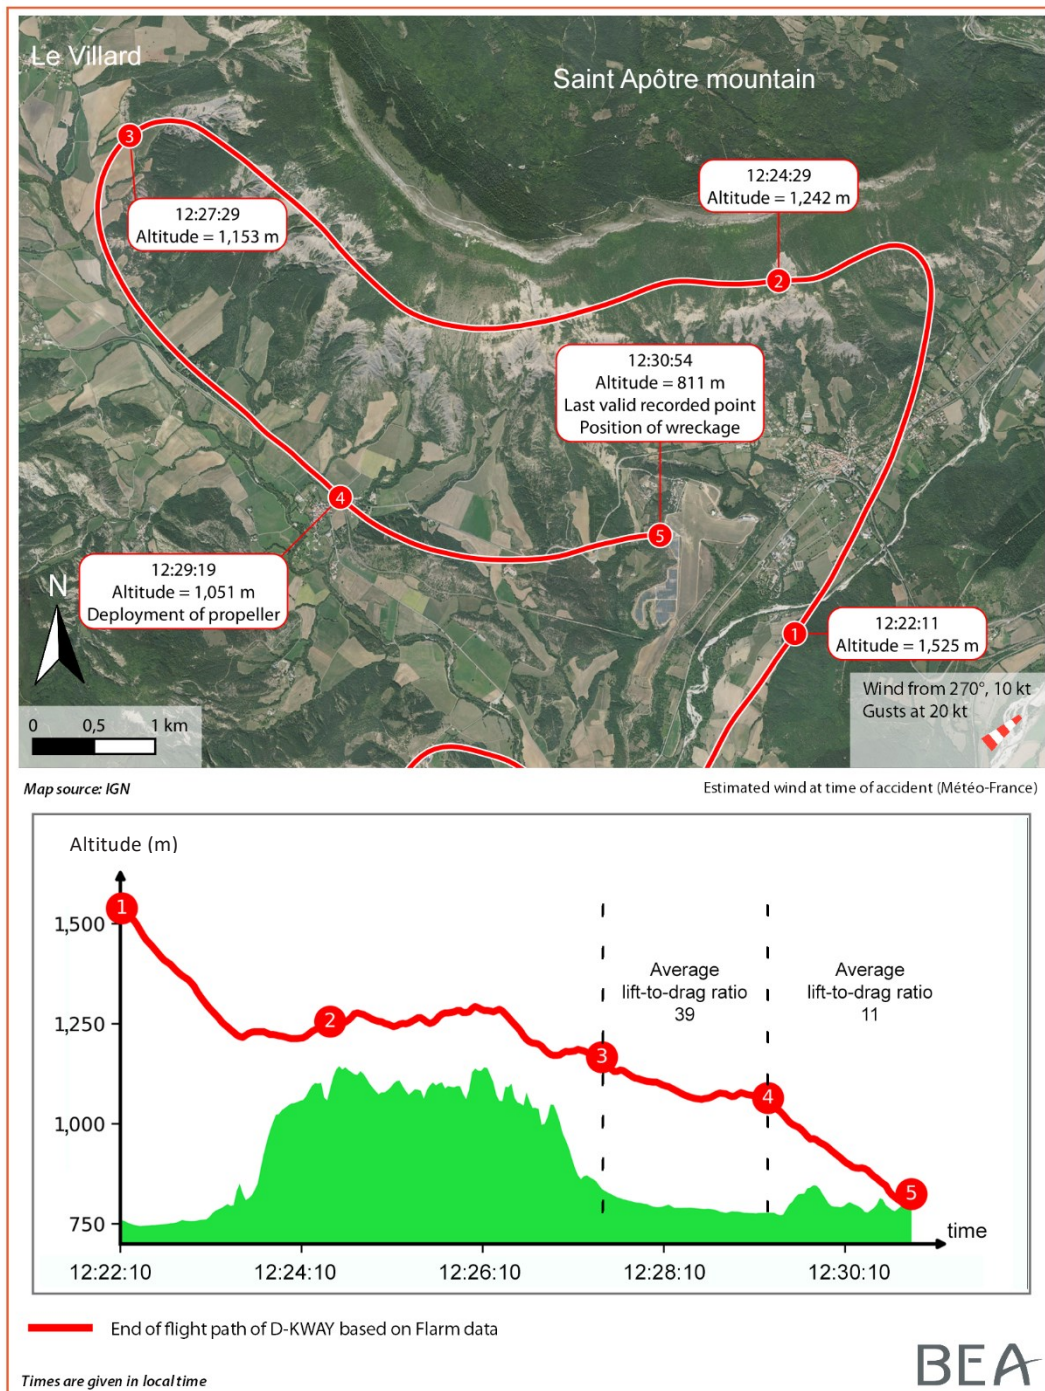
The pilot took off without assistance at around 12:07 from Serres-la-Batie Montsaleon (Hautes-Alpes) for a local flight north of the aerodrome. He switched off the engine and retracted the propeller before starting a spiral in a thermal uplift enabling him to gain around 650 m in altitude. At around 12:20, he exited the spiral, headed towards Saint-Apôtre mountain and then flew along the south slopes. Having lost nearly 600 m in altitude and not finding any updrafts, he then turned into the valley towards Aspres-sur-Buëch aerodrome where he would have been able to land with ease given the glider's altitude and lift-to-drag ratio². He decided to use the engine to gain altitude and continue his flight. At 12:29, when he was at a height of 260 m and at a distance of 2,850 m from the runway, he deployed the propeller³ and tried to start the engine, without success.

The glider continued to lose height and struck trees at a few dozen metres from the threshold of runway 10 at Aspres-sur-Buëch before finishing its run on the ground.

Figure 1: flight path of glider

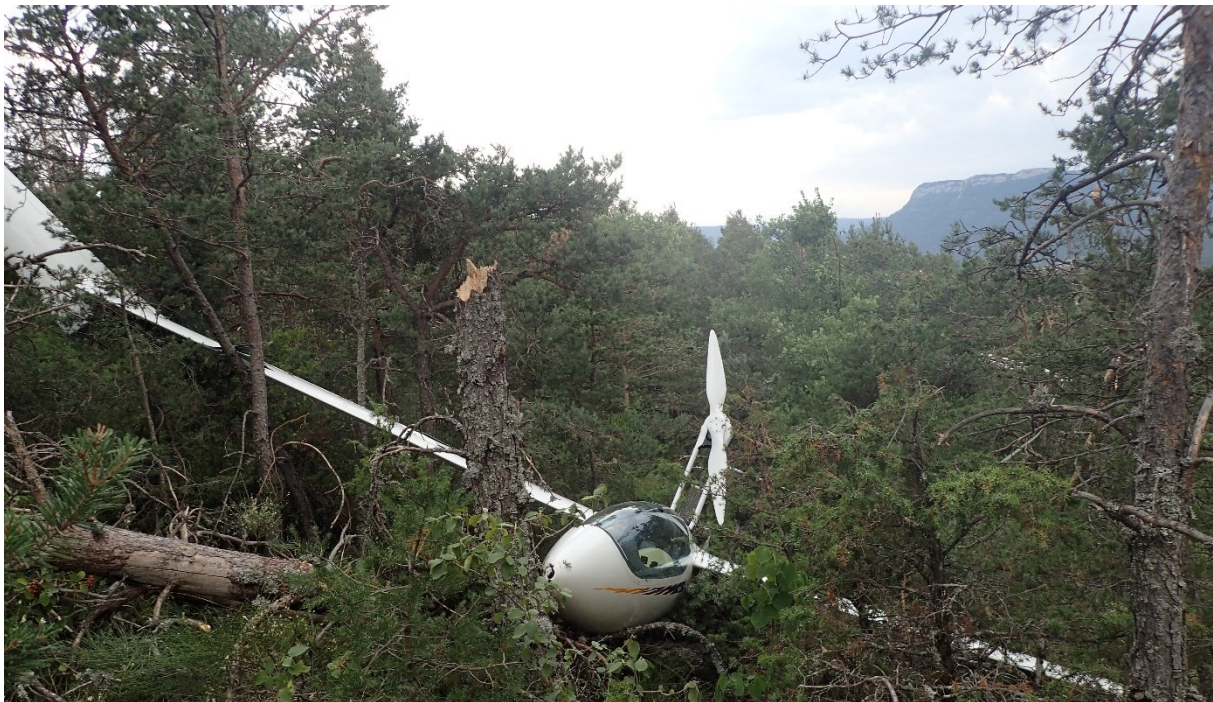
The wreckage was situated at a distance of 30 m from the threshold of runway 10 at Aspres-sur-Büech and offset 85 m to the right of the edge of the runway.

The glider had collided with several trees before finishing its run on the ground. The propeller was deployed and intact.

Figure 2: photo of glider on accident site (source: BEA)
