Accident to the Schempp Hirth - Nimbus 4DLM
registered **D-KXXY**
on Wednesday 10 July 2024
at Vars

Time	Around 15:55 ¹
Operator	Private
Type of flight	Local
Persons on board	Pilot and one passenger
Consequences and damage	Pilot and passenger fatally injured, glider destroyed
This is a courtesy translation by the BEA of the Final Report on the Safety Investigation. As accurate as the translation may be, the original text in French is the work of reference.

Collision with terrain, slope soaring

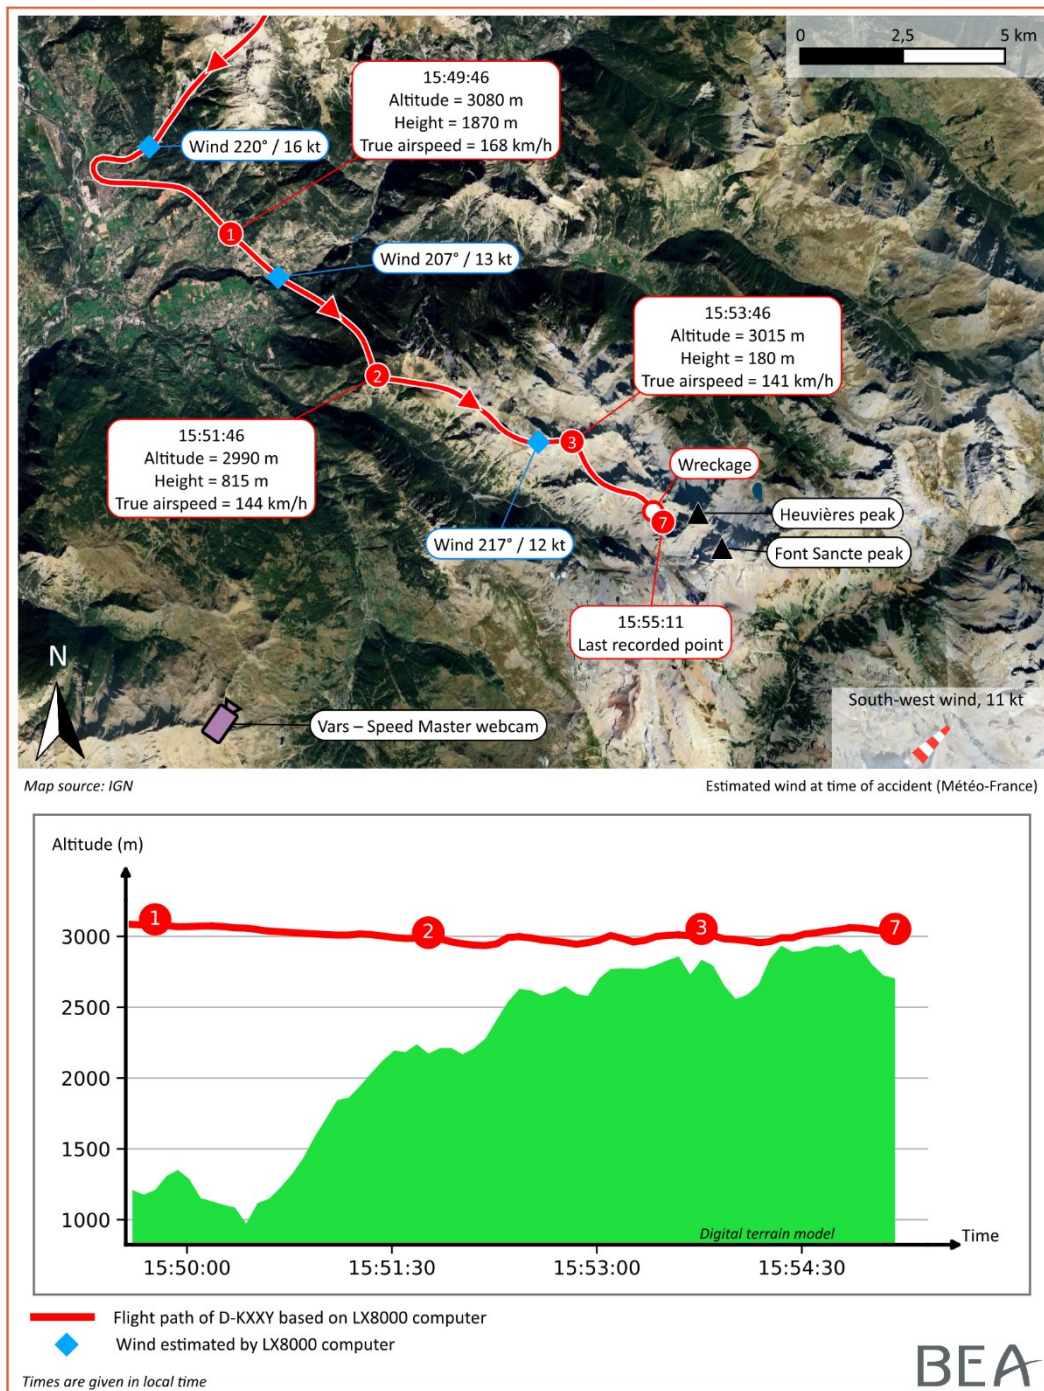
Figure 1: end of flight path

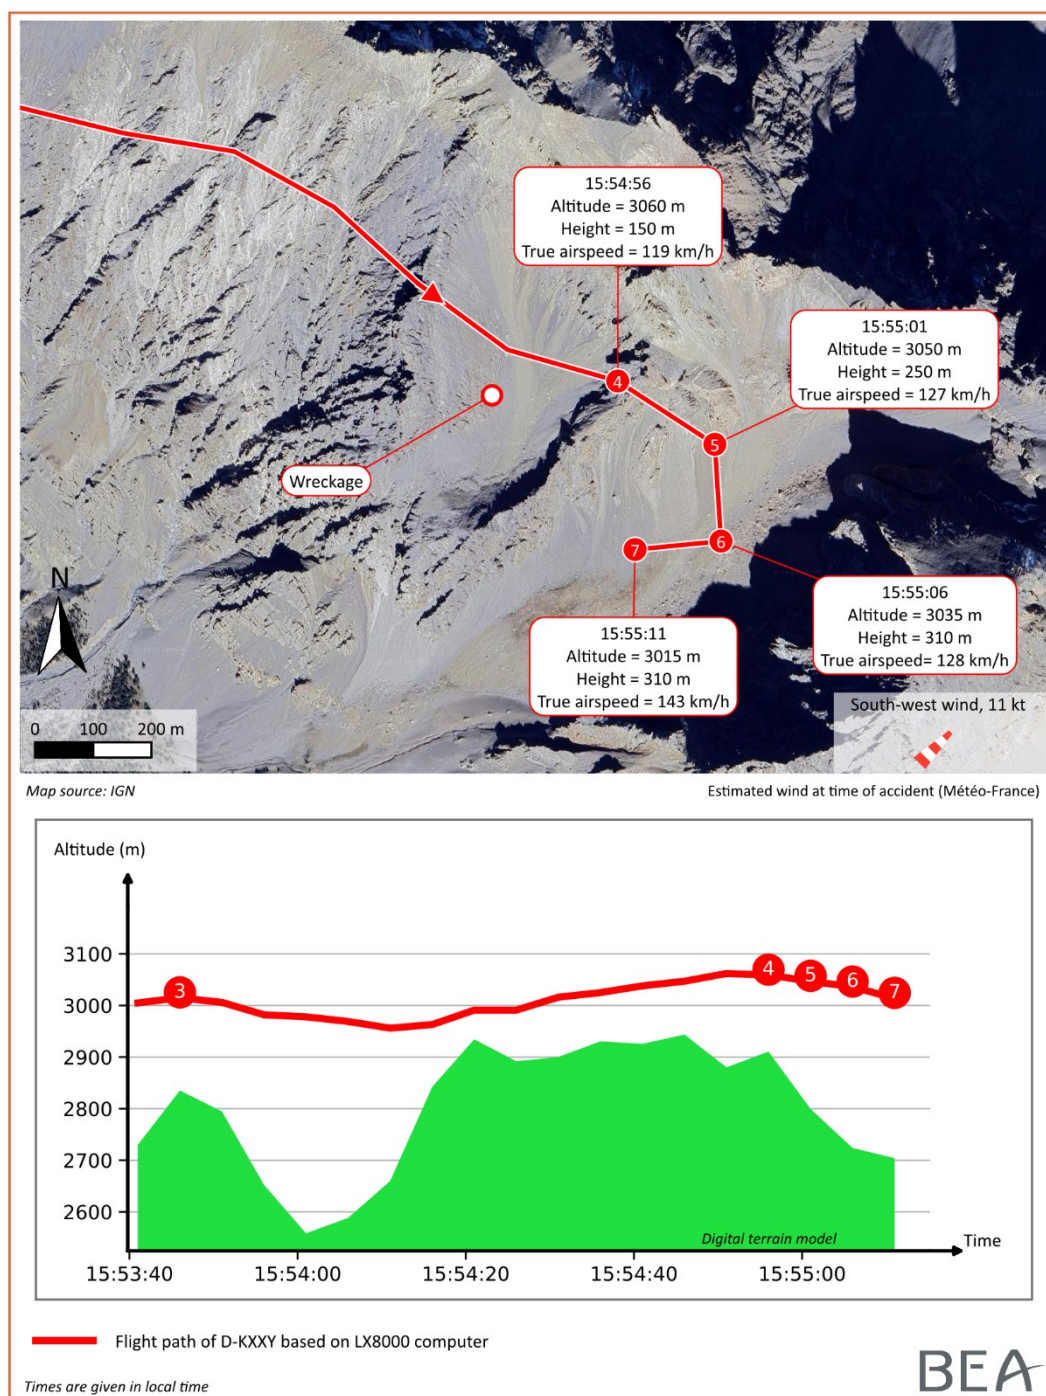
At 15:48, he headed for the Queyras mountain range, initially following the ridges from above before slope soaring from 15:53 onwards. At 15:55, when facing a ridge sloping down from Heuvières peak, he turned right into the valley (see **Figure 2**, point **4**).

The glider collided with the terrain close to the last point recorded by the on-board computer (see **Figure 2**, point **7**).

Figure 2: last minutes of flight path

When the glider started the turn at point 5, it was at an altitude of 3,060 m:

- facing a ridge of an altitude of between 3,200 and 2,800 m, descending from the Heuvières peak;
- facing the ridge between the northern peak of Font Sancte and the Panestrel peak of an altitude of between 3,350 and 3,100 m.

Between points 4 and 7, the true airspeed of the glider was between 119 km/h and 143 km/h. This corresponds to an indicated airspeed of between 100 and 120 km/h, i.e. 1.20 Vs⁴ and 1.45 Vs.

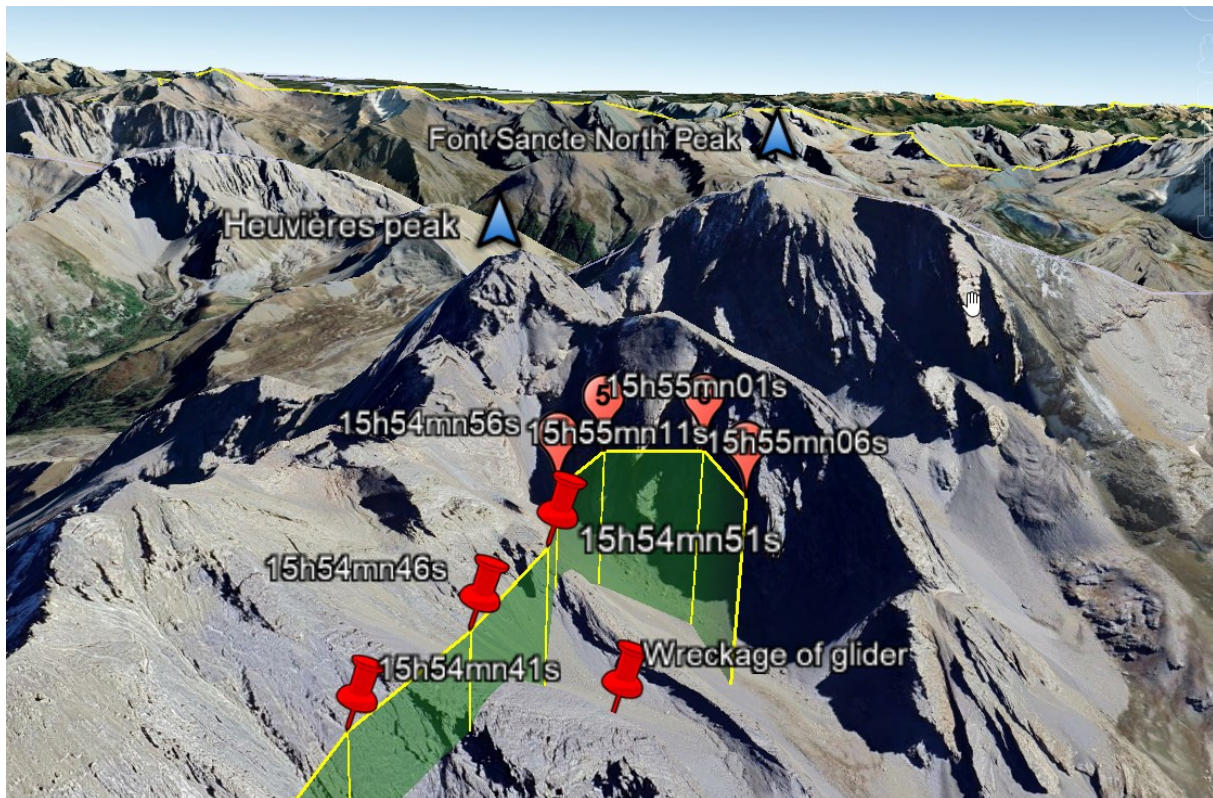
Figure 3: 3D view of end of flight path (source: Google Earth, annotations BEA)

All of the pilots consulted indicated that the ridge followed by D-KXXY before the collision with the terrain (points ③ to ⑧) was steep and often the seat of a very complex and changeable, even rough aerology. For this reason, they advised against using this ridge, in particular for slope soaring flight with a wide-wingspan glider.

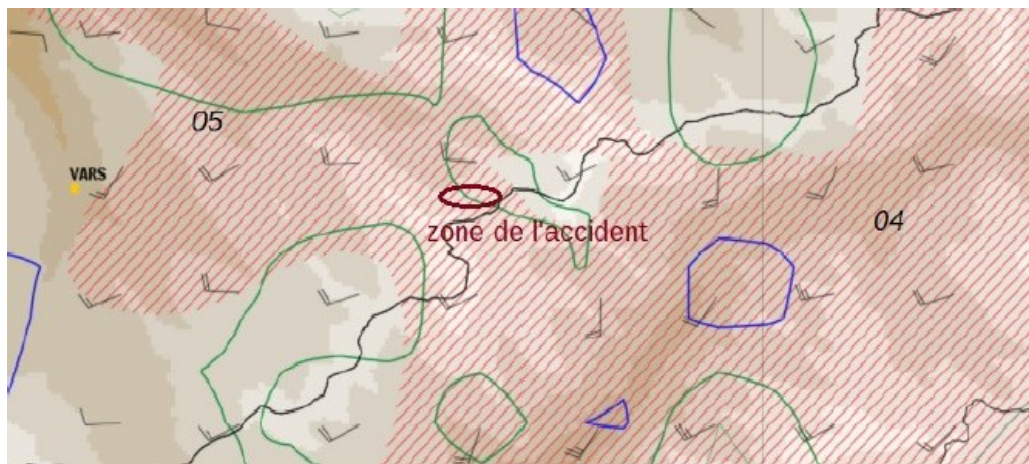
*Figure 4: modelling of turbulence, the area with red diagonal lines corresponds to an area of light to moderate turbulence at a height of 20 m, the areas outlined in green correspond to areas with uplift and the areas outlined in blue to areas of subsidence
(source: Météo-France)*

According to the turbulence chart provided by Météo-France, the accident site was in an area of light to moderate turbulence. The presence of westerly gusts reaching 20 kt and uplifts could have created surface windshear and increased turbulence.

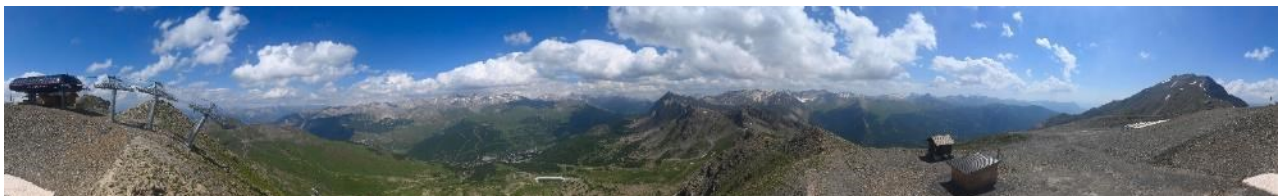
*Figure 5: recording of Vars – Speed Master webcam at 16:00
(source: Vars – La Forêt Blanche)*

The various recorded images confirm that the peaks close to the accident site were not in clouds.

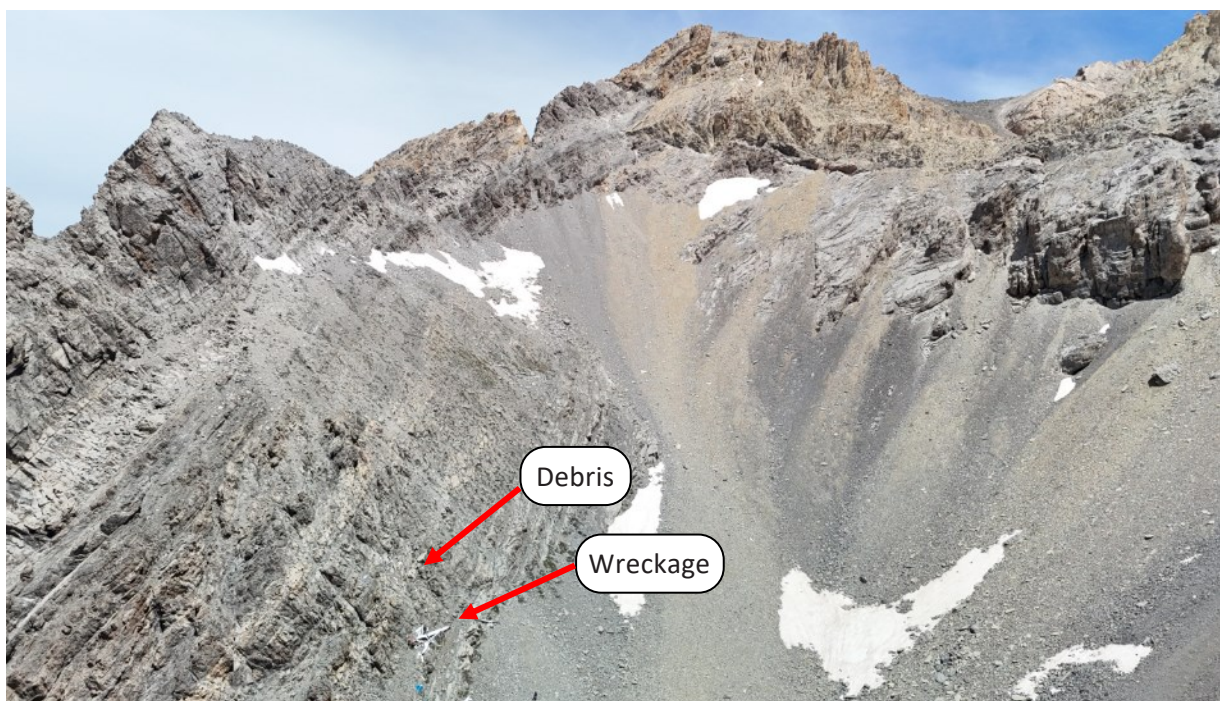
The glider wreckage was found two days after the accident. It was situated at an altitude of 2,820 m below a ridge line rising to around 3,000 m. As the site was difficult to access and did not lend itself to an examination of the wreckage, the BEA did not go to the site.

Figure 6: location of wreckage (source: SRTA, annotations BEA)

The wreckage was recovered by helicopter and then examined by the BEA in a hangar. This examination and the photos taken by the emergency services on the accident site made it possible to determine that the glider very probably collided head-on with the rock face with high energy. Following this first impact, the wreckage experienced other damage when it fell towards the point where it finally came to a stop lower down. The examination of the flight controls found that all the ruptures were characteristic of a sudden overload and therefore very probably a result of the impacts with the ground. The position of the flaps could not be determined.

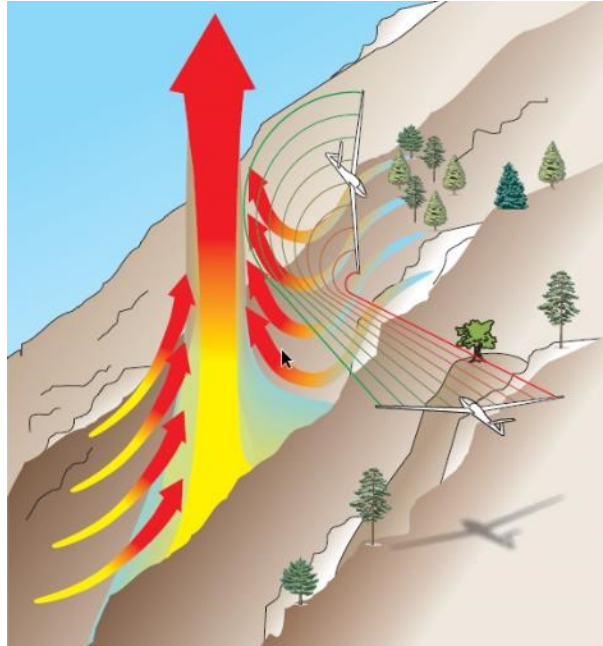
Figure 7: diagram showing the hazard of a displaced thermal in slope soaring flight with high thermal activity (source: *Dancing with the Wind*)

This phenomenon can generate a high rotational torque on the glider's roll axis. In addition, if the area of lift is situated below the area of sink, this torque will be stronger and may override roll control.

Given the strong thermal lifts estimated by Météo-France in addition to the dynamic activity on the slope caused by the west to south-westerly wind, the presence of displaced thermal lifts was possible in the area of the accident.
