Serious incident

to the Boeing 737- 809
registered **EC-NGC** operated by Albastar
and to the Embraer 190
registered **F-HBLD** operated by HOP!
on 21 July 2023
in cruise close to Limoges VOR/DME

Undetected in-flight transponder failure, following of a conflicting flight path in RVSM airspace without radar contact

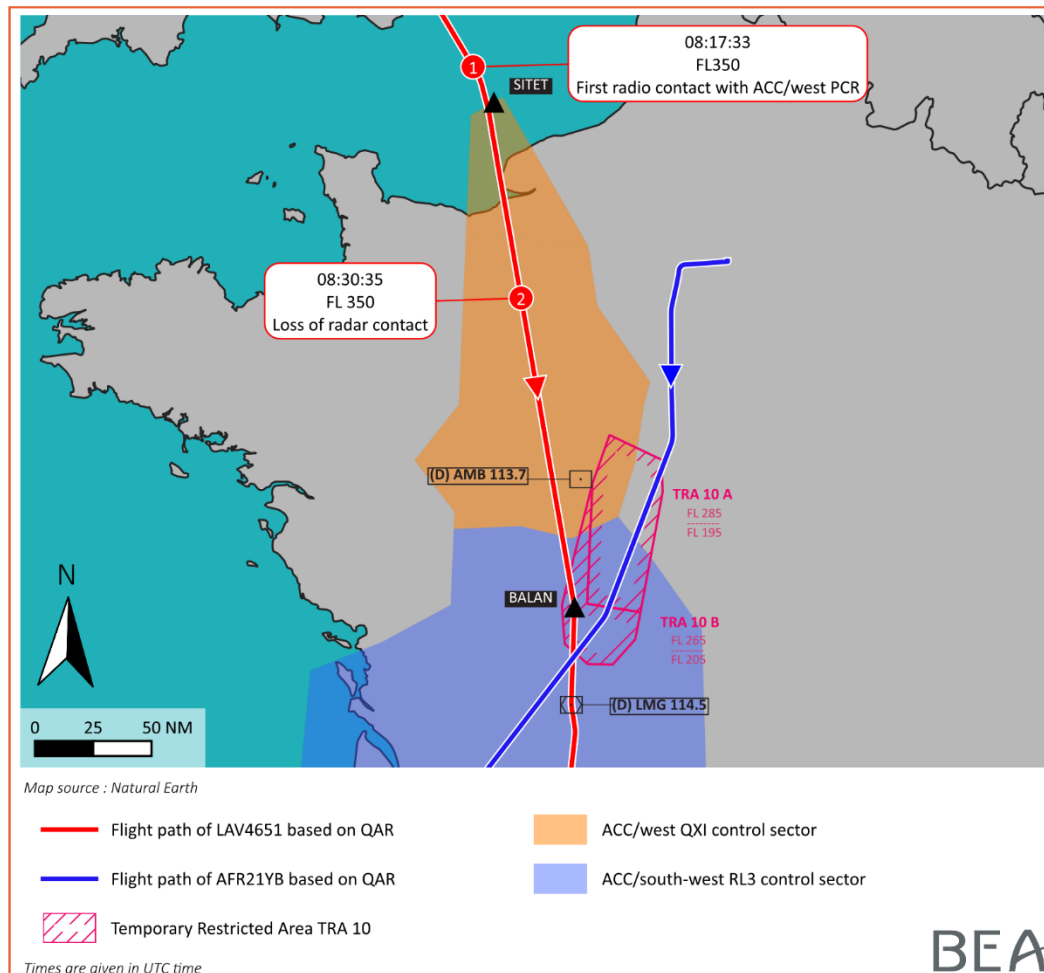
Figure 2: flight paths of LAV4651 and AFR21YB

Around 20 min after the transponder failure, the Boeing 737 crossed the route of an Embraer 190 operated by HOP! (Flight AFR21YB) at the same flight level, with a minimum horizontal separation of 2.6 NM for a required minimum distance of 5 NM. Despite the failure of the transponder, the Boeing 737's TCAS functioned. Based on the information received from the transponder and from the TCAS of the Embraer 190, the algorithm of the 737 TCAS determined that there was no threat of collision with the Embraer. As a consequence, no Traffic Advisory (TA) or Resolution Advisory (RA) was transmitted on board the Boeing 737. However, the crew of the Embraer 190 had had no information about the position and path of the Boeing 737 and were therefore surprised to see it cross their route ahead of them at the same flight level.

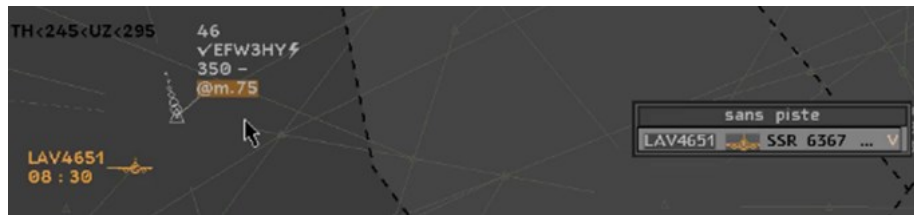
Figure 3: track marker and “Flights without track” window (Source: DSNA)

Between 08:30:47 and 08:30:59, in response to the transponder malfunction, several alert messages and symbols appeared on the label of flight LAV4651 and in the windows containing information about the flight on the screens of the two QXI sector controllers. The 737 was then around 130 NM north of BALAN. The alerts warned the controllers of the loss of certain correlation functionalities between the information from the aeroplane's flight plan and that received from the transponder (see paragraph 1.17.3.6). At 08:30:58, the track of flight LAV4651 was replaced by a track marker⁴ (see Figure 3) and its label was also modified. A "Flights without track" window drawing attention to the flights which have an active flight plan but no associable track information also appeared on the screens of the two controllers, on the right side of the track marker.

None of these alerts were perceived by the two QXI sector controllers. The PCR screen was organised as follows:

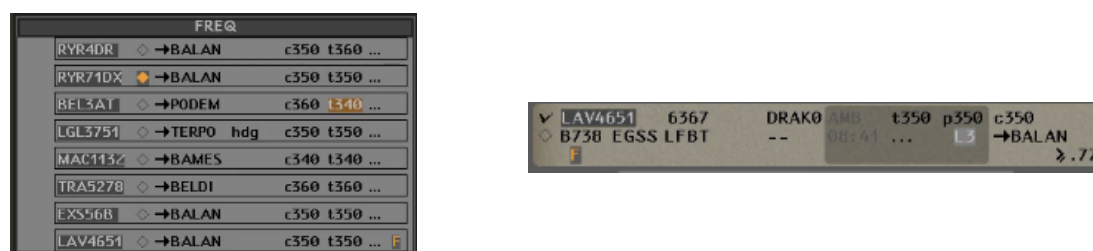
Figure 5: “Aeroplanes on frequency” window (on left side) and LAV4651 flight information after disappearing from the “Flights without track” window (on right side) (Source: DSNA)

At 08:41:02, as flight LAV4651 was supposed to have left the limits of the QXI sector, the “Flights without track” window disappeared from the screens of the two QXI sector controllers. Flight LAV4651 was still displayed in the “Aeroplanes on frequency” window and the flight information was still present on the right side of the PCR and PCO screens (see **Figure 5**).

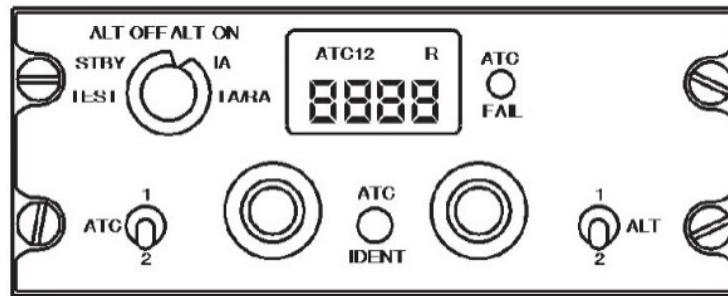
Figure 7: ATC Control Panel (Source: Boeing)

According to the crew, there were no alerts relating to a transponder malfunction. The crew specified that they did not see the amber **ATC FAIL** light (see paragraph 1.6.1.1) illuminated during the flight.

An amber **ATC FAIL** light lights up if there is a failure on the selected transponder. The antennas situated on the top and bottom of the fuselage are used for transmitting and receiving messages exchanged with the transponder selected by the crew, via coaxial selectors (see Figure 8).

The tests performed on transponder 2 also confirmed the transmission of a signal to the ATC control panel to trigger the illumination of the **ATC FAIL** light.

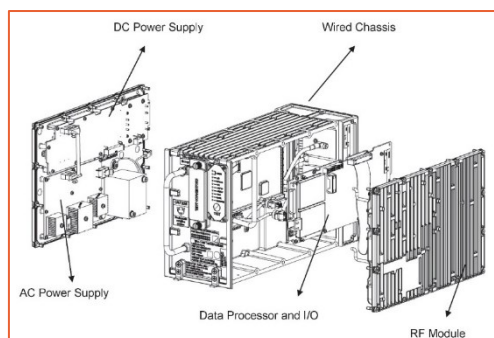
Figure 9: transponder modules (Source: Honeywell)

In 2022, Honeywell was informed of TRA-100B transponder malfunctions, with respect to the +50 VDC power supply circuit, with the same failure messages as those identified during the examinations of EC-NGC transponder 2. At the end of June 2023, 44% of transponders sent back to Honeywell were returned due to a transistor problem, while 34% were due to other causes and 22% had no identified fault.

Honeywell's analysis concluded that these malfunctions were due to an operating fault on a transistor in the conditions of use of the transponder. The analysis also revealed that the design margins relating to transistor heat dissipation requirements were insufficient.

Based on this analysis, Honeywell developed a technical solution that was the subject of a Service Bulletin¹⁴ issued on 23 August 2023. One of the main modifications was the replacement of some components on the DC power supply sub-assembly. Since this date, Honeywell has not received any new reports of malfunctions with respect to the power supply of transponders.

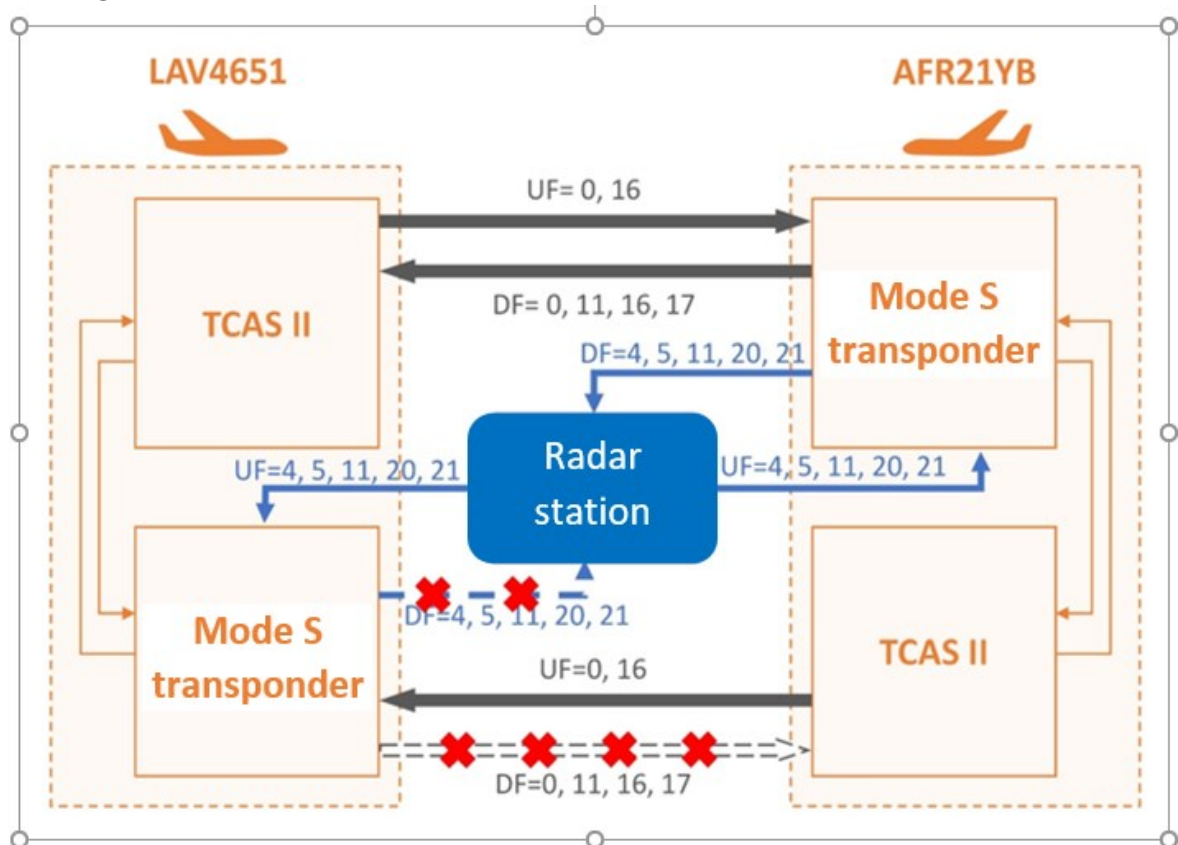
However, Eurocontrol stated that during the period of around 25 min of no transponder transmissions, periodic messages in TCAS broadcasts using UF=16 continued to be transmitted by the TCAS 737-809. These TCAS broadcasts indicate that the TCAS continued to operate during the interruption of transponder transmissions. The read-out of these messages indicated that the messages exchanged remained in the surveillance phase and that a coordination phase did not occur at any time (see paragraph 1.9.1.4). Moreover, the TCAS on board the Embraer 190 also regularly transmitted messages in reply to the messages transmitted by the TCAS on board the Boeing 737-809.

Figure 15: TCAS communication (the red crosses indicate functions lost during the serious incident)
(Source: adaptation of figure B-1 of EUROCAE document ED-143 on standards for TCAS II)

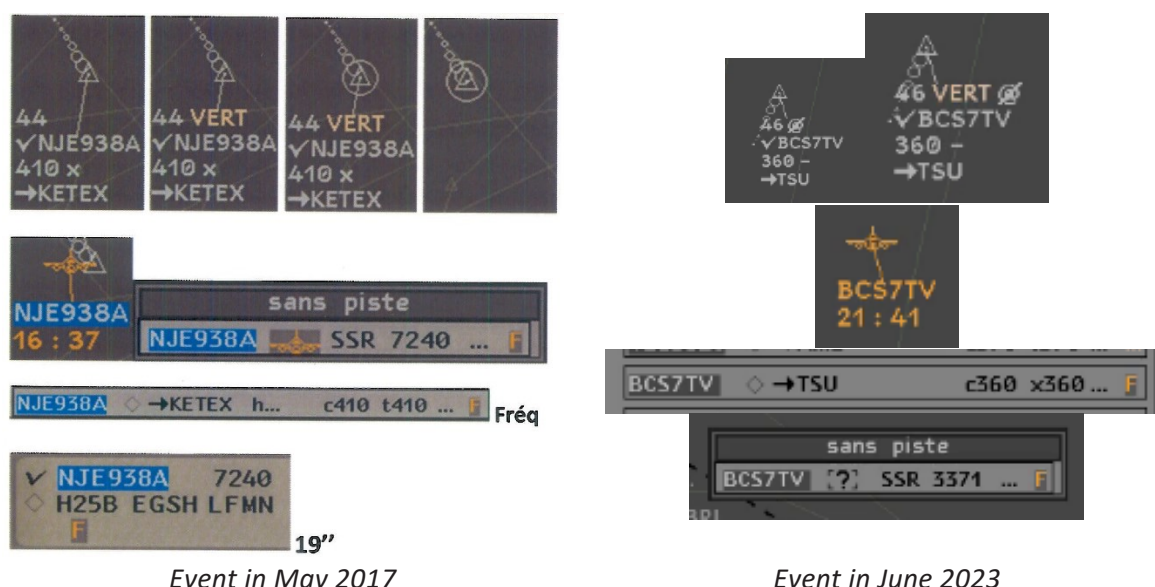
Figure 31: alert display sequence (Source: DSNA)

The two events occurred in May 2017 and June 2023. For both occurrences, different alerts were displayed for around 15 s maximum, in a sequence similar to that of the serious incident on 21 July 2023 (see **Figure 31**). In both cases, track markers were deleted a few seconds after they appeared, despite the presence of “Flights with no track” windows. The other alerts were not perceived.
