Accident to the BOEING 737 - 400
registered **EC-NLS**
operated by Swiftair
on Saturday 24 September 2022
at Montpellier - Méditerranée

SAFETY INVESTIGATIONS

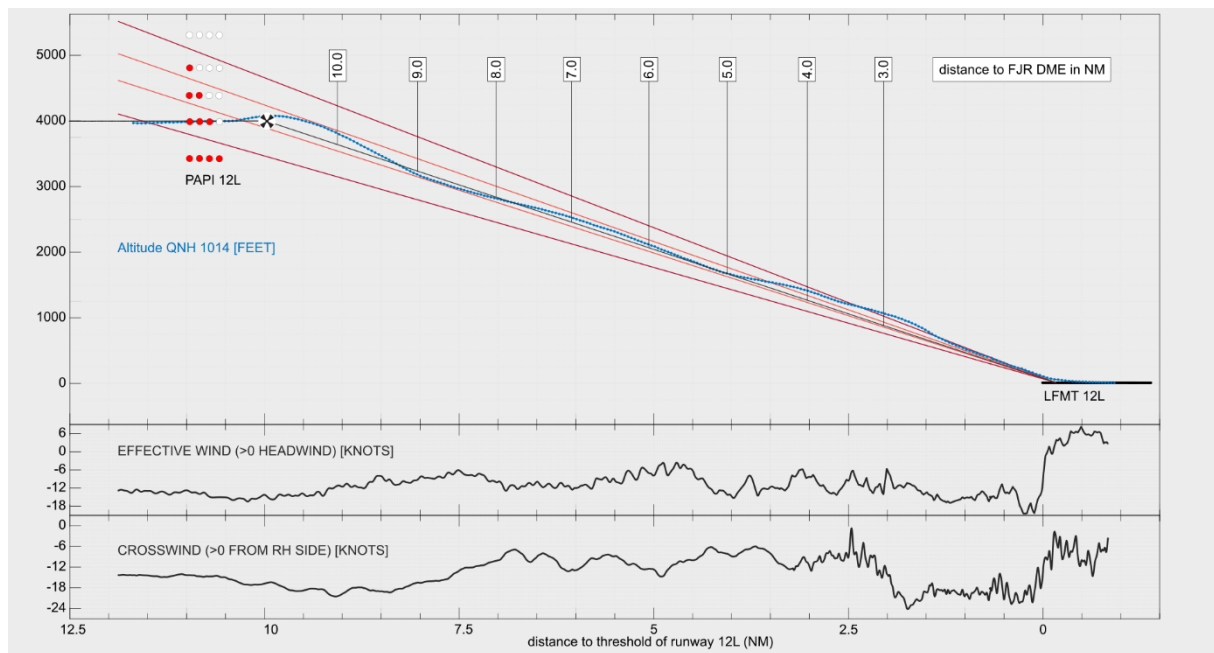
Figure 1: vertical profile of flight path and wind^{9, 10} (Source: BEA)
(The labels with numbers correspond to the VOR-DME altitude/distance cross-checks of the procedure)

On approaching the altitude/distance cross-check at 10 NM, the PM informed the PF that the aeroplane was above the approach slope. The PF called out the landing checklist. The aeroplane passed the 10 NM cross-check point 200 ft above the published altitude. While the checklist was being carried out, the rate of descent increased to values of the order of 1,700 ft/min¹¹.

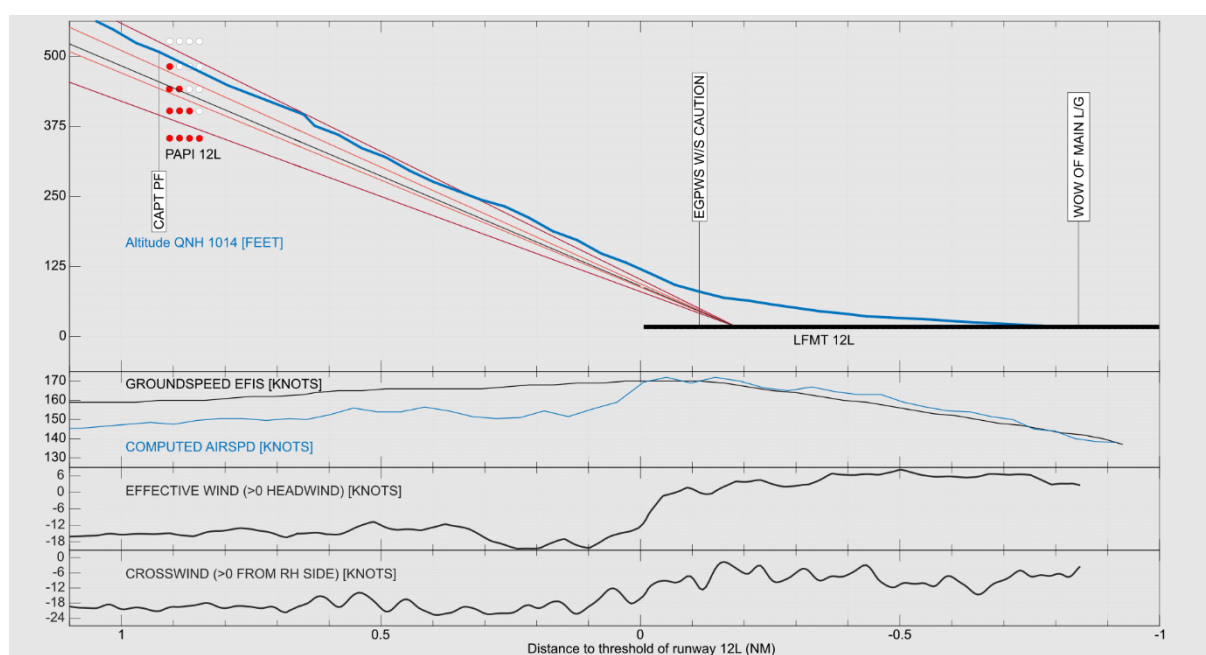
Figure 2: vertical profile of flight path and wind (zoom)

As the aeroplane was descending from 250 ft to 210 ft, the wind slightly turned to 350° and increased in strength to 30 kt. The tailwind component increased from 12 kt to 20 kt. The crosswind component remained at around 17 kt from the LH side.

In nearly four seconds, as the aeroplane was descending from 200 ft to 100 ft, the wind encountered by the aeroplane turned from 350° to 70° and decreased from 30 kt to 8 kt. The aeroplane's airspeed increased up 170 kt. The ground speed slightly increased to 170 kt.

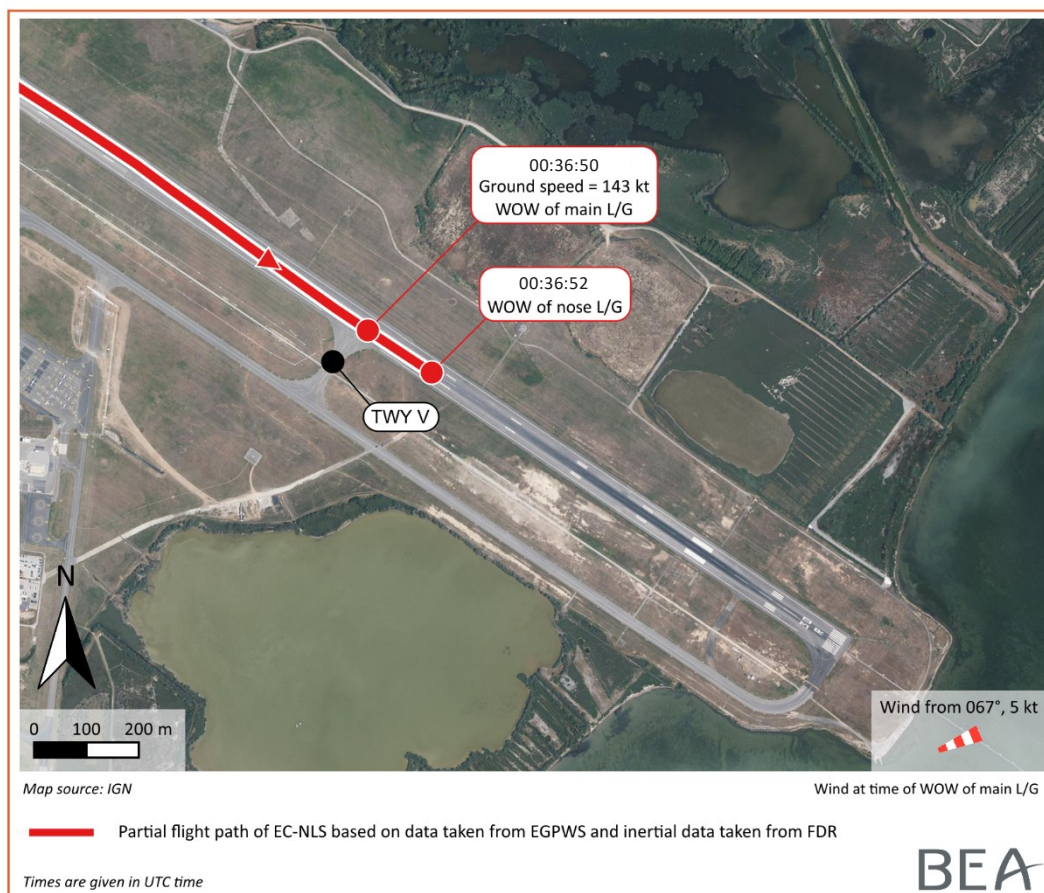
Figure 3: wheel touchdown point

Six seconds later, at 00:36:50, all the parameters¹⁷ showed that the main landing gear had touched down on the runway. The aeroplane's speed was 144 kt. The aeroplane was at 1,500 m from the threshold of runway 12L. It was at 1,100 m from the end of the runway.

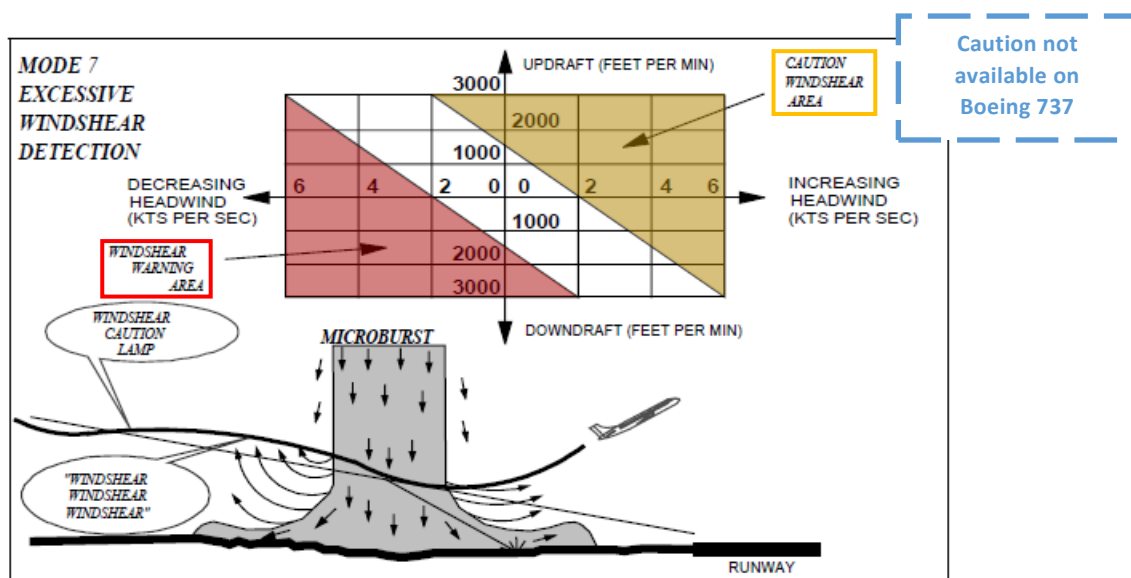
Figure 5: windshear detection modes²⁵ (Source: Honeywell, annotated by the BEA)

On the Boeing 737, windshear warnings are generated when the level of windshear exceeds certain values, either in the horizontal profile or in the vertical profile (see Figure 5, red area of graph). Warnings are generated when the headwind decreases (or the tailwind increases) or when there is a downdraft.

The EGPWS Mark V is capable of detecting and generating cautions when the headwind increases (or the tailwind decreases) or when there is an updraft. The warning functionality generates cautions in the cockpit only if it is certified and configured for the specific aeroplane on which the EGPWS is installed. This function has not been certified by Boeing for the 737.

Thus the windshear caution functionality was not available on EC-NLS. For this reason, the crew did not receive a caution when the EGPWS detected the windshear on the sudden reduction in tailwind between 200 and 100 ft (see paragraph 1.11.3).

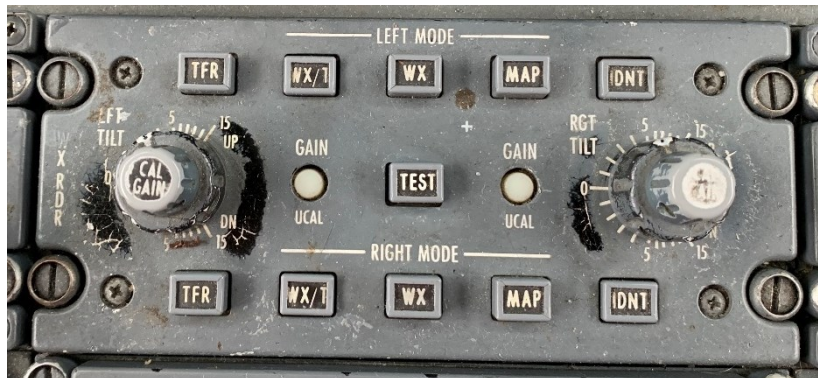
Figure 6: EC-NLS radar control panel photographed after the accident
(Source: BEA)

The EC-NLS radar control panel was not described in the FCOM for the 737-400 used by Swiftair. Other control panels, corresponding to different types of radar, were described. This lack of information was mentioned in Swiftair's 737-CL fleet familiarisation manual, which listed the differences between the aeroplanes in the fleet. The EC-NLS radar control panel was identical to the one on EC-NML, on which the co-pilot had carried out 22 flights.

The examination of the radar control panel after the accident found that:

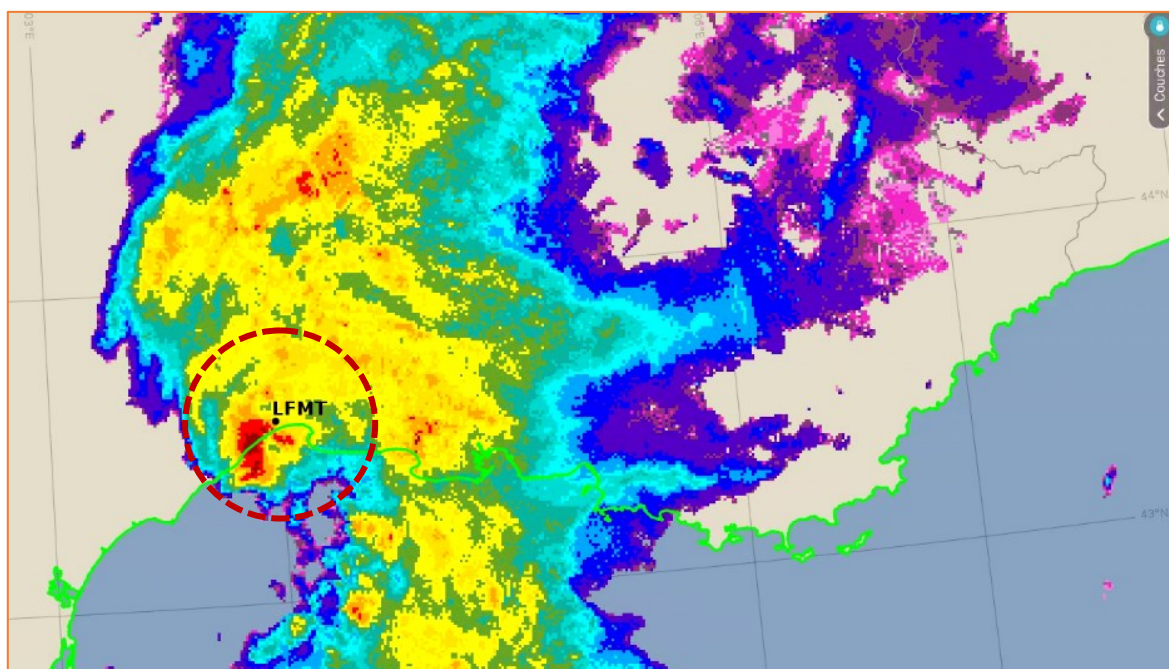
Figure 11: precipitation reflectivity radar image at 00:35
(Source: Météo-France, annotated by the BEA)
(The circle corresponds to a 20 NM radius around the airport)

In the Montpellier area, the reflectivity image (see Figure 11) shows an extended area associated with heavy precipitation (in yellow and orange) and a core of more intense precipitation (in red and bistre) at the edge of the airport at 00:35.

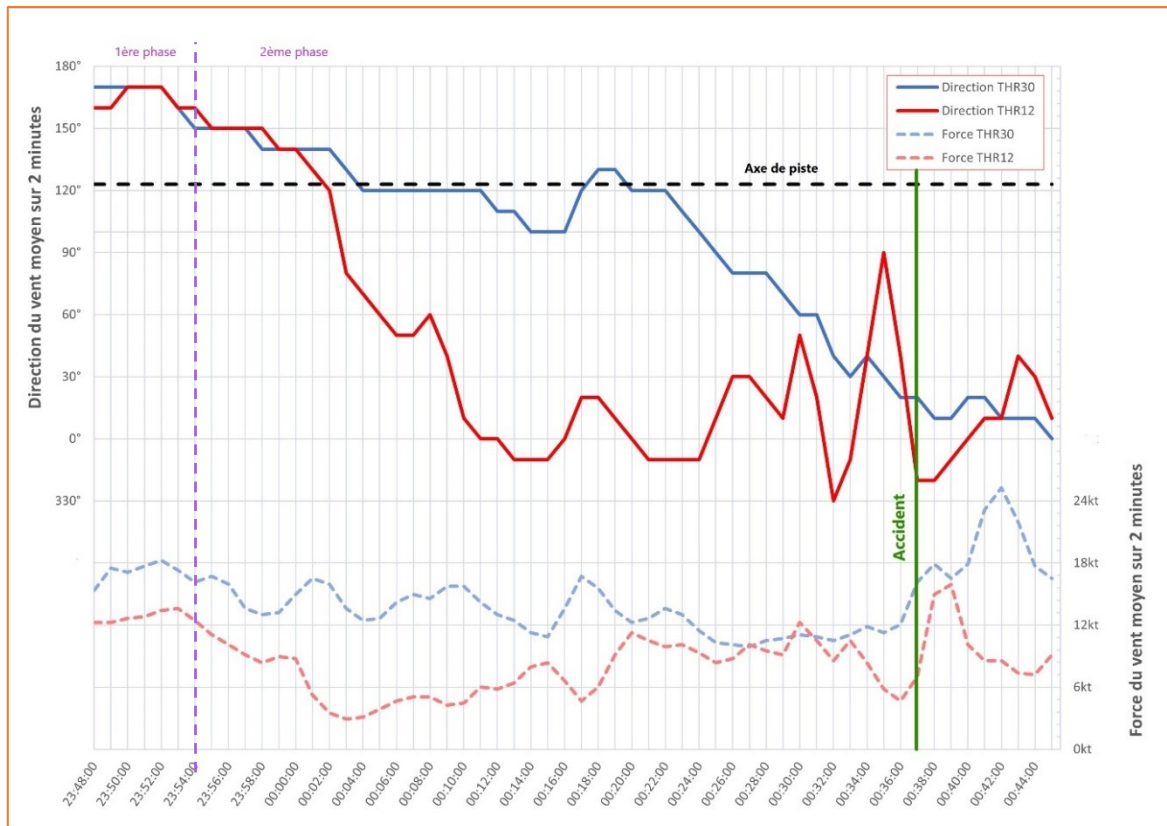
Figure 12: evolution of wind strength and direction every two minutes³³ at the thresholds of runway 12L and 30R (Source: Météo-France/BEA)

Météo-France concluded that it was probable that the aeroplane temporarily encountered LH crosswinds during the landing along with windshear that could not be quantified.

The study of the recording of gusts over one minute found that these followed the same phases as the mean wind. Météo-France indicated that the accident coincided with a north-north-westerly gust of 25 kt at the threshold of runway 12L at 00:37 whereas the wind had not exceeded 10 kt at 00:36.

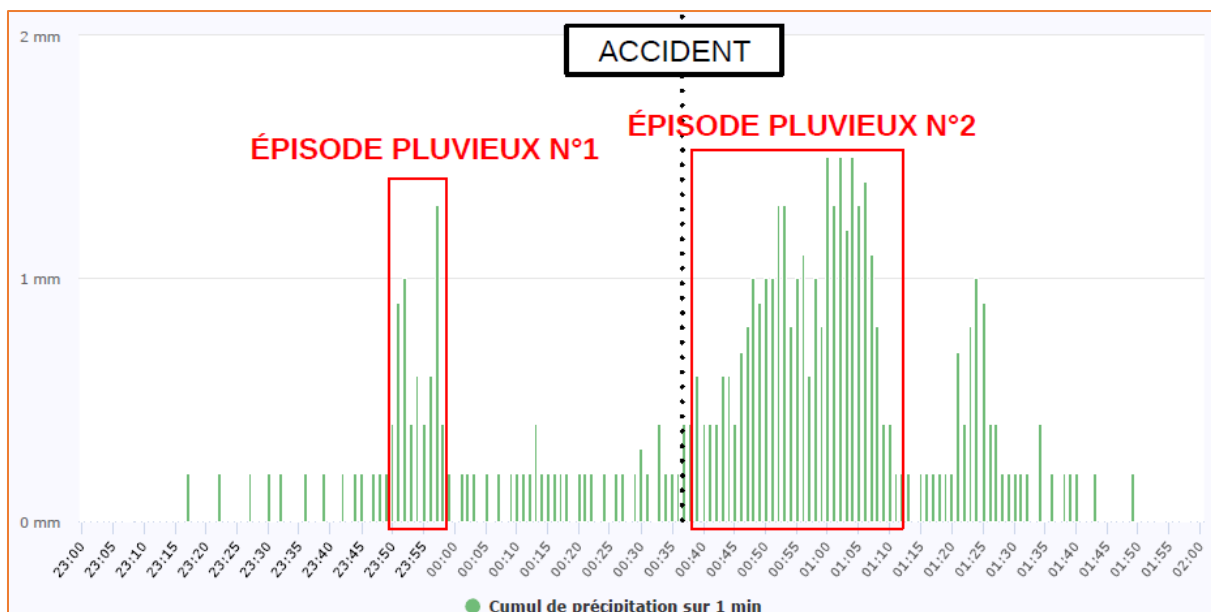
Figure 13: cumulative total precipitation per minute at airport weather station
(Source: Météo-France)

Météo-France described the precipitation as being low to moderate between 23:16 and 23:46, giving a cumulative total of 2.6 mm for the period, followed by an episode of heavy rain up to 23:59, resulting in a cumulative total of 6.8 mm. Between 23:59 and 00:32, there was a lull, with moderate rainfall giving a cumulative total of 5.1 mm over the period. At 00:32, a second episode of heavy rain began, comparable in intensity to the first, but lasting much longer.

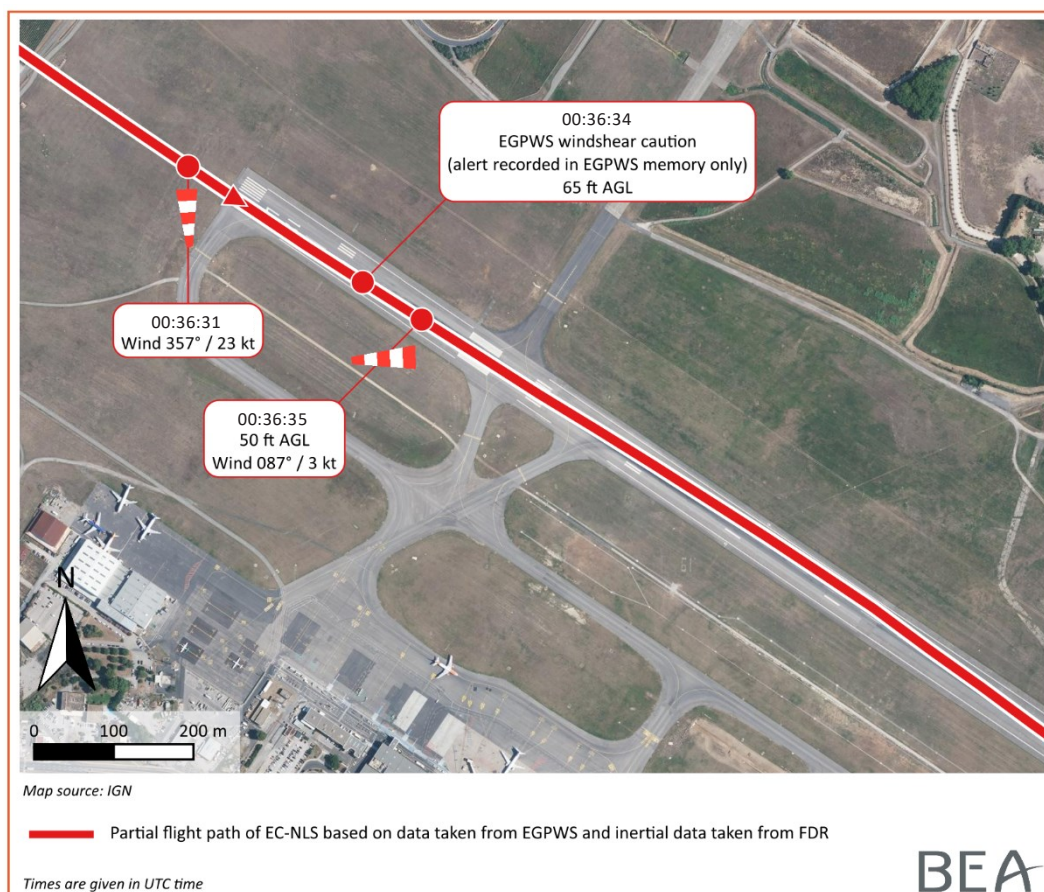
Figure 16: occurrence recorded by the EGPWS

A windshear caution situation was internally detected by the EGPWS. This situation did not produce a caution in the cockpit because this functionality was not installed on the 737 (see paragraph 1.6.4.2.1). It was recorded by the EGPWS when the aeroplane was at 65 ft AGL⁴³, shortly before the detection of the landing situation. The aeroplane was nearly 225 m after the threshold of runway 12L. This windshear situation corresponded to the true speed of the aeroplane increasing by 16 kt in three seconds without a corresponding acceleration. This type of caution is typical of the front of a microburst. This detection was consistent with the meteorological information and the evolution of the recorded FDR parameters.

No alert was recorded by the EGPWS memory when the aeroplane encountered an increase in the tailwind component from 12 kt to 20 kt when it descended between 250 and 210 ft.

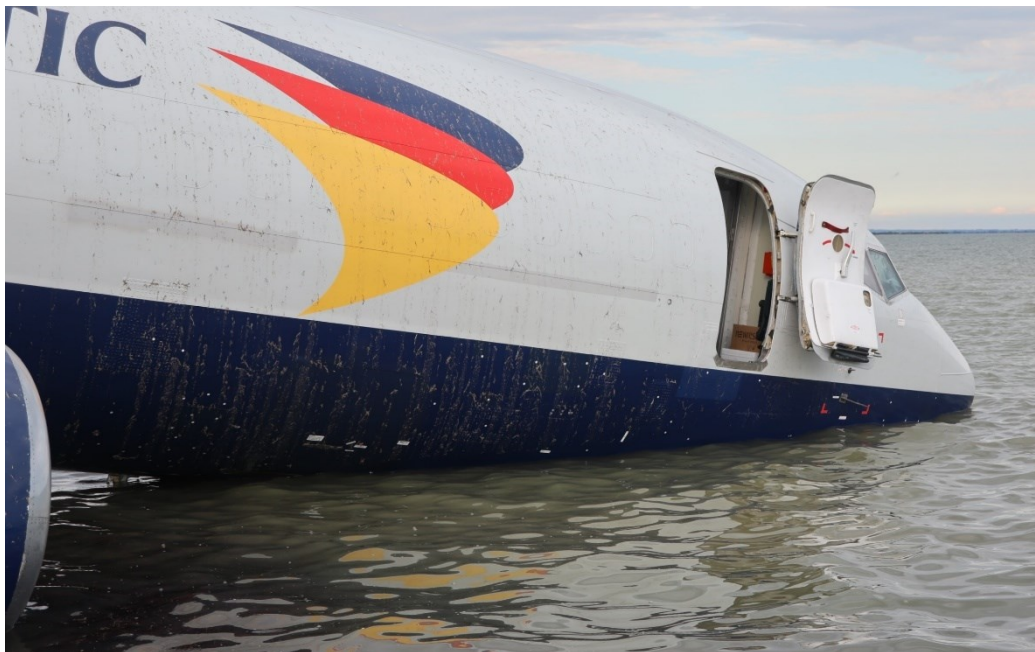
Figure 17: emergency exit after the accident (Source: BEA)

The crew were evacuated through the aeroplane's forward RH door using one of the boats provided by the RFFS. Due to the relative urgency after the accident, in the absence of any fire, and the limited height of the door sill in relation to the water level, the emergency escape slide was not used.

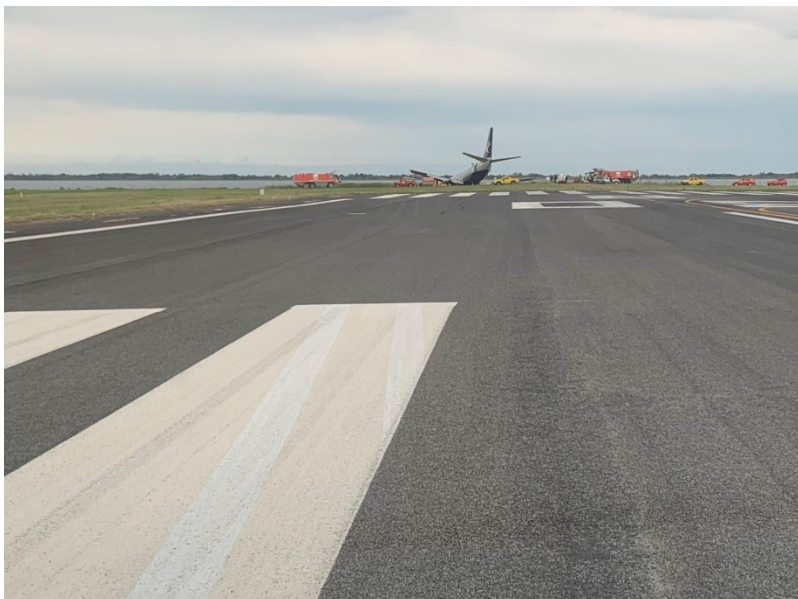
Figure 18: marks similar to a case of vapor cleaning (Source: BEA)

The examination of the run marks on the runway found areas whitened by the passage of the EC-NLS main landing gear tyres (a phenomenon known as "vapour cleaning"). These marks may correspond to hydroplaning. However, the examination of the aeroplane's tyres did not reveal any characteristic tread rubber reversion marks that would have confirmed with certainty that the aeroplane had hydroplaned.
