**Accident** to the Beechcraft Beech 18S  
registered **F-AZEJ**  
on 11 September 2021  
at Melun-Villaroche aerodrome (Seine-et-Marne)

**Loss of control on take-off in tailwind conditions, runway veer-off, during a formation flight at an air show**

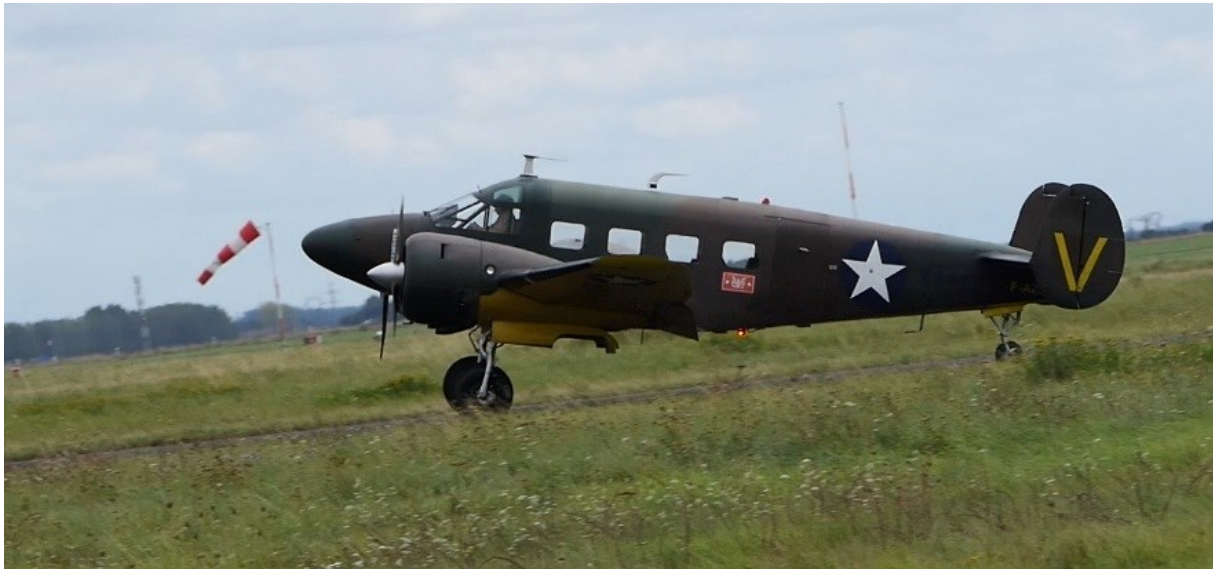
Photos and videos taken by spectators confirmed the wind speed and the tailwind component at the time the Beech 18 took off.

**Figure 3: excerpt from a video taken from the public area during the Beech 18's take-off run on runway 01 (source: YouTube)**

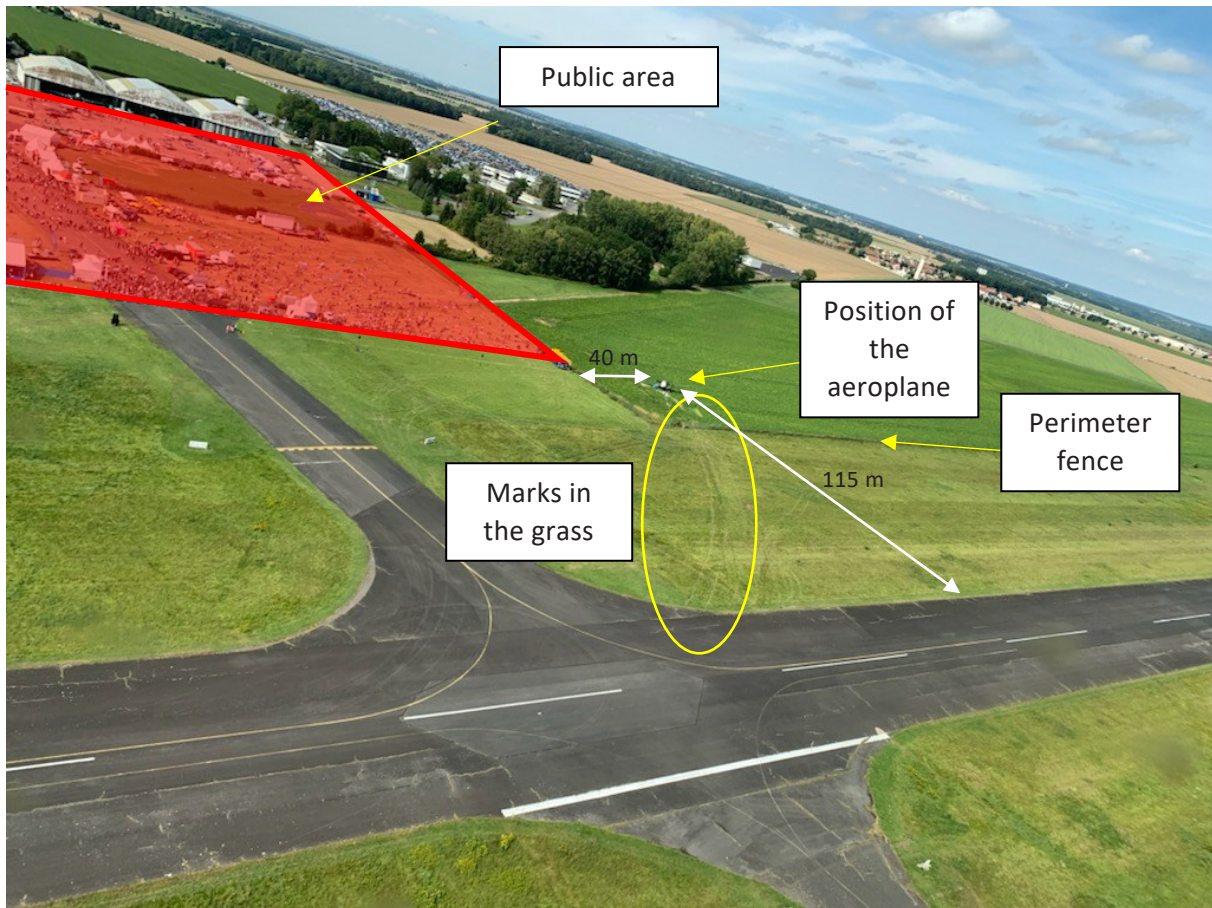
The aeroplane deviated to the left while the main landing gear wheels made contact with the runway again. It skidded off the left side of the runway and ripped out the aerodrome's perimeter fence beyond the public area (see Figure 4). The right landing gear ruptured as it crossed an embankment, and the aeroplane made a ground loop before coming to a stop in a field beyond the public area.

The aeroplane came to a stop approximately 115 m to the left of the edge of runway 01, around 40 m after the end of the public area.

**Figure 4: aerial photograph taken after the accident (source: DGAC; annotated by the BEA)**

Marks were visible in the grass from the point where the aeroplane exited the runway. The aerodrome's perimeter fence was ripped off when the aeroplane went through it. The right main landing gear of the aeroplane detached as it crossed an embankment about 50 cm high which runs along this fence.

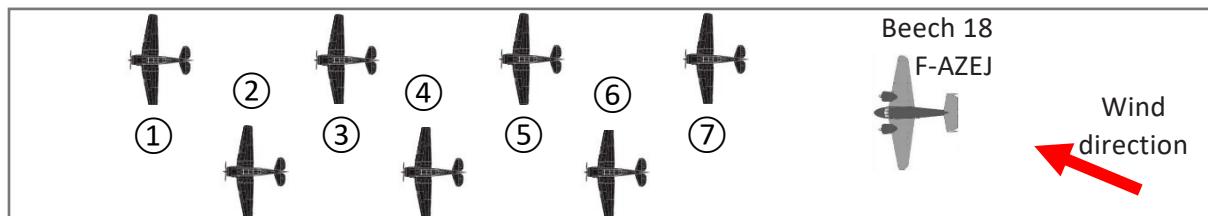
A few seconds after the last of the T6s had released its brakes, the Beech 18 pilot lined up on the runway and stopped to lock the tail wheel. He then increased power before releasing the brakes to take off. The Beech 18 was brought into a level attitude 20 s after the last T6 had taken off.

Figure 5 : positioning of the seven T6s and the Beech 18 registered F-AZEJ on runway 01

The videos showed that the Beech 18's first swerve to the left occurred almost immediately after it had been brought into a level attitude.
