Accident to the CM-170 Fouga Magister
registered **F-AZPZ**
on Friday 16 August 2024
off the coast of Bormes-les-Mimosas

Time	16:56 ¹
Operator	Private
Type of flight	Air show
Persons on board	Pilot
Consequences and damage	Pilot fatally injured, aeroplane destroyed
This is a courtesy translation by the BEA of the Final Report on the Safety Investigation. As accurate as the translation may be, the original text in French is the work of reference.

Pilot incapacitation under positive G-force, collision with surface of sea, during an airshow

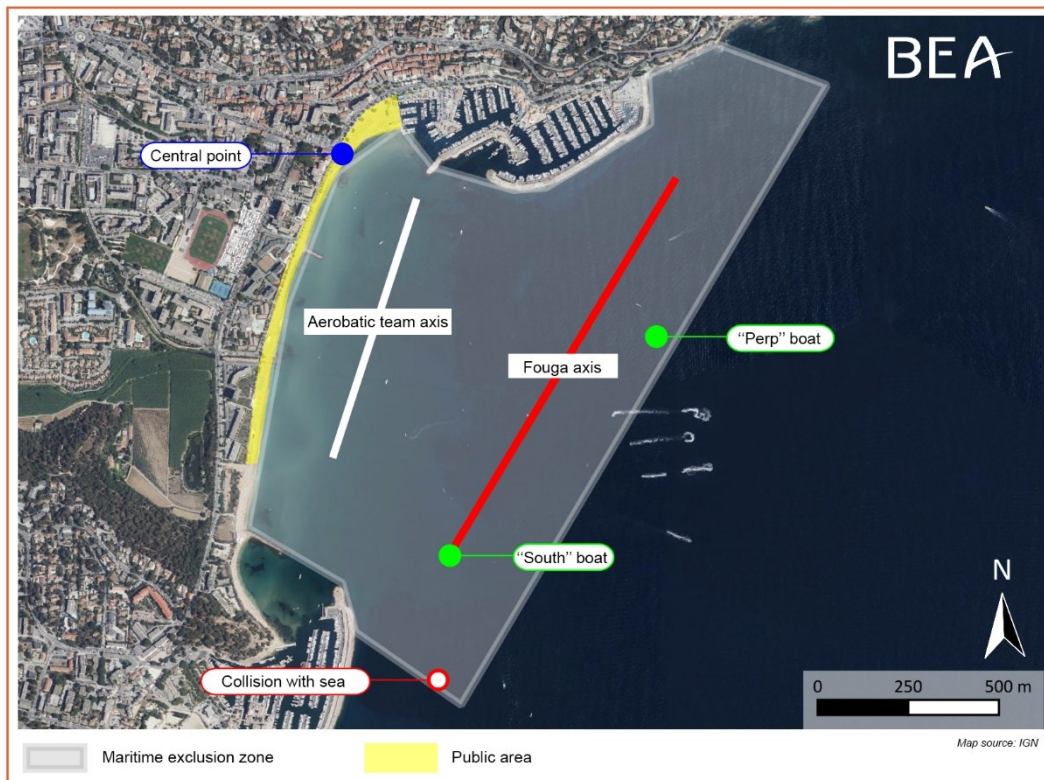
The "FOUGA" axis, located between the two ports (see **Figure 2**), was indicated by seven red buoys, 1.5 m in diameter and spaced 200 m apart (1,200 m in total). Two boats were used to mark the axis. One boat (South) was positioned south of the axis, and another boat (Perp) was positioned 200 m from and perpendicular to the display axis, opposite the central point (see **Figure 1** and paragraph 2.3.4).

Figure 1: positions of the display axes, the area with the public, the maritime exclusion zone, the boats, the central point, and the position of the collision with the sea surface

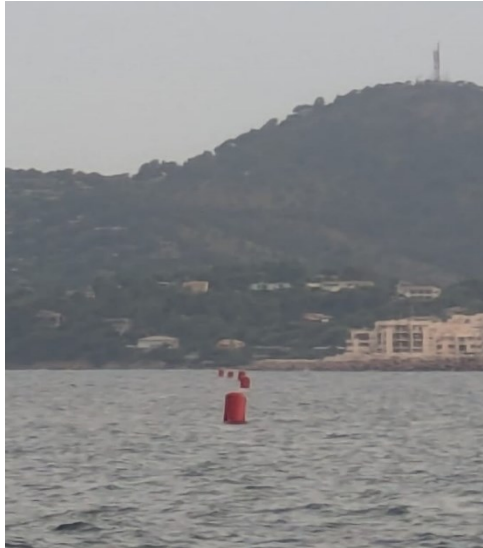
Figure 2: buoys marking the "FOUGA" axis (source: FDD)

The FDD stated that during the debriefing in the evening of the rehearsal flight, the pilot indicated that he had had difficulty seeing the axis marked by the red buoys, that he only saw them at the last moment and then had to tighten his turns. He mentioned that the white buoys were easier to identify.

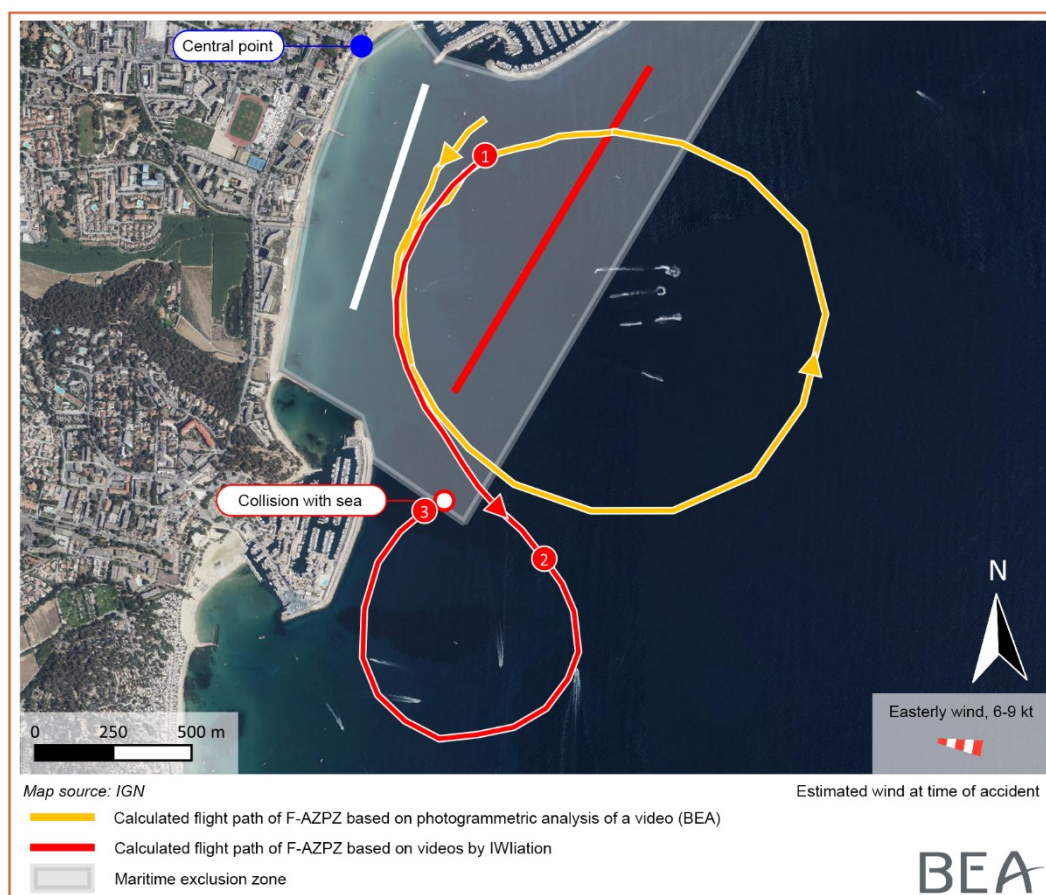
Figure 3: estimated flight path of F-AZPZ based on videos taken by ground witnesses

The analysis of the flight path in the preceding manoeuvres showed that:

- the loop was flown along the display axis;
- the wingover followed by a Derry turn led to an overshoot of the display axis at the beginning of the following 360° turn;
- the 360° turn was performed with a steep bank (around 60°), under a G-force of around +2 g;
- the 360° turn ended beyond the display axis.

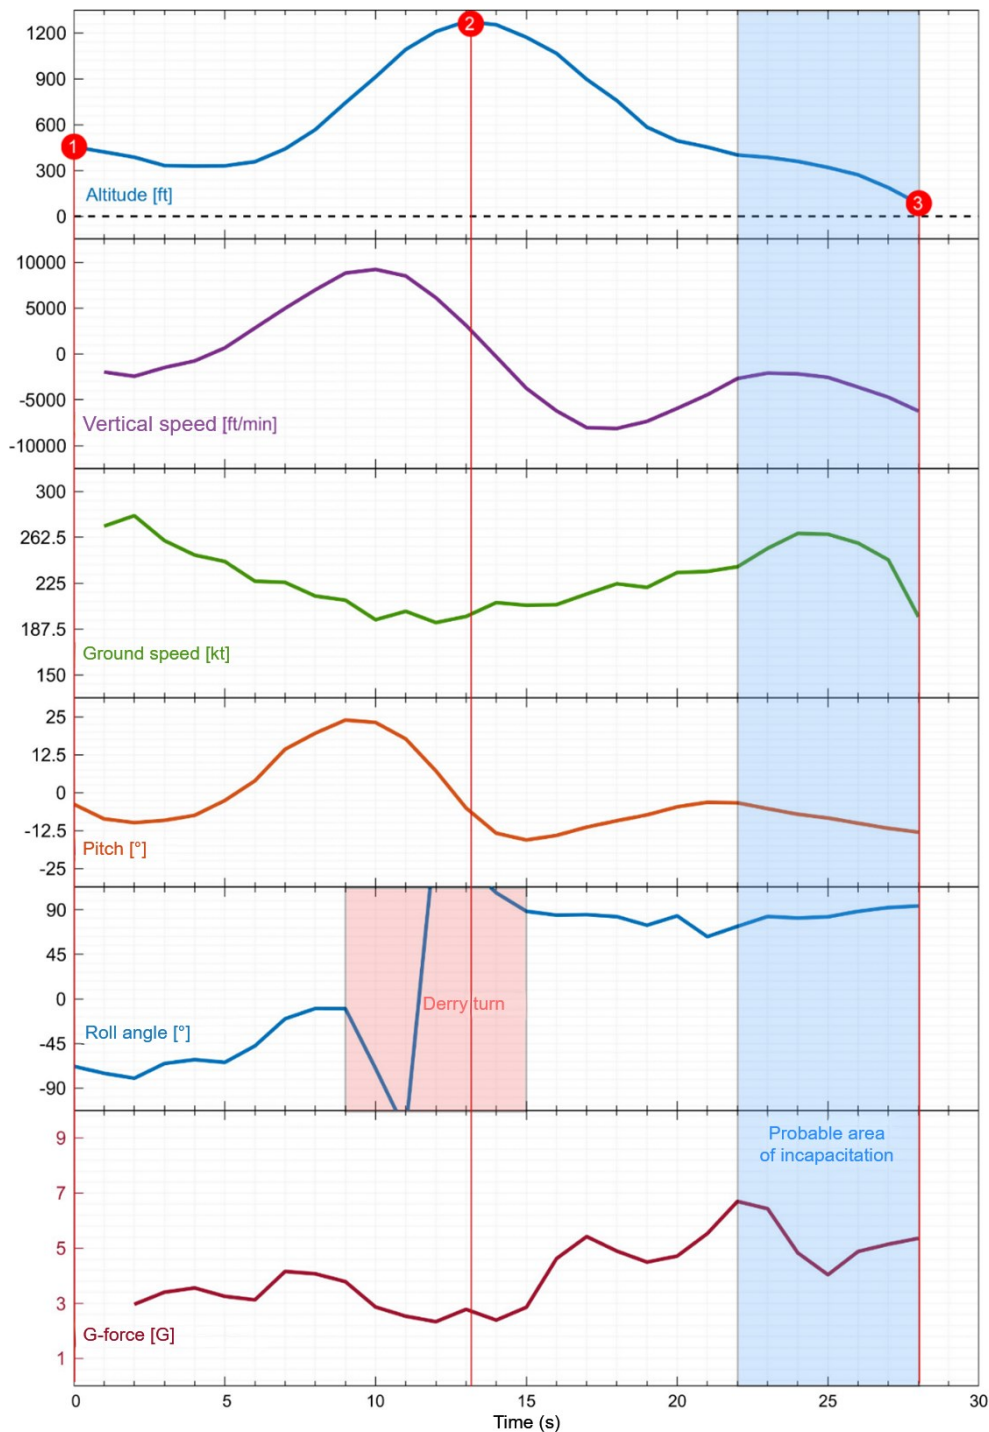
Figure 4: estimated parameters based on iwiation's videos, formatted by the BEA. The derived parameter calculations based on the aeroplane's positions and attitudes, such as the G-force, are subject to uncertainty and should be taken as orders of magnitude.

After the 360° turn and in order to turn around and return to the display axis in preparation for the following pass, the pilot performed a wingover manoeuvre, including a three-quarter climbing roll to the right (the "Derry turn"). When he found himself facing and close to the port of Bormes-les-Mimosas and probably within sight of the port of Le Lavandou, two major references for the display axis, the pilot tightened the turn to intercept the display axis. This descending manoeuvre increased the G-force, up to approximately +5 g for about ten seconds, with a probable peak at a higher value.

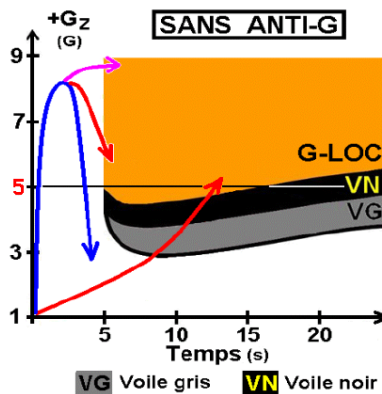
Figure 5: schematic representation of G-force tolerance, without an anti-g device (Stoll, 1956)

Analysis of the Stoll diagram indicates that a rapid and sustained acceleration lasting more than five seconds can lead a pilot directly from wakefulness to loss of consciousness (G-LOC), even in highly experienced pilots, without perceiving the warning visual cues (gray-out, blackout) that could be used as warning signals to refrain from maintaining or increasing the G-force.
