**Serious incident** to the DOUGLAS DC3  
registered **F-AZTE**  
on Saturday 9 July 2022  
at Meaux - Esbly aerodrome

**Stall in turn and in climb, recovery at low height,  
during airshow repetition flight**

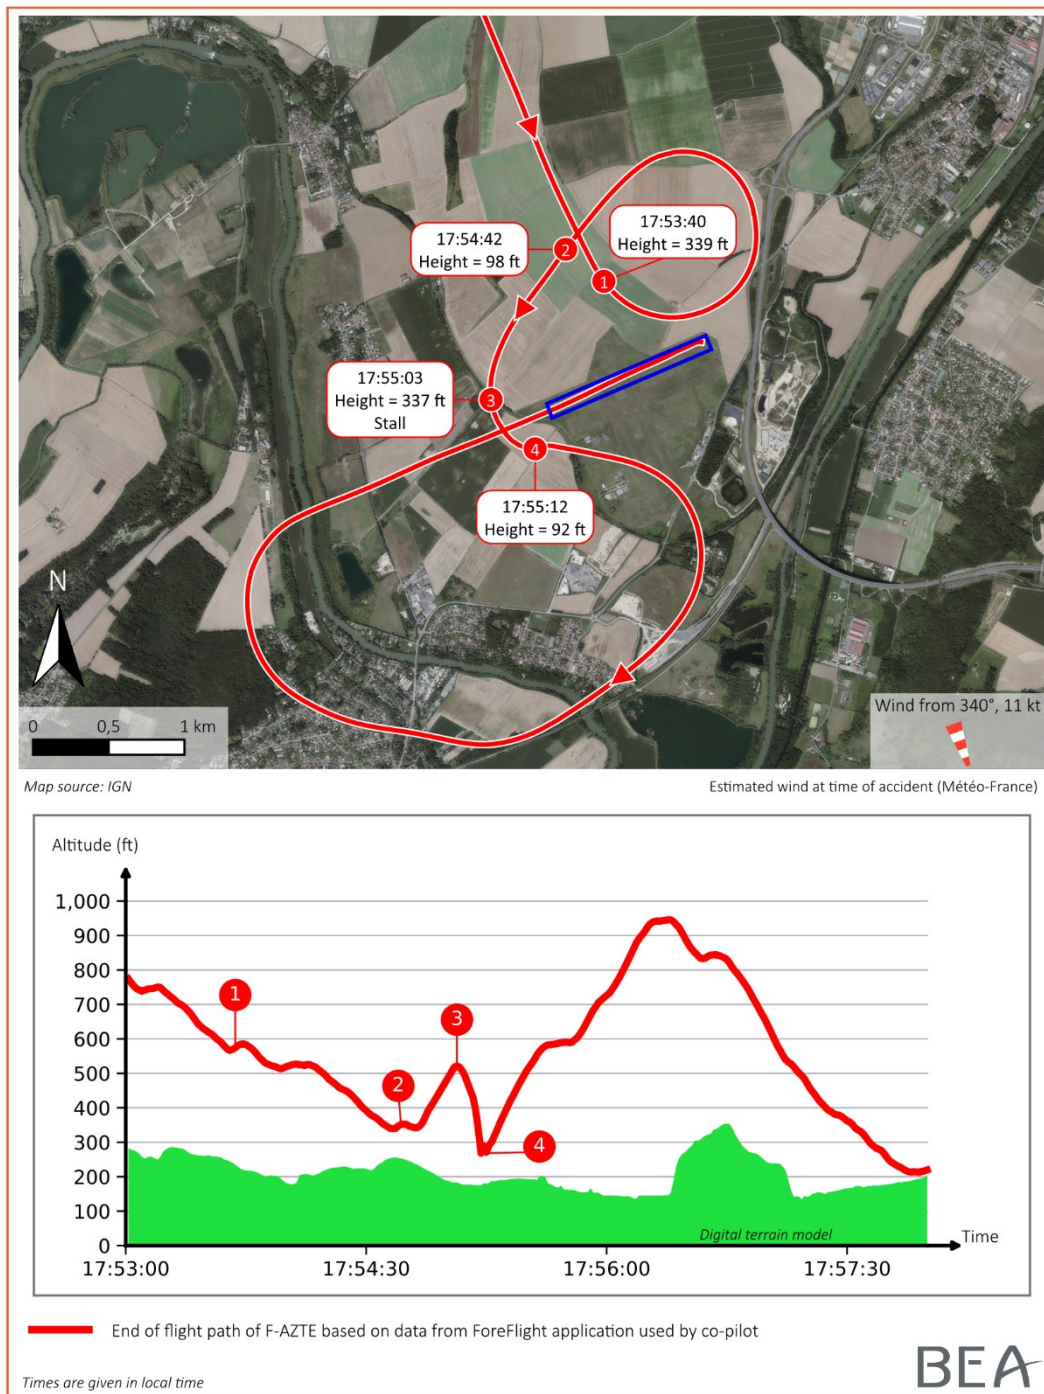
At 17:53, the formation separated when it reached the northern edge of the aerodrome in descent at a height of less than 500 ft. The co-pilot turned left at a height of around 340 ft (see **Figure 1**, point ①) and then asked the captain if he had sight of the aerodrome on his left-hand side and if he was ready to take the controls. The captain confirmed and took the controls. As he continued the turn in descent, the captain had difficulties in finding his visual references. He broke off the turn and the descent at a height of around 100 ft (point ②). He then turned left again in climb. He accentuated the bank and when the aeroplane reached a height of around 340 ft, the left wing stalled (point ③). The loss of control was recovered at a height of around 100 ft (point ④).

Figure 1: flight path based on data from the co-pilot's aeronautical application

- 113 mph when the aeroplane reached the maximum height of around 340 ft (see **Figure 1**, point **3**) before losing height;
- 133 mph when the minimum height of 100 ft was reached (point **4**).
