**Accident** to the MORANE SAULNIER MS733  
registered **F-AZXU**  
on Friday 6 June 2025  
near Rochefort - Charente-Maritime airport

**Unintentional start of spin, collision with ground,  
during an airshow**

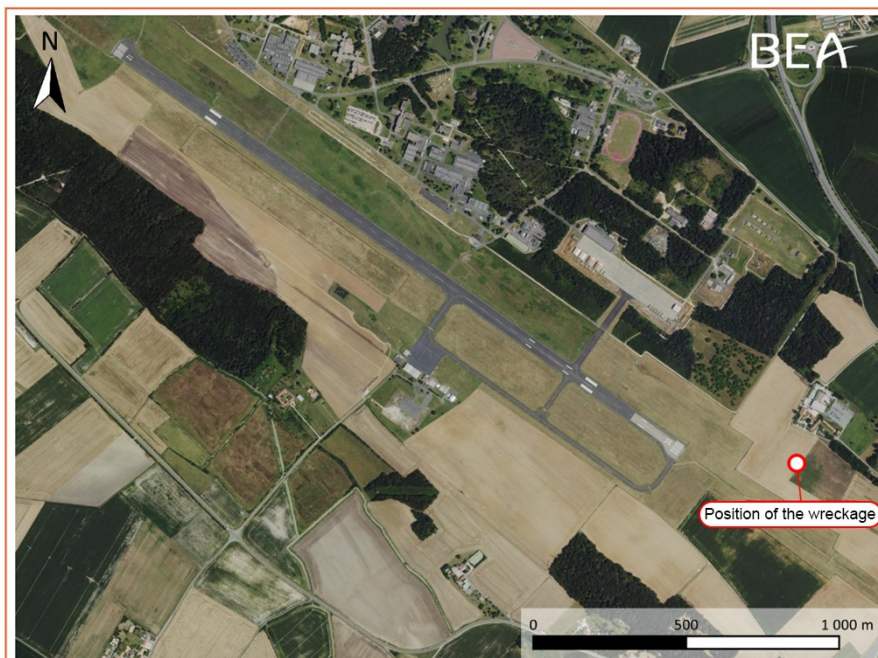
The wreckage was lying in a field situated outside the airport grounds, at around 370 m from the runway 30 threshold. It was complete and grouped together.

Figure 2: position of wreckage east of the airport (source: IGN, annotations BEA)

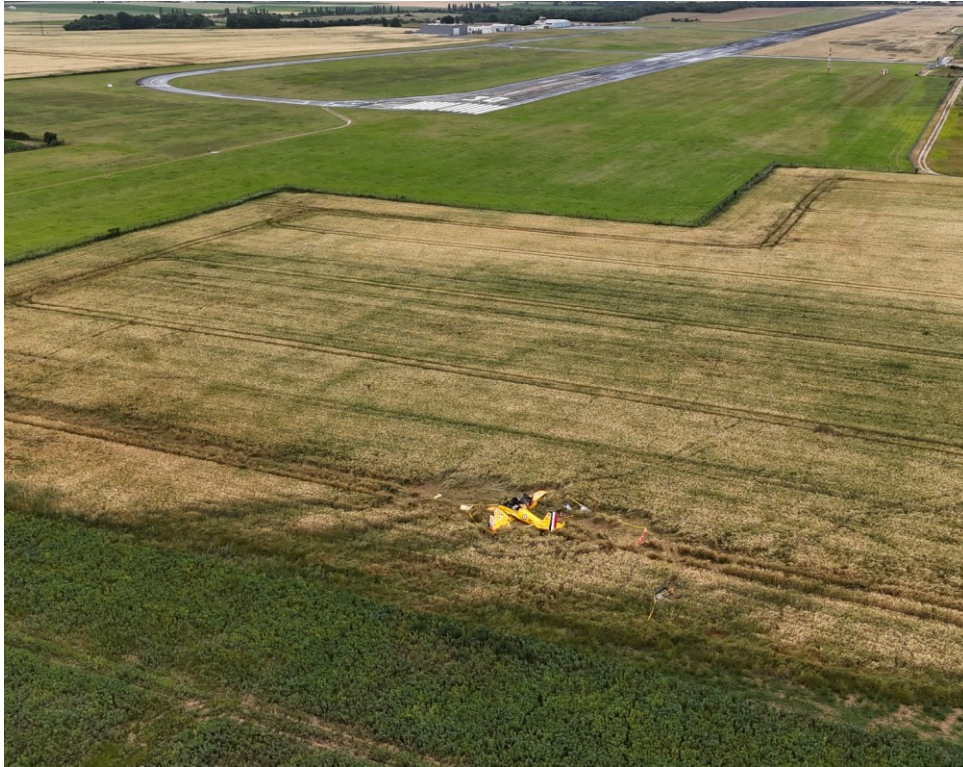
The aeroplane struck the ground with a very steep nose-down attitude and a left-hand bank. The energy of the impact caused the airframe to bounce. It then came to a stop around ten metres behind the first contact with the ground.

*Figure 3: drone view of accident site (source: BEA)*

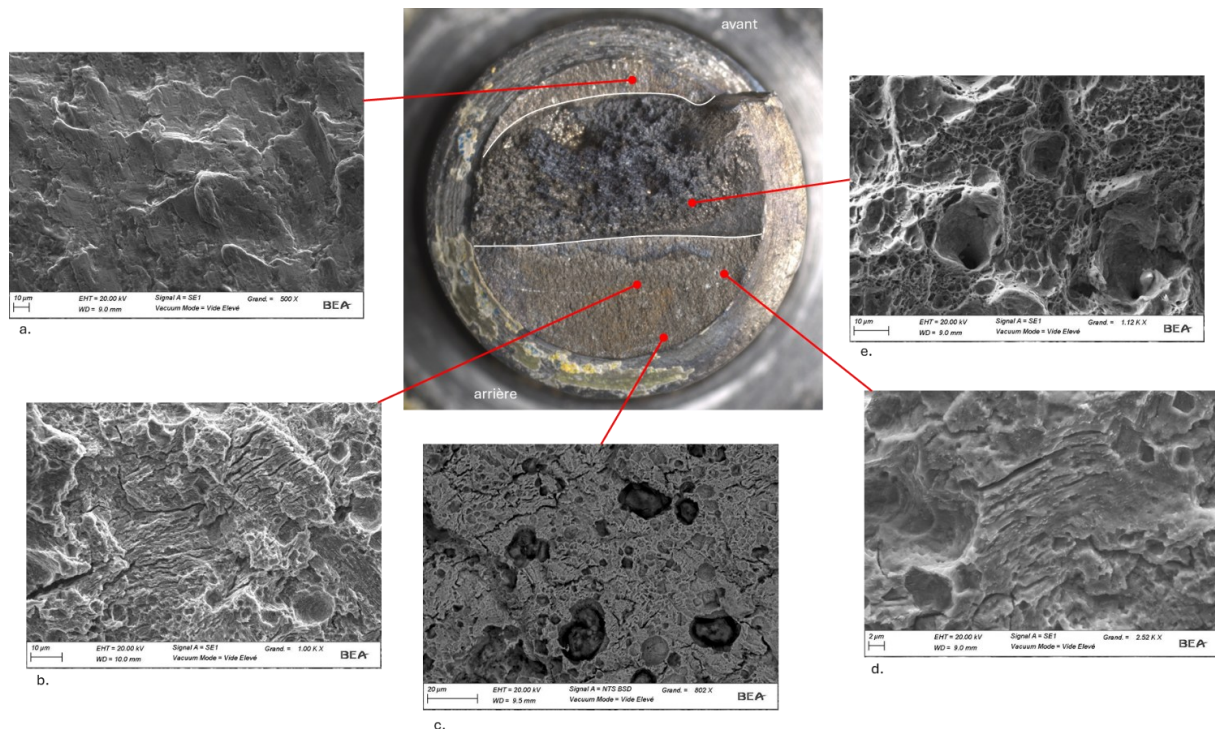
On the flap control linkage, on the left-hand side under the Karman fillet, a rupture showing a two-colour fracture surface was identified on a rod which was removed for examination by the BEA laboratory. Progressive fatigue cracking in this rod was observed. The examinations were not able to determine if the final rupture of this part occurred in flight or during the collision with the ground.

Figure 4: SEM images of the rupture surface - buttering (a.), dimples (e.), fatigue striations (b. and d.), presence of oxides (c.) (source: BEA)

The results of the examination of this rupture were shared during the investigation with the DSAC which gave rise to an information bulletin being produced, BI 2025-07, including, in particular, a recommendation to implement an inspection of this flap control rod. BI 2025-07 was published by the DSAC in August 2025<sup>3</sup> and also distributed to the ICAO contracting states.

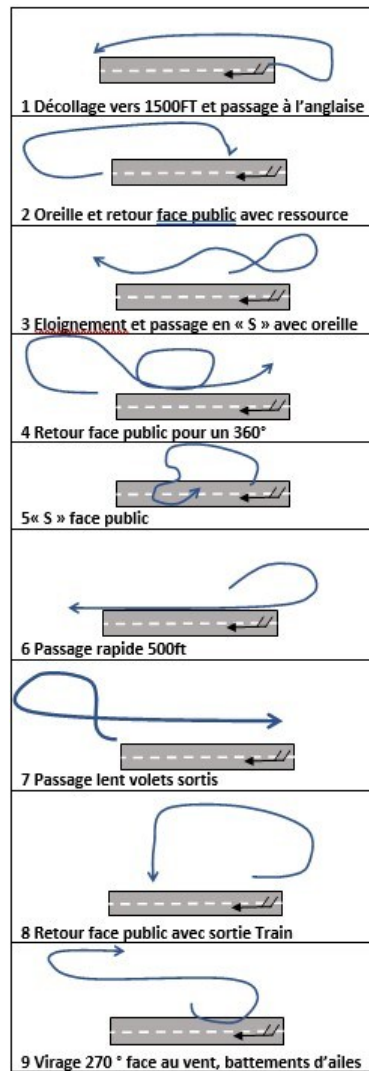
On his display sheet, the pilot planned to carry out a ten-minute flight without aerobatic figures, between 500 and 1,500 ft agl, in accordance with the programme below:

Figure 6: flying programme planned by pilot of F-AZXU (source: ASC)
