Accident to the BELL 47G-2
registered **F-BIFN**
on Wednesday 12 July 2023
at Arles

Time	Around 10:05 ¹
Operator	GIRAGRI 17
Type of flight	Spraying
Persons on board	Pilot
Consequences and damage	Pilot severely injured, aircraft substantially damaged
This is a courtesy translation by the BEA of the Final Report on the Safety Investigation. As accurate as the translation may be, the original text in French is the work of reference.

Loss of yaw control during a spraying flight

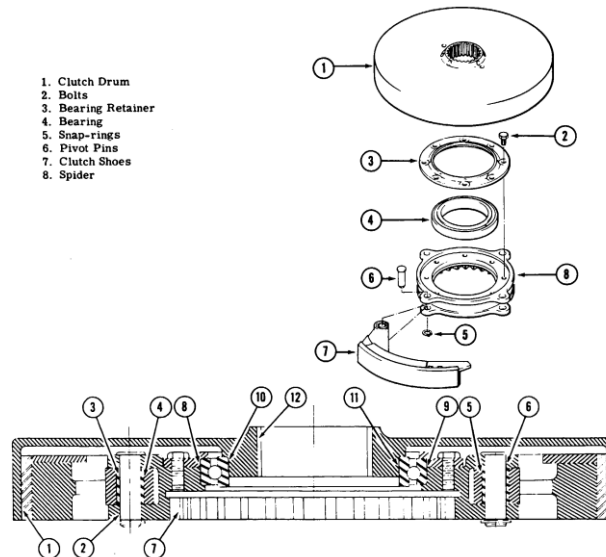
Figure 3: clutch parts (Source: manufacturer, Bell 47 Maintenance Manual)

The clutch was visually examined. The thickness of the linings was greater than the minimum required². Significant discolouration, consistent with local heating, was observed at the bottom of the drum. It was not possible to determine whether this discolouration was normal. On the day of the accident, the clutch had logged 1,555 flight hours. The manufacturer prescribes an intermediate visual inspection of the clutch every 600 hours and an overhaul every 1,200 hours. The last overhaul was carried out on 15 December 2021. Since then, the helicopter had logged 306 flight hours.

As a general rule, increasing the main rotor pitch also increases the lift, and consequently, the drag coefficient that the main rotor has to overcome. This places a greater load on the clutch, which must transmit a higher torque from the engine to the main rotor. If the engine speed is not sufficient or is decreasing, this reduces the clutch's ability to transmit power efficiently to the main rotor. The torque transmitted by the clutch may not be sufficient to maintain engagement, which may cause clutch slip, or even increased clutch wear and overheating.

The pilot reported that he felt a sudden yaw movement to the left, described as "a short sharp shock", while flying in a straight line at a stable altitude, approximately two rotations before the accident. He did not report any other similar events during the 25 spraying sequences that preceded the accident. Apart from a discolouration of the clutch drum, nothing unusual was observed on the helicopter prior to the collision with the ground. A clutch slip may cause disconnection between the engine and the main gearbox. As the rotor is

no longer receiving full power from the engine, the reaction torque decreases and the helicopter begins to yaw to the left. A clutch slip may result from a substantial reduction in engine revolutions, combined with an increase in the main rotor collective pitch.
