**Accident** to the Jodel DR1050 Ambassadeur  
registered **F-BJOZ**  
on Saturday 5 July 2025  
close to Châteauroux – Villers aerodrome

**In-flight engine failure, return to departure aerodrome,  
loss of control during go-around<sup>2</sup>**

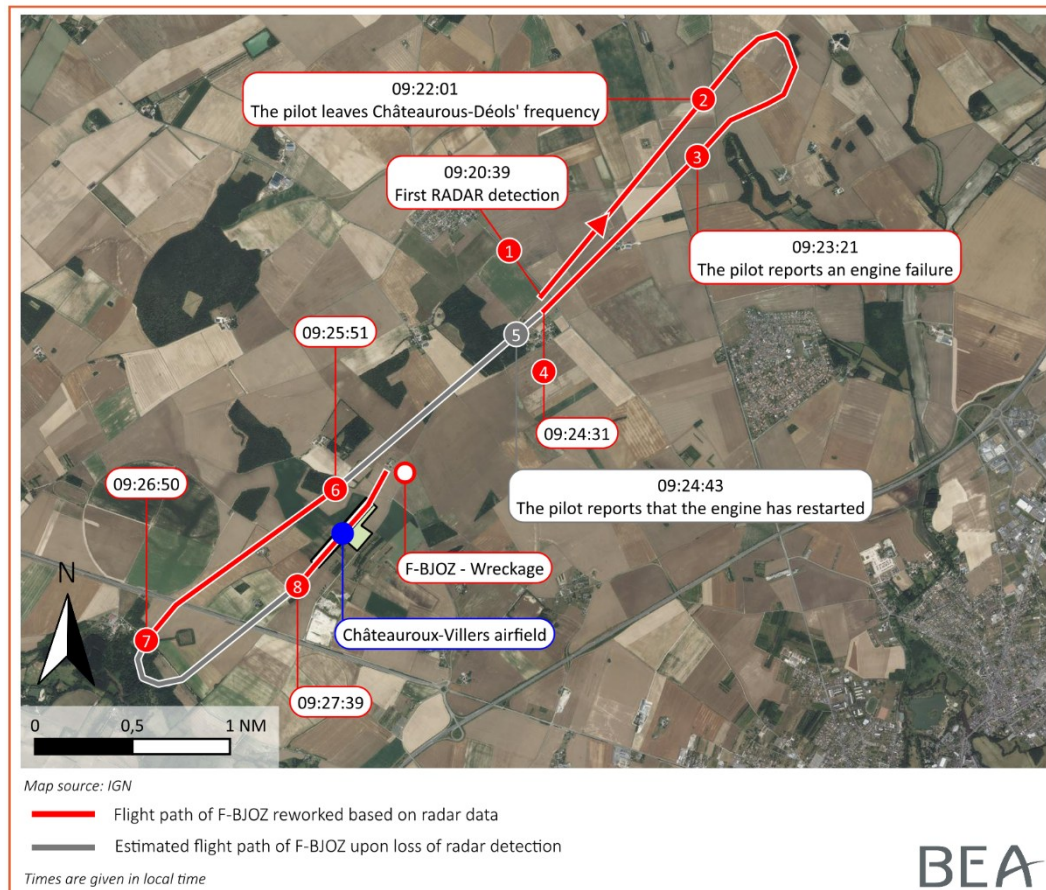
Figure 1: flight path of F-BJOZ

The pilot took off from runway 04 of Châteauroux – Villers aerodrome to carry out a local flight in the north sector. A few minutes later, at 09:19, the pilot called the AFIS officer at Châteauroux – Déols aerodrome, informed him of his intentions and indicated that the aeroplane was at an altitude of 2,500 ft. He left the frequency at 09:22 (see **Figure 1**, point ②).

The pilot then carried out a U-turn at 09:23 and came back onto the frequency, indicating that he was returning to Châteauroux – Villers due to an “engine failure” (point ③) and that he was trying to restart the engine. One minute later, he informed the AFIS officer that the engine had restarted and then left the frequency to contact Châteauroux – Villers (point ⑤).

The pilot flew over the aerodrome, carried out a U-turn in the south (point ⑦) and then joined the final for runway 04. According to two eyewitnesses on the ground (see **Figure 2**), the aeroplane was travelling fast when it flew over the runway. At a height of a few metres, the pilot initiated a go-around and passed in front of the first of the two eyewitnesses situated close to the hangars. The latter estimated that full power was not reached. At the end of the runway, the pilot opened up to the left, passed close to the second eyewitness situated on the road and then turned right in the direction of the runway.

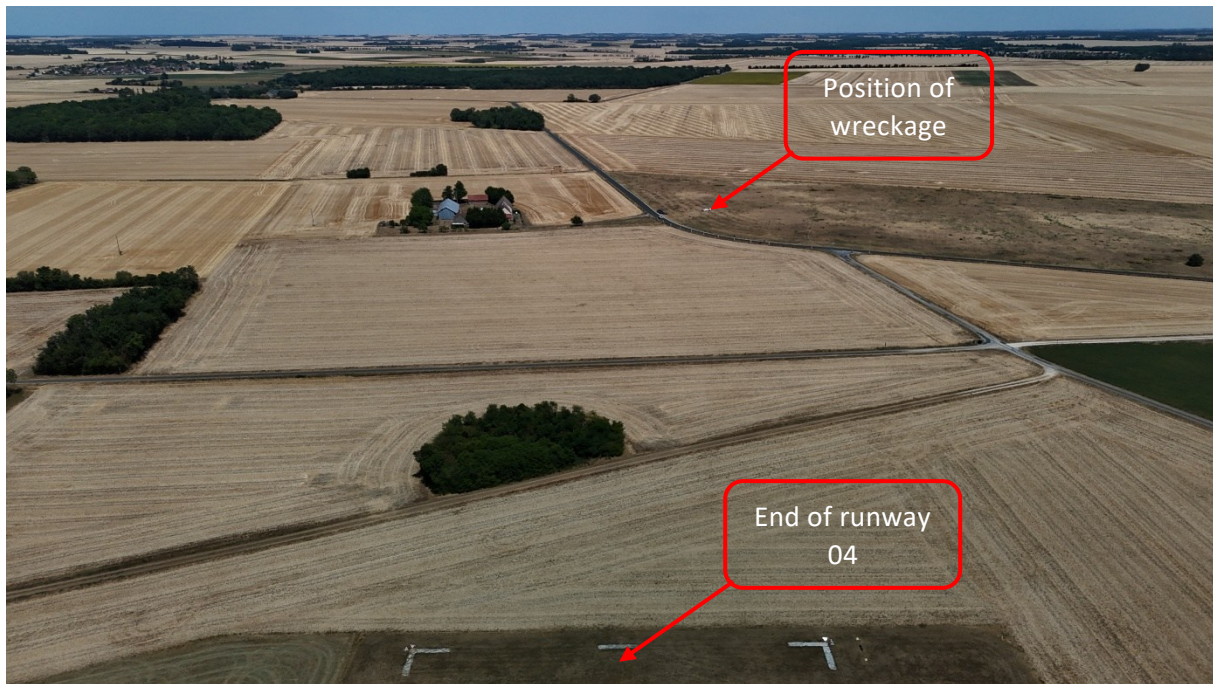
*Figure 3: surroundings of end of runway 04 on day of accident  
(source: GTA drone, annotations BEA)*

The wreckage was situated around 400 m from the end of runway 04, in a field without crops or obstacles, alongside a road. This field was surrounded in all directions, by numerous other recently harvested fields.

The wreckage was complete and grouped together. The aeroplane had collided with the ground on the right front.

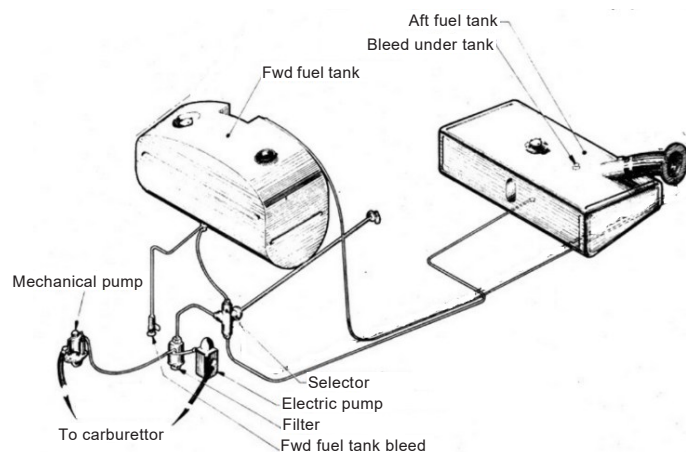
*Figure 4: partial diagram of fuel system of DR1050 (source: aeroplane manual, annotations BEA)*

Several litres of fuel were present in the aft fuel tank. The forward fuel tank was ripped open and found empty. The fuel selector was damaged during the accident, its position could not be determined due to the deformations. It was in a position close to that for the forward tank. There was fuel in the gascolator filter and in the electric pump. However, the carburettor bowl was empty.
