Accident to the Jodel D140
registered **F-BMFV**
on Friday 28 February 2025
on the Vallée Blanche glacier

Time	Around 11:30 ¹
Operator	Aéroclub de Megève
Type of flight	Local
Persons on board	Pilot and passenger
Consequences and damage	Pilot and passenger injured, aeroplane substantially damaged
This is a courtesy translation by the BEA of the Final Report on the Safety Investigation. As accurate as the translation may be, the original text in French is the work of reference.

Flight on backside of power curve, loss of control, collision with surface of a glacier, in mountains

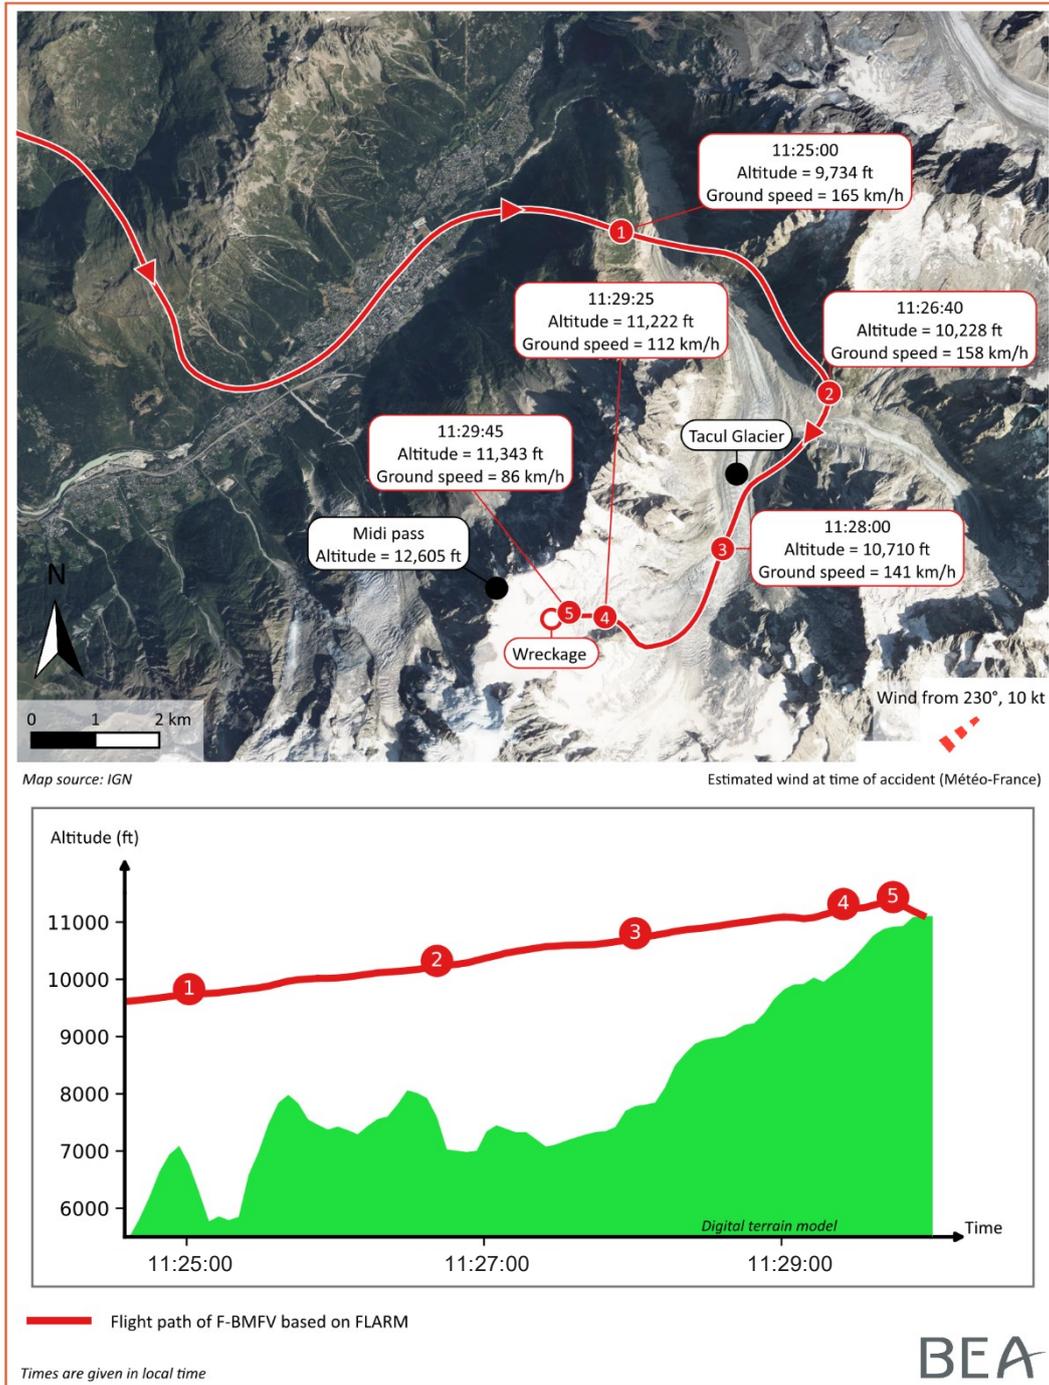
The pilot, accompanied by a passenger, took off at around 11:00 from Megève mountain airfield for a flight in the Mont Blanc massif. He followed Chamonix valley and then entered the Mer de Glace at 11:25 (see **Figure 1**, point **1**).

The aeroplane was flying at an altitude of approximately 9,800 ft, climbing towards the Col du Midi pass, located about ten kilometres away, and which rises towards an altitude of 11,615 ft (3,540 m). The ground speed was approximately 165 km/h.

At 11:27:40 (point **2**), the aeroplane reached an altitude of 10,600 ft (height of 1,000 m) overhead Tacul glacier. The average vertical speed was approximately 320 ft/min, and the ground speed was approximately 155 km/h. The ground speed would then gradually decrease until the end of the flight. From this position, the slope of the terrain ahead of the aeroplane became a lot steeper (rising slope gradient of approximately 20%).

At 11:28 (point **3**), the ground speed was 130 km/h. The pilot considered that the aeroplane was no longer climbing as planned, which he interpreted as an engine power anomaly. The aeroplane's performance did not appear sufficient to reach the Col du Midi pass. He explained that he had decided against carrying out a left-hand turn and then a right-hand turn before continuing (before Gros Rognon summit) towards Vallée Blanche to make an emergency landing there.

Figure 1: flight path and vertical profile of path of F-BMFV

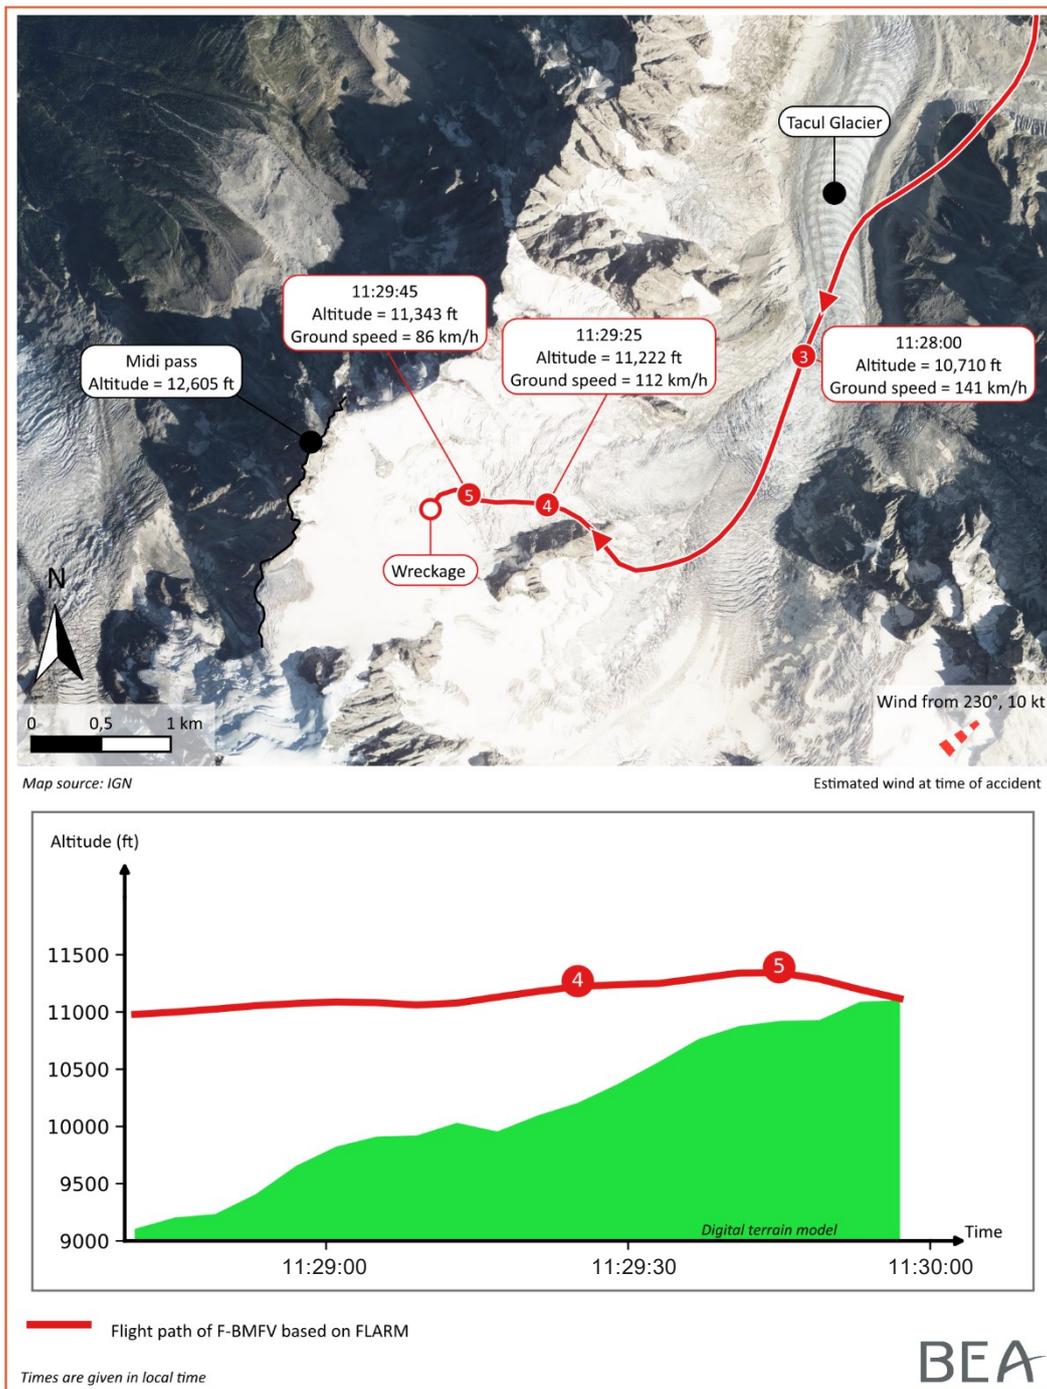
At 11:29:25, (point 4), the ground speed was approximately 110 km/h. A photo of the aeroplane's instrument panel taken by the passenger showed that the indicated airspeed was approximately 112 km/h and the vertical speed slightly above 500 ft/min during the climb.

At 11:29:45 (point 5), the aeroplane's ground speed reached approximately 90 km/h, its altitude peaked at 11,340 ft (a height of 400 ft), and the vertical speed dropped suddenly. The aeroplane then descended approximately 70 m for about ten seconds before colliding with the ground. The two occupants struck the aeroplane's instrument panel upon impact. A witness raised the alarm, triggering a helicopter rescue operation.

Figure 2: end of flight path and vertical profile of path of F-BMFV

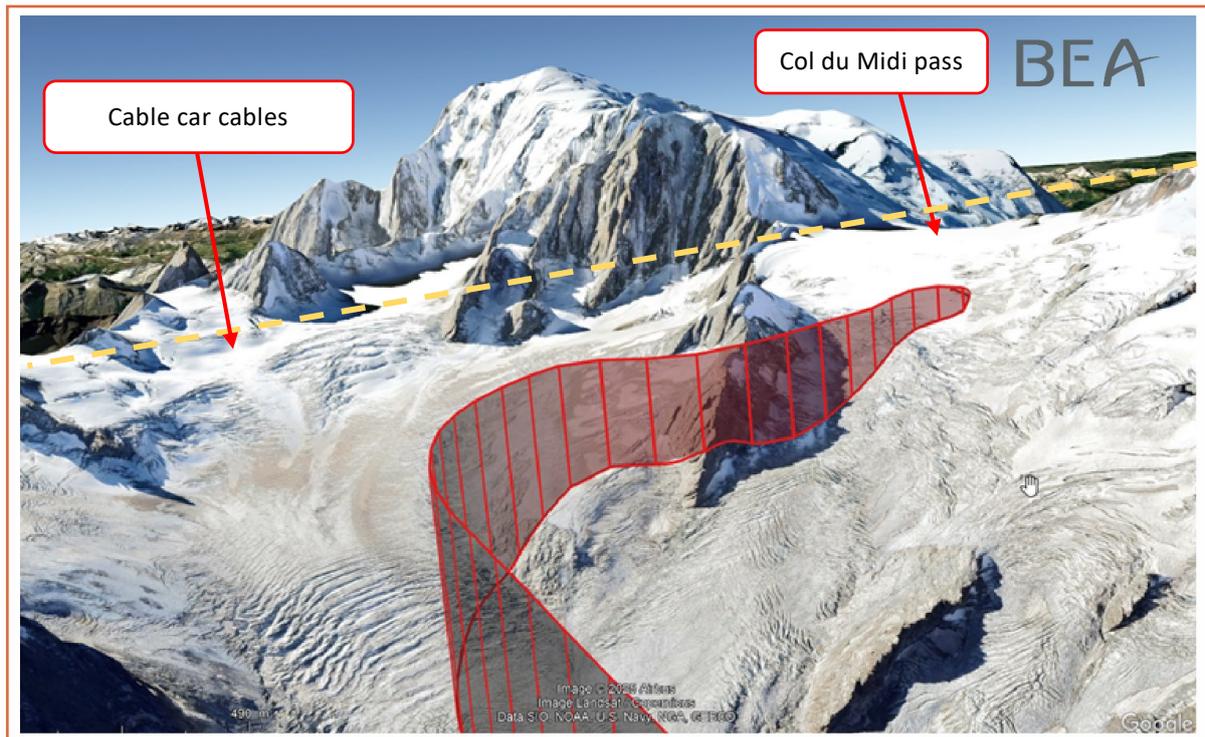
Figure 3: end of flight of F-BMFV (geographic background: Google Earth)

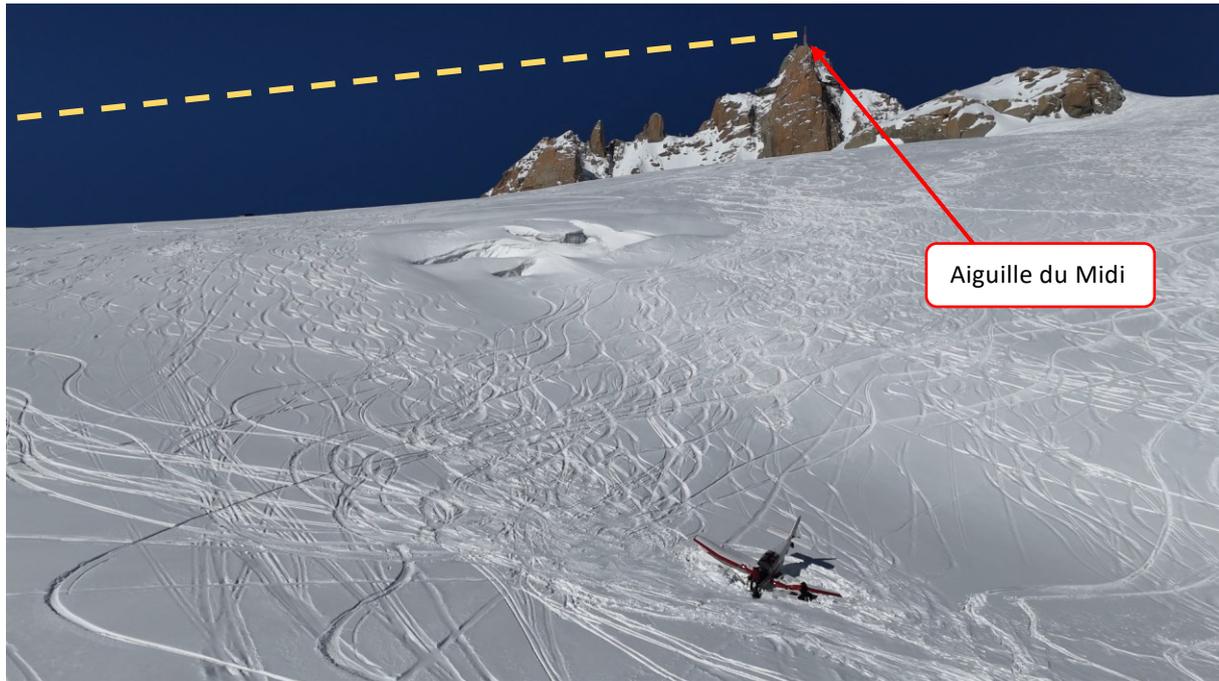
The wreckage was located at an altitude of 3,404 m on the Vallée Blanche glacier, to the south-east and approximately 1 km from the Col du Midi pass. The cables of the cable car linking Helbronner (Italy), the summit of Gros Rognon, and the Aiguille du Midi were located about 100 m higher up than the wreckage and at a horizontal distance of approximately 200 m.

The wreckage was complete and oriented south-east (137°). No marks were visible in the snow around the wreckage. It was resting on its forward fuselage, with a slight nose-down attitude. Photos transmitted to the BEA, taken just after the accident, as well as witness statements, indicated that the nose of the aeroplane was buried roughly 10 cm in soft snow.

The examination found that the aeroplane probably struck the ground at a low horizontal speed and in a left-hand roll.

Figure 4: photo taken by drone of accident site (source: BEA)

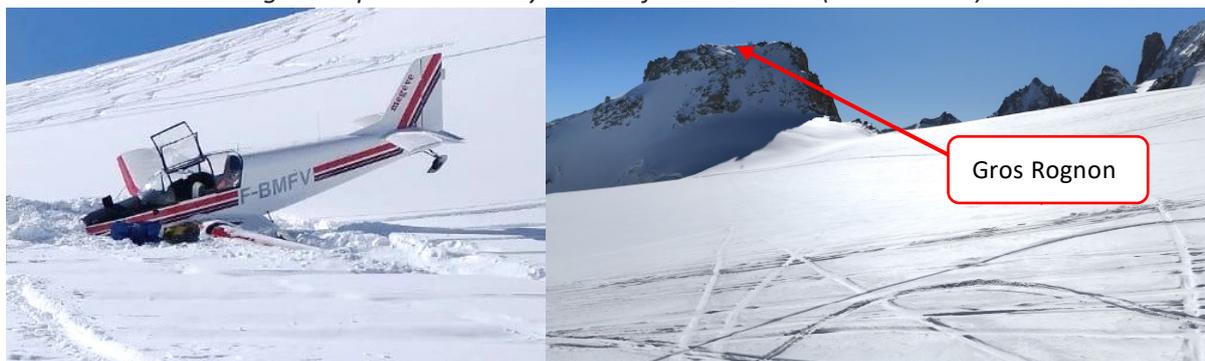
Only the landing gear and wings sustained damage as a result of the impact with the ground. The blades of the propeller were intact. Snow was present in the nose cowling. The flight controls were continuous and the flaps were retracted. The controls connected to the engine were all pushed forward (corresponding to maximum richness, maximum engine power and carburettor heat inactive). However, they may have been moved by the first responders. The engine underwent a detailed inspection and bench testing. No malfunctions that could have contributed to the accident were identified.

Figure 5: photos of F-BMFV and from BMFV (source: BEA)

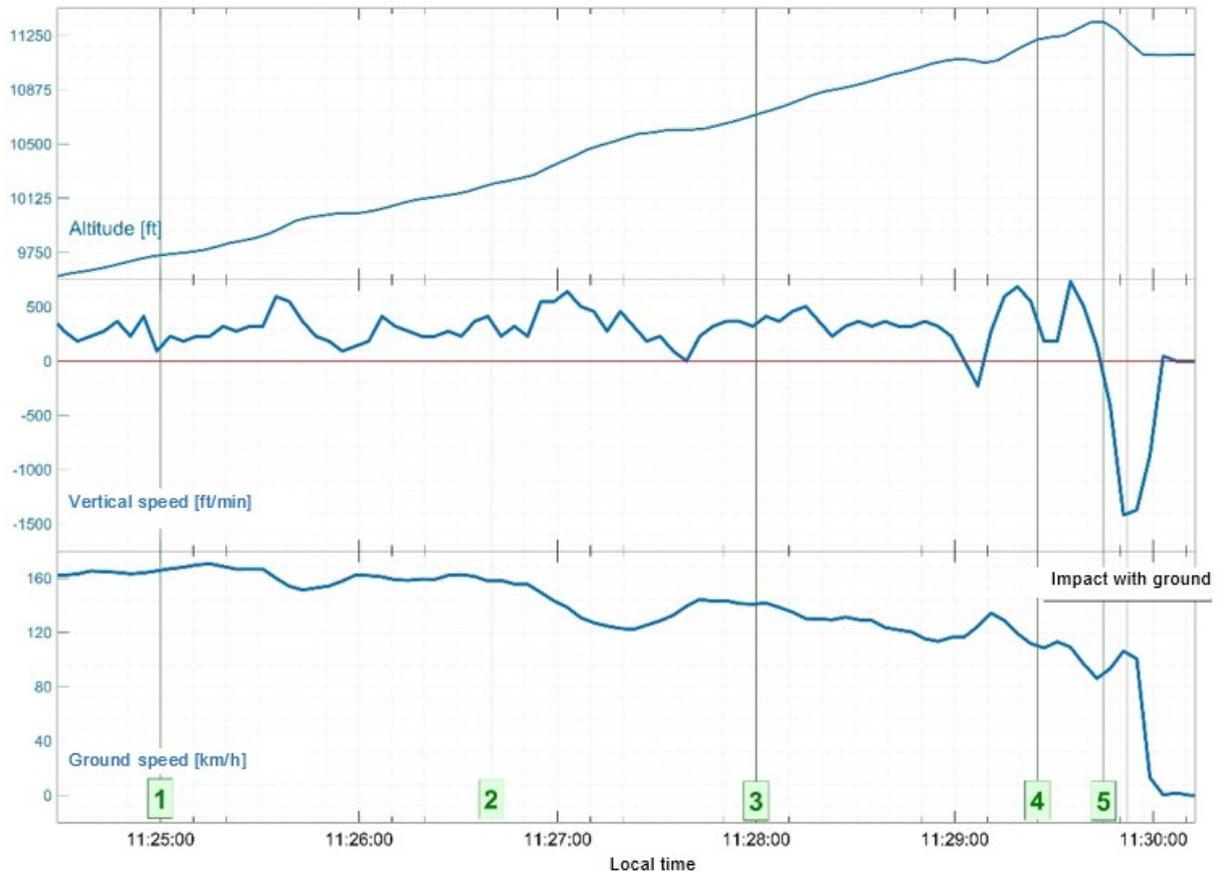
The evolution of the ground speed and the vertical speed is evidence of the aeroplane progressively entering flight on the backside of the power curve during the climb.

- the vertical speed varies around 300-400 ft/min during the climb and then suddenly drops in the last seconds of the flight;
- the horizontal (ground) speed which at this point, roughly corresponds to the indicated airspeed, progressively decreases to around 90 km/h, at which point the vertical speed drops.

Figure 6: ground speed and vertical speed of F-BMFV according to time, calculated using FLARM data
