Accident to the Piper PA30
registered **F-BPIR**
on Monday 4 December 2023
at Villejuif

**Unpriming of fuel system, uncontrolled engine shutdown,
forced landing in urban area at night**

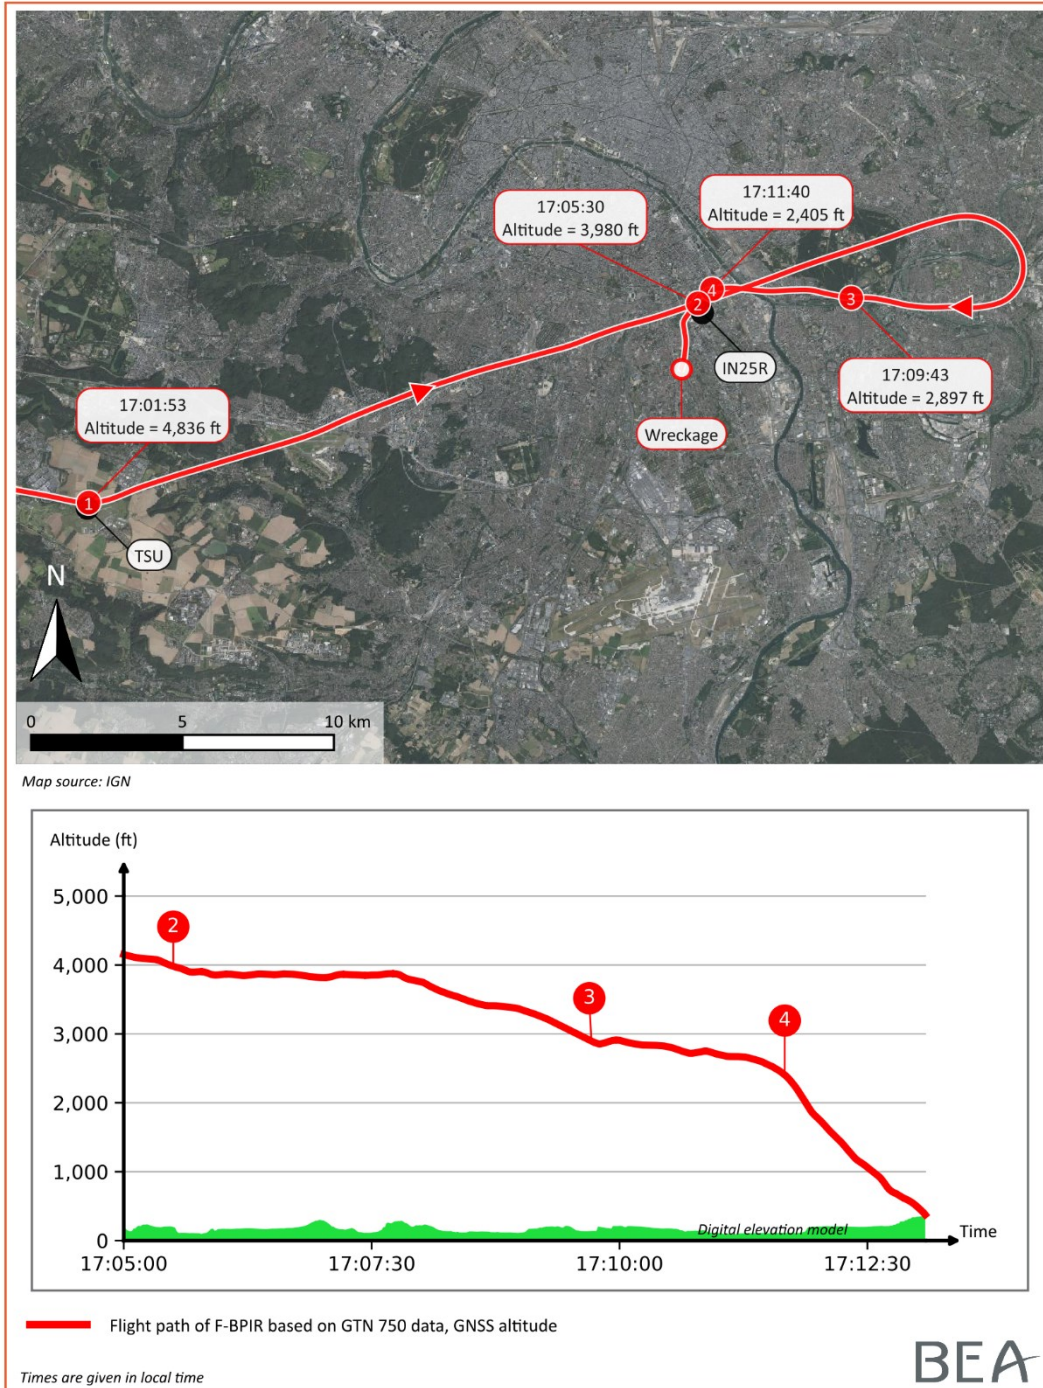
Figure 1: end of flight path

At 17:11:40 (point 4), overhead IN25R and at 2,400 ft, the flight path of the aeroplane took a southerly direction. The vertical speed was -1,400 ft/min during the descent. One minute and thirty seconds later, the instructor tried to land in the courtyard of a building. The aeroplane came to a stop against a low wall, the occupants evacuated the aircraft.

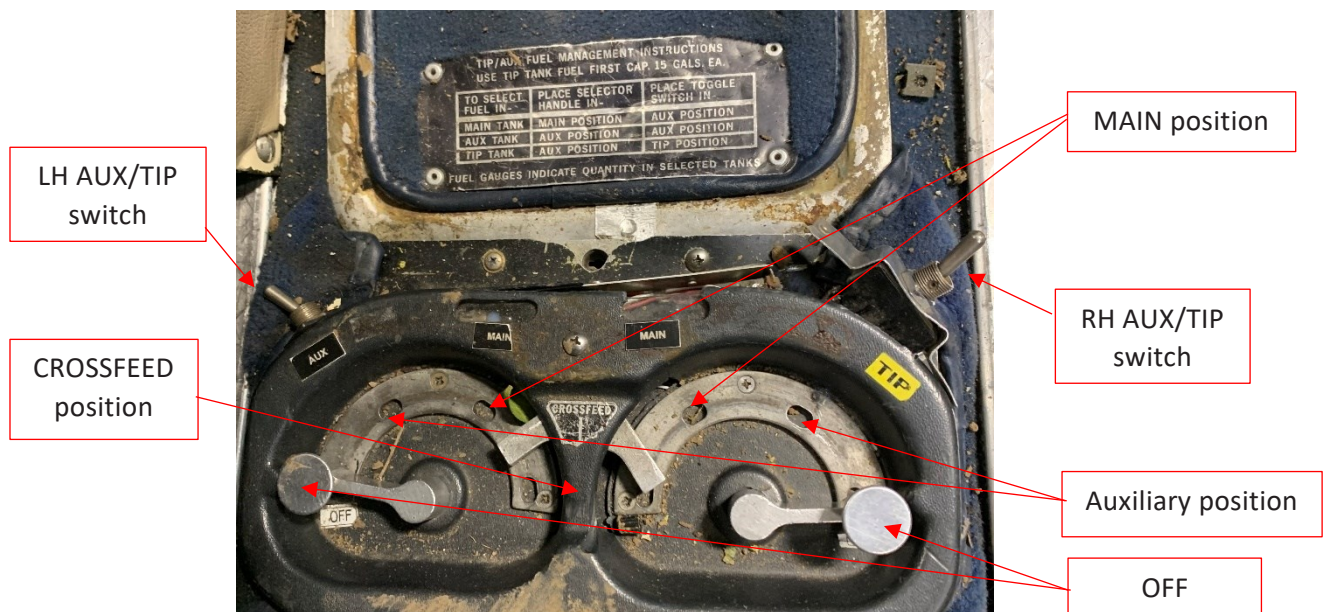
Figure 5: F-BPIR fuel tank selectors, set to OFF (source: BEA)

It can be seen that certain MAIN, AUX, TIP, OFF indications are missing. They were not damaged during the accident or during the examinations. It was found that this was also the case on the other two PA 30s in the ATO fleet.

In addition, the poor condition of the fuel tank selector indications, combined with the reduced visibility at night, may have made it difficult to check that the selectors were in the correct position, both for the instructor and for the pilot in training, who had limited experience of the aeroplane and insufficient knowledge of the fuel system.

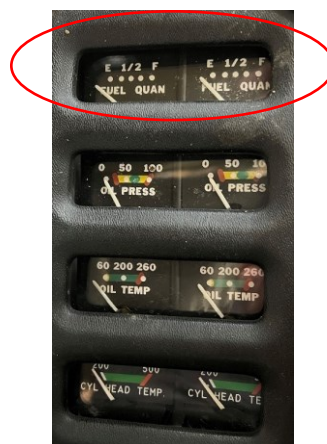
Figure 6: fuel tank gauges (source: BEA)

The aeroplane was not equipped with a low fuel level light. Two gauges, one for each side, were situated on the instrument panel, opposite the RH seat (instructor's position). Each gauge indicated an estimation of the quantity of fuel contained in the selected fuel tank.

The outbound and return flights were then carried out using the fuel in the AUX fuel tanks without the occupants being aware of this. The pilot in training and the instructor thought that they were carrying out the flight using the fuel in the MAIN fuel tanks, in accordance with the ATO's practices which recommended their exclusive use for this type of flight. The fuel tank gauges were used neither on the ground or in flight.

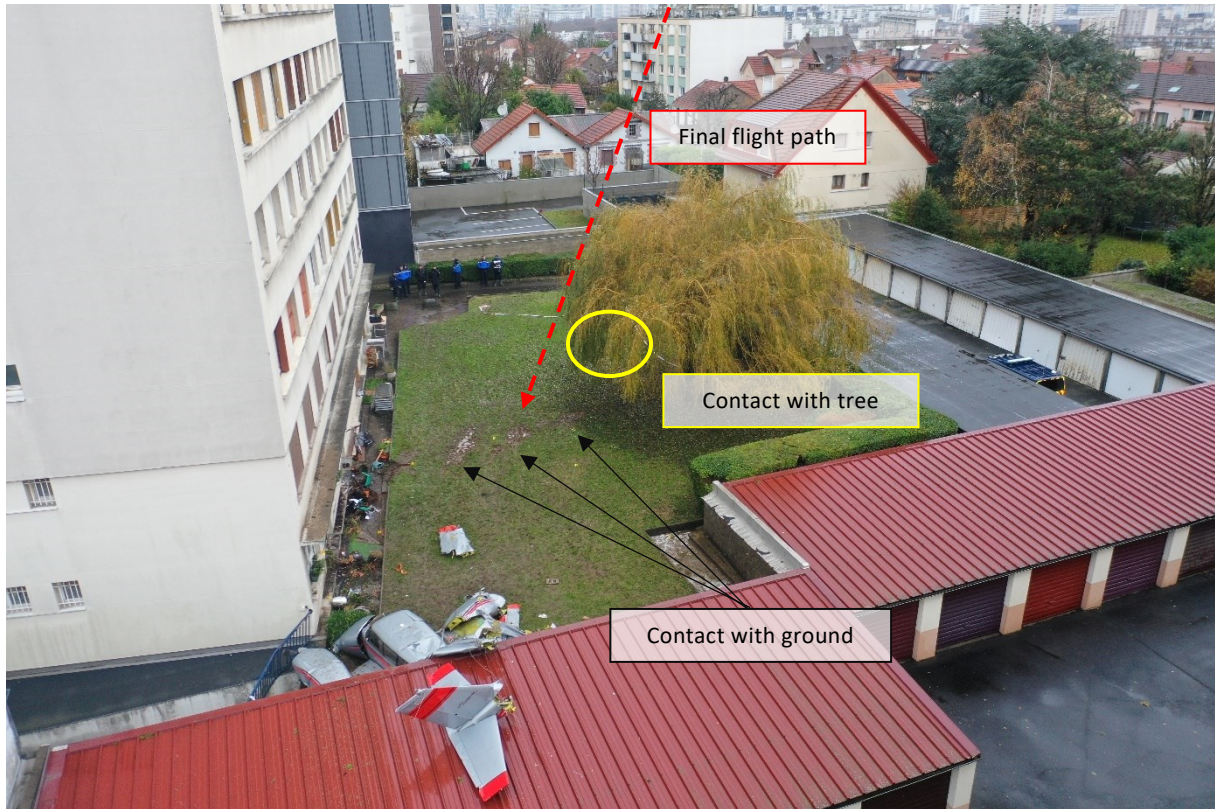
Figure 7: final flight path (source: GTA drone, annotations BEA)

The aeroplane collided with the ground in a clean configuration (landing gear and flaps retracted), on a southerly heading, close to a tree approximately ten metres tall, in the middle of an inner courtyard belonging to a building of several floors. At night, this courtyard was not lit.

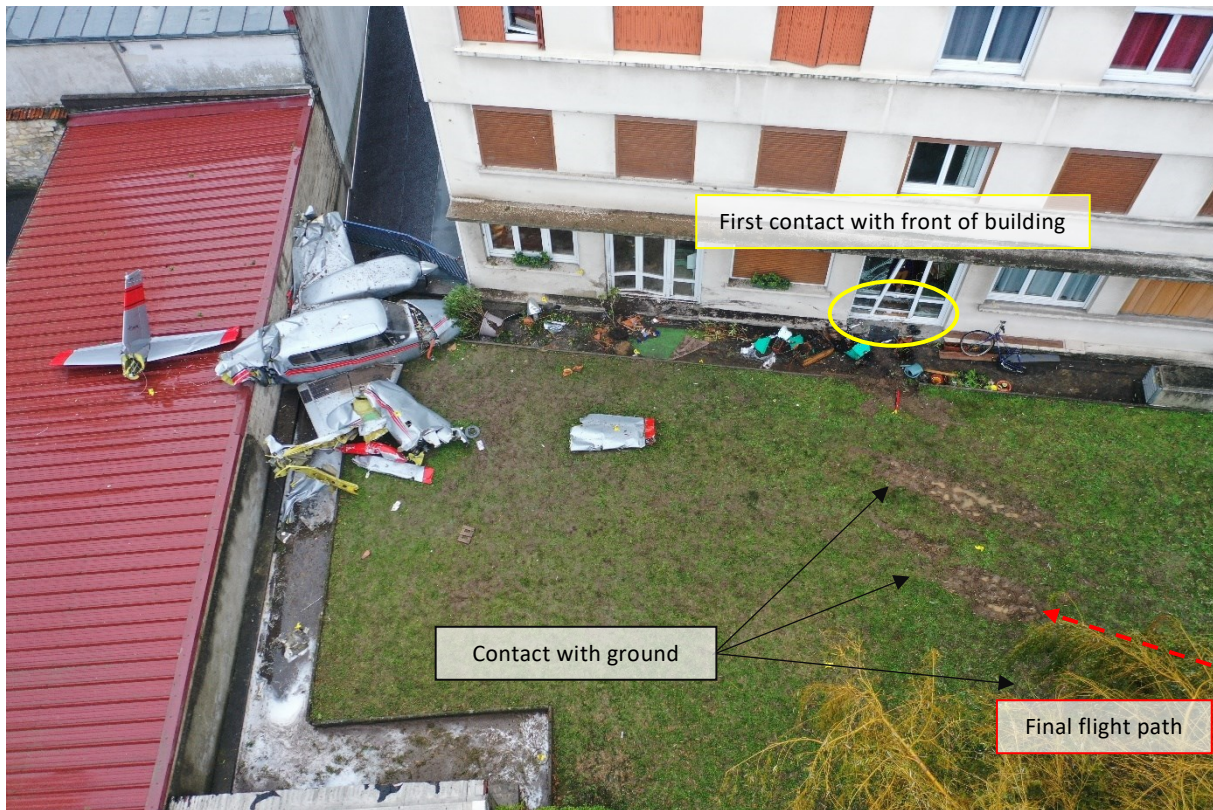
Figure 8: aerial view of accident site (source: GTA drone, annotations BEA)

The examinations of the accident site and wreckage found that the aeroplane had a quite low vertical speed when it came into contact with the ground. The LH wing severed several branches of the tree. The tip of the aeroplane's RH wing then came into contact with the front of the building, causing the separation of the tip fuel tank, propeller and part of the wing. The airframe then pivoted around 180° before coming to a stop against the low rear wall of a row of garages. The rear of the airframe absorbed the energy by compressing against the low wall. The rear section of the tail still integral with the tailplane separated from the airframe and came to a stop on the roof of the garages.

The wreckage of the aeroplane was complete and grouped together. No sign of engine power was observed on the elements of the site or on the propeller blades.

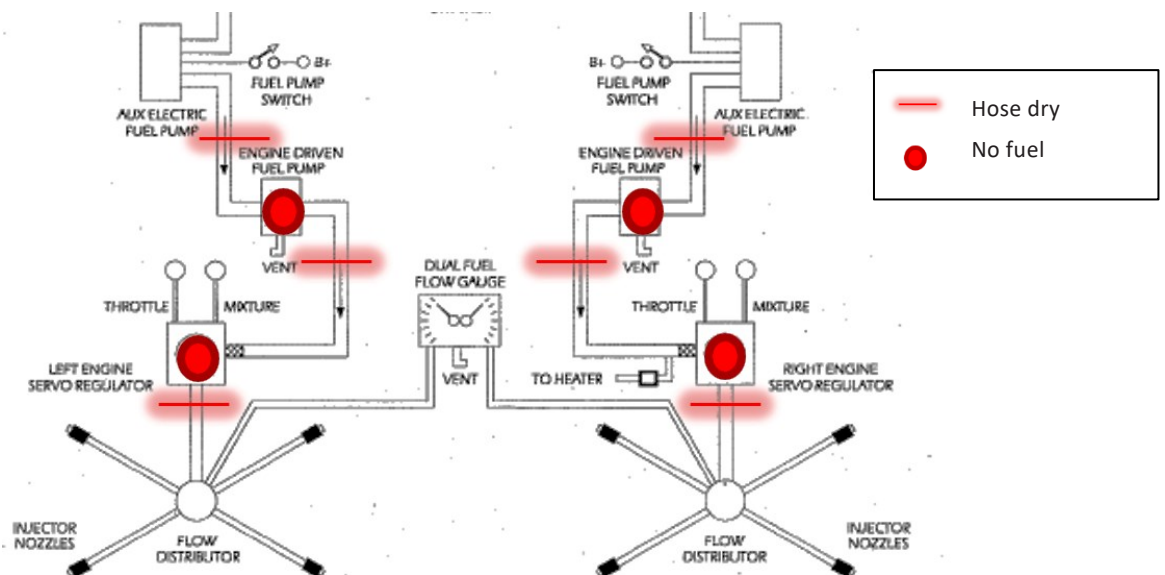
Figure 10: end parts of fuel system where the absence of fuel was observed (source: Piper PA30 Service Manual, annotations BEA)

Lastly, the examinations carried out on the end part of the fuel system, just downstream of the engines, led to the conclusion that the engines had been starved of fuel, leading to their complete shutdown.
