**Accident to the Robin DR300 - 140**  
registered **F-BSPK**  
on 24 September 2023  
at Calais-Marck (Pas-de-Calais)

**Collision with kite lines in aerodrome circuit,  
during an introductory flight**

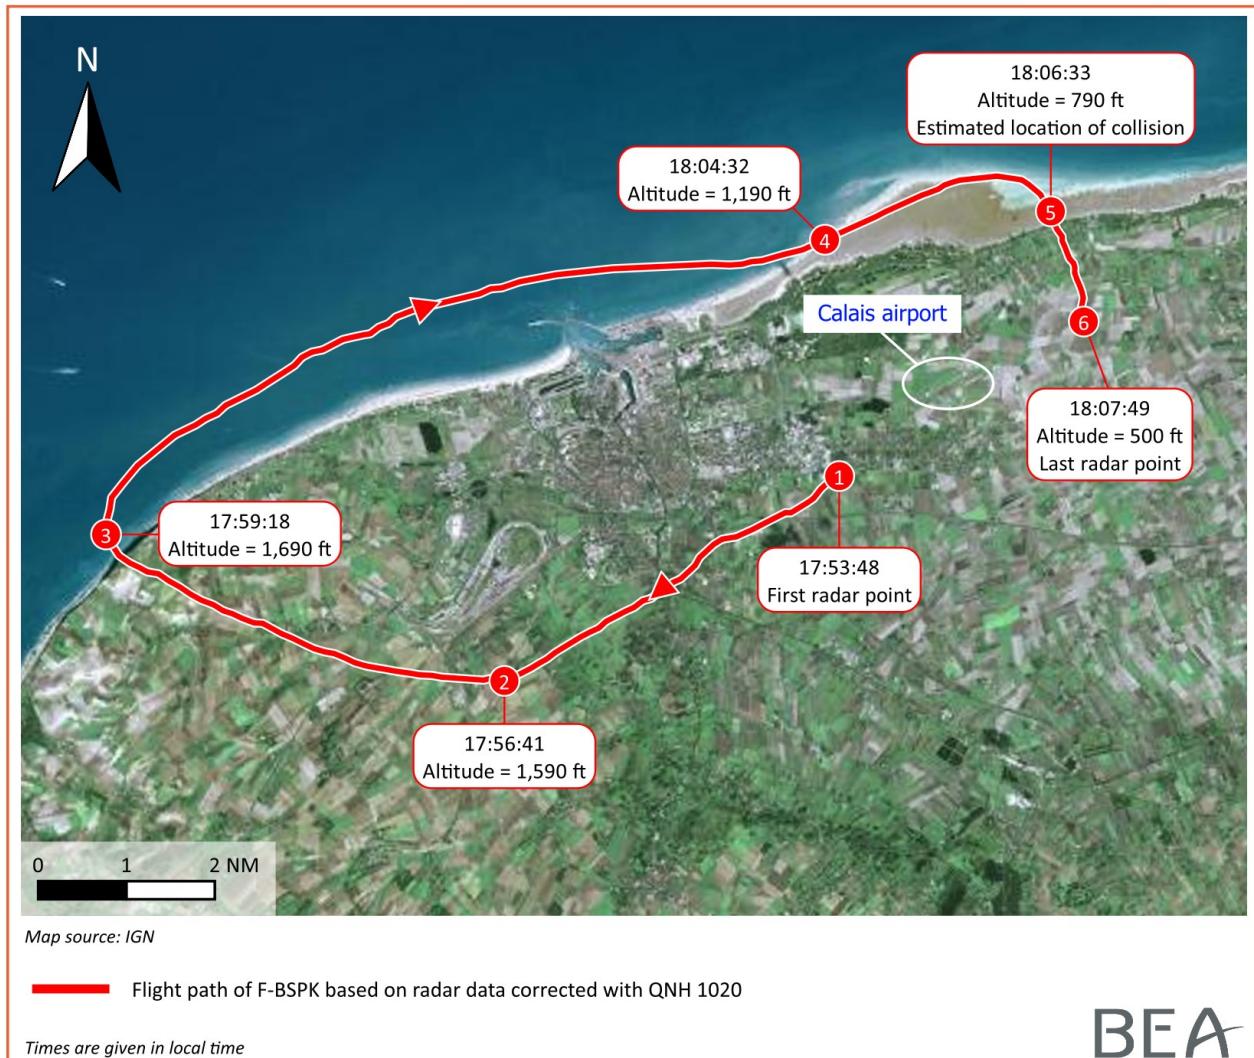
Figure 1: flight path of F-BSPK (Source: BEA)

It was determined that this event was caused by the aeroplane colliding with kite tether lines while flying over the beach on the base leg at an altitude of 790 ft (point ⑤). During the collision, no jolts were felt on board, and no warnings or warning lights were activated.

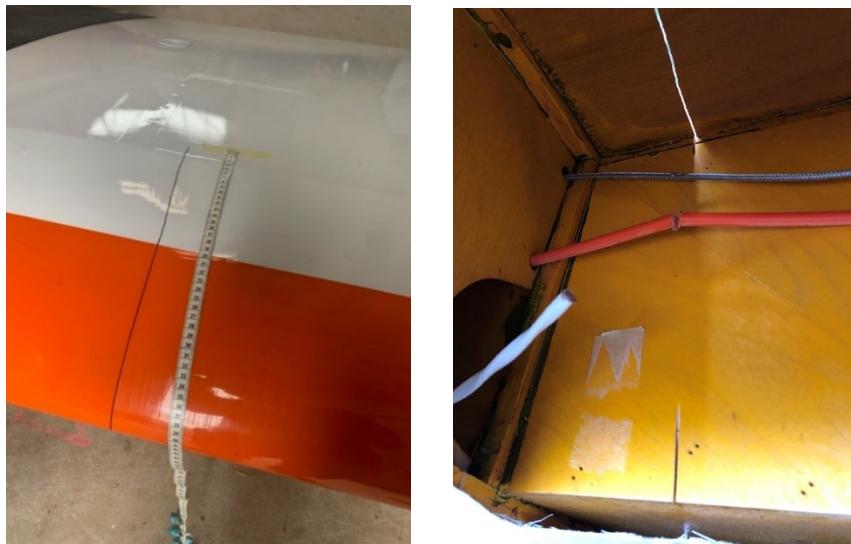
Figure 2: LH wing (Source: BEA)

On the LH wing (see Figure 2), there was a cut in the leading edge over around 40 cm, the wiring for the navigation lights and the Pitot tube line had been severed and there was a cut in the spar over around 5 cm.

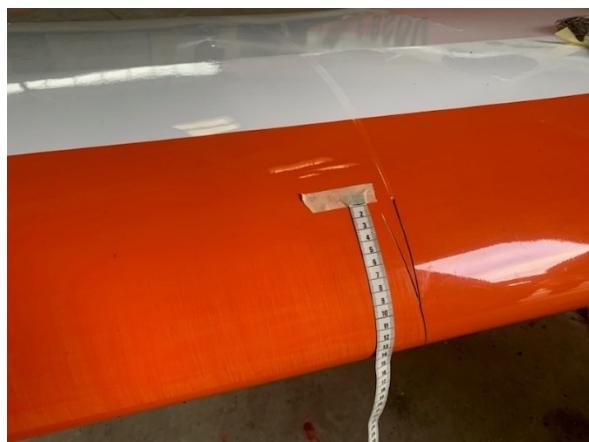
Figure 3: RH wing (Source: BEA)

On the RH wing (see Figure 3), there was a cut in the leading edge over around 12 cm, and a very small cut in the spar.

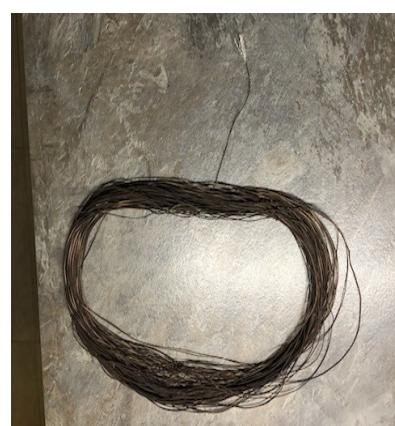
Figure 4: line found caught in wing (Source: BEA)

A line measuring 69 m long with a section of 0.8 mm was found caught in the cut in the LH wing (see Figure 4 below).

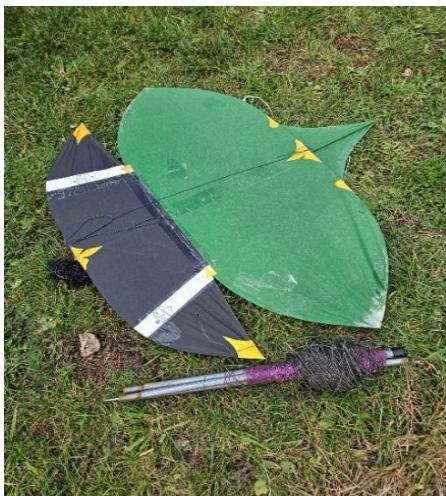
Figure 5: kite found on beach (Source: BEA)

A metal bar, around which a kite retaining line was wound, was handed to the BEA, the day after the accident, by witnesses who had been on the beach on the day of the occurrence (see Figure 5 below). The line found on the aeroplane and the one handed over to the BEA were similar. The sum of the lengths of line found was of the order of 500 m.

The upper part of the line, close to the kite, was coated with an abrasive material. The examinations carried out at the BEA using energy dispersive spectrometry coupled with a Scanning Electron Microscope (SEM) revealed the presence of silicon carbide and aluminium oxide (alumina). These components are known for their abrasive characteristics<sup>3</sup>.
