Accident to the Robin - DR300 - 180R
registered **F-BTBC**
on Tuesday 12 July 2022
at Revel-Montgey

**Glider higher than tug aircraft while being towed,
loss of control of aeroplane, release by glider pilot,
collision with trees then ground**

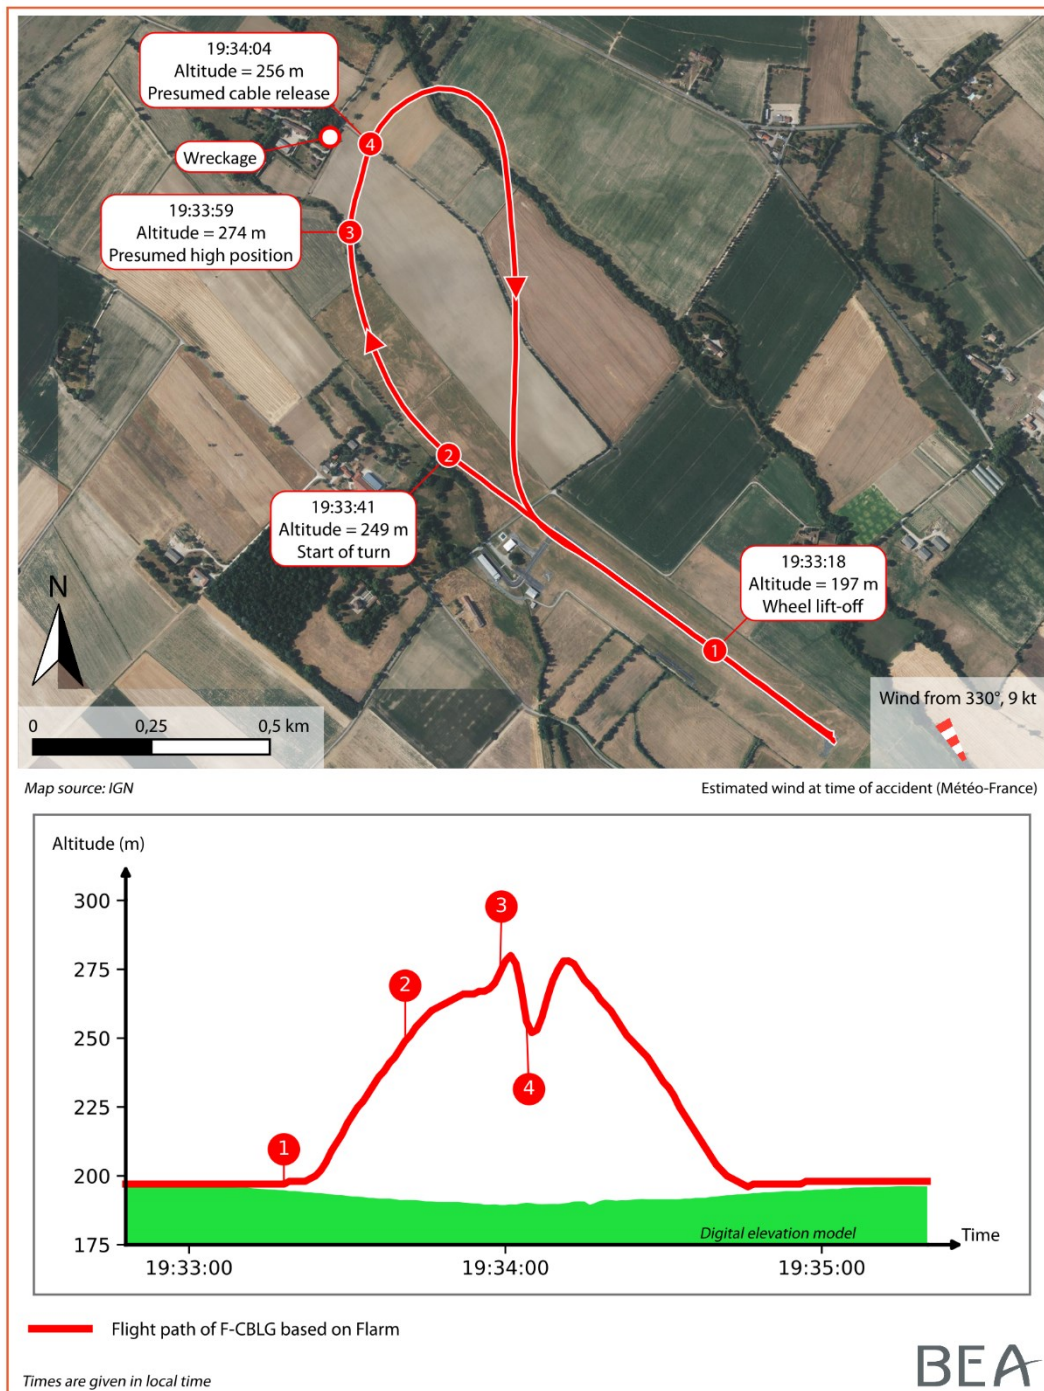
Figure 1: flight path of F-CBLG (source: BEA)

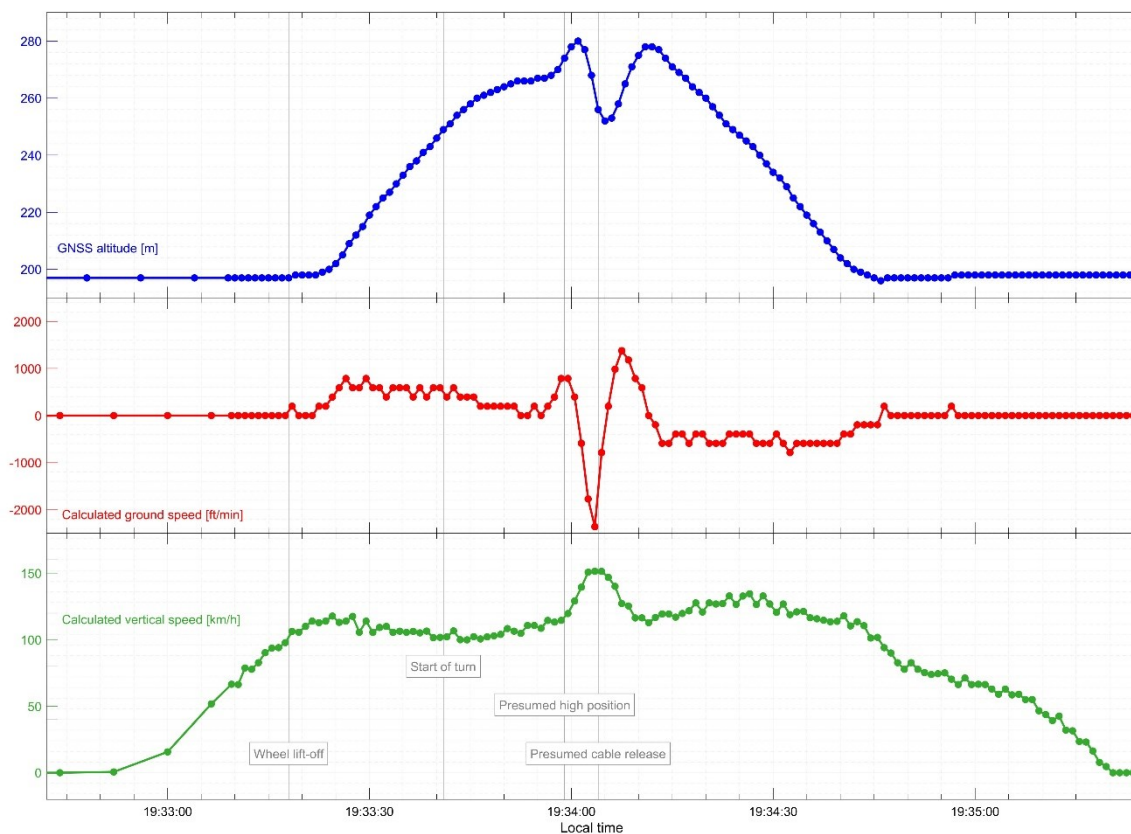
Figure 2: flight parameters taken from glider's Flarm (source: BEA)

- at 19:33:57, the glider's altitude rapidly increased up to 280 m, before swiftly decreasing in the following moments. During this phase, the glider's ground speed rapidly increased. This phase can very probably be associated with the glider being in a high tow position and then being pulled downwards by the tug aircraft;

- after losing an altitude of around 25 m, the glider gained altitude again. The BEA considered that the effective release of the cable corresponds to the first moment when the glider's rate of descent started to decrease, at 19:34:04;

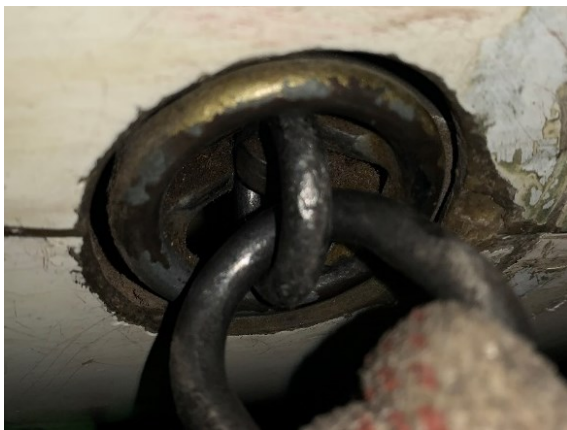
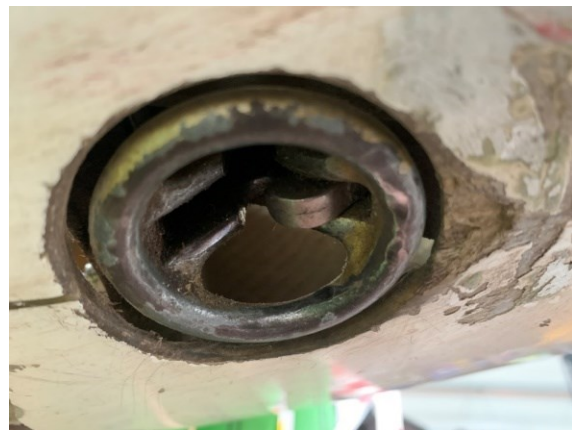
*Figure 3: hook in CLOSED position
(source: BEA)*

*Figure 4: hook in OPEN position
(source: BEA)*

The tests carried out by the BEA did not reveal any malfunction of the release system.

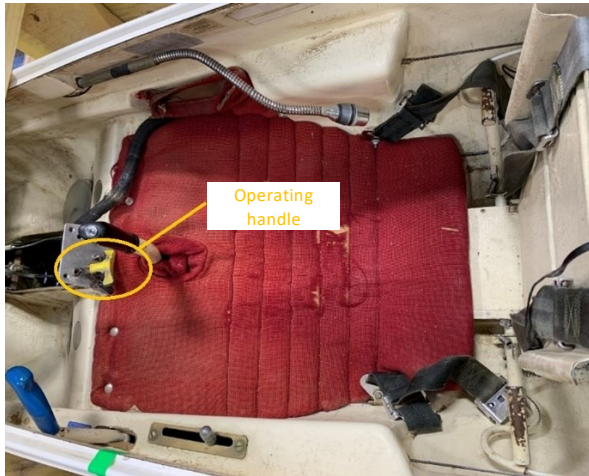
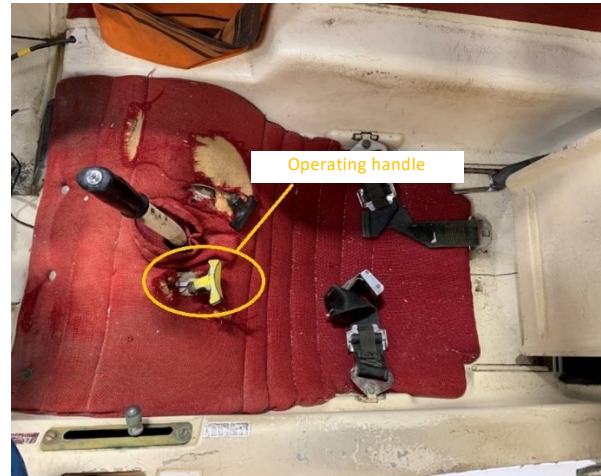
Figure 5: front seat in glider
(source: BEA)

Figure 6: rear seat in glider
(source: BEA)

Without cable tension, in the front and rear seats, the traction force to be applied to the handle was respectively 11 and 18 daN higher than the value specified in the TOST manual but remained below the maximum force specified in the applicable certification requirements¹⁰ which was 20 daN whatever the release configuration.

When the cable was taut, in the front seat, the traction force to be applied to the handle remained homogeneous, between 9 and 11 daN, below the maximum force specified in the certification requirements. In the rear seat, the traction force that had to be applied to the handle was 4 to 9 daN more than in the front seat. However, this value remained below or equal to the maximum force set out in the certification specifications.

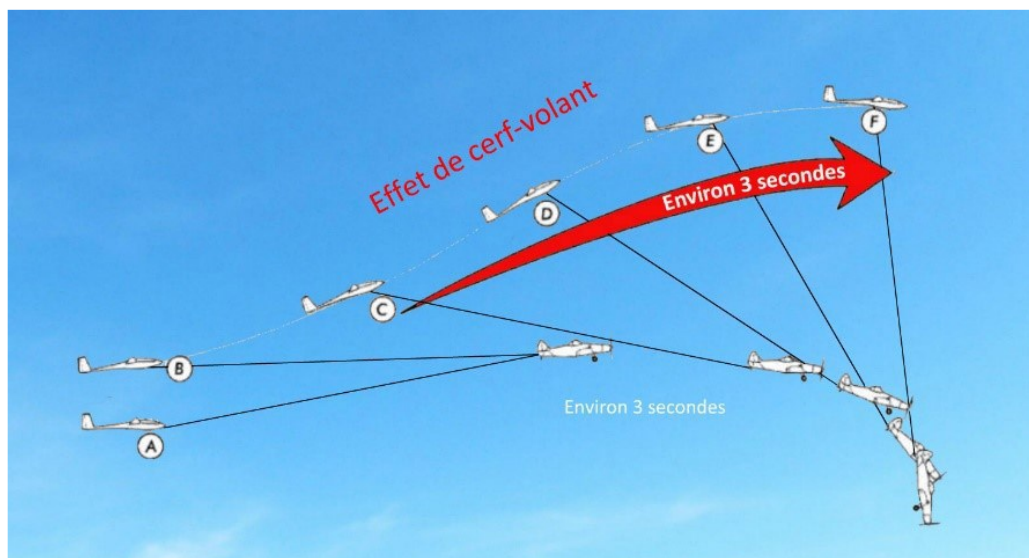
The glider pilot manual states in the section about towed flight, that if the glider climbs too high behind an aircraft, this position can quickly become dangerous. Once a certain limit determined by the effectiveness of the tug aircraft's elevator is exceeded, this can result in the tug-glider combination entering an uncontrollable nose-down attitude which risks finishing on the ground.

Figure 7: high position of glider (source: FFVP, towing safety seminar)

For the tug pilot, the immediate measure recommended by the guide if the glider starts to rise, is to immediately release the glider.
