**Accident** to the CESSNA U 206  
registered **F-BXAM**  
on 7 June 2022  
at Punaauia (French Polynesia)

**Engine shutdown during descent after parachute drop,  
ditching in a lagoon**

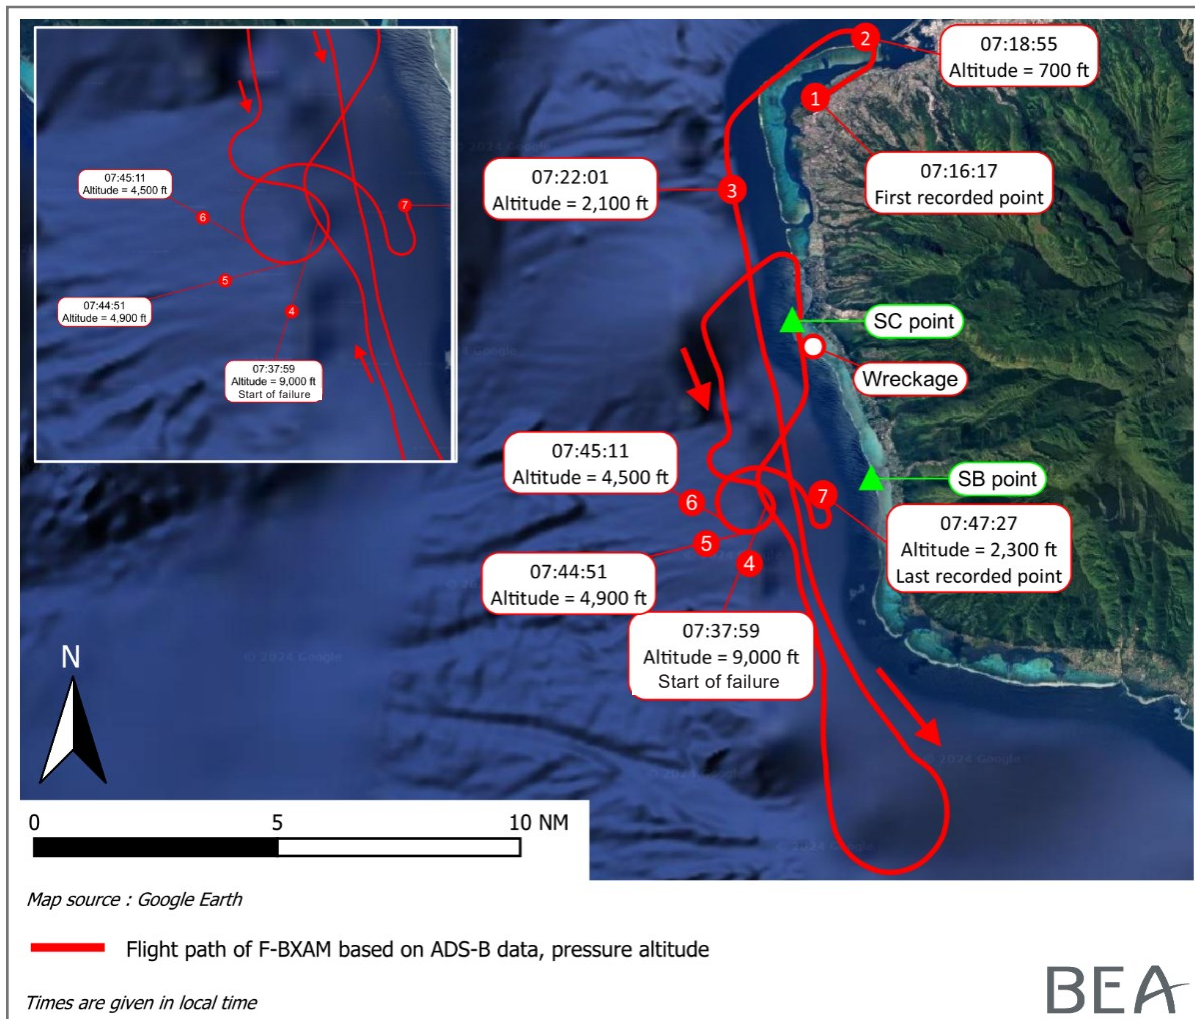
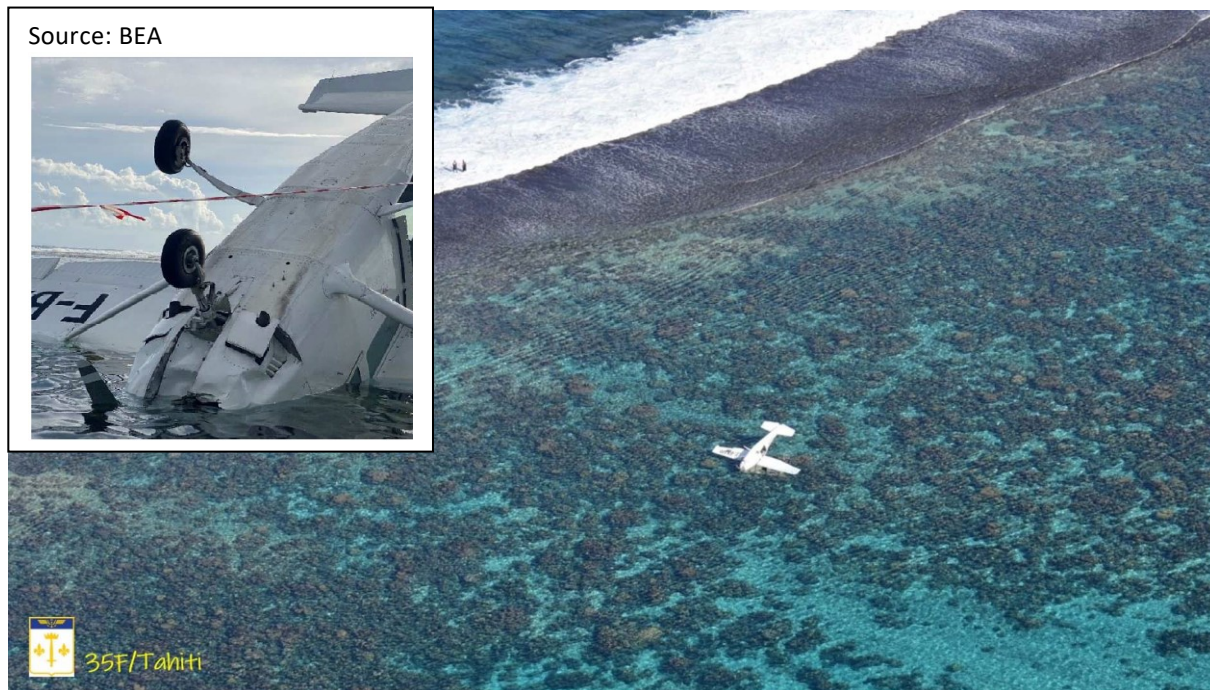
The pilot ditched down at the point which he had indicated. The aeroplane turned over on impact (cf. figure 1). The two occupants, unharmed, evacuated the aeroplane.

Figure 1: F-BXAM lying on reef  
Source: French naval aviation Flotilla 35F

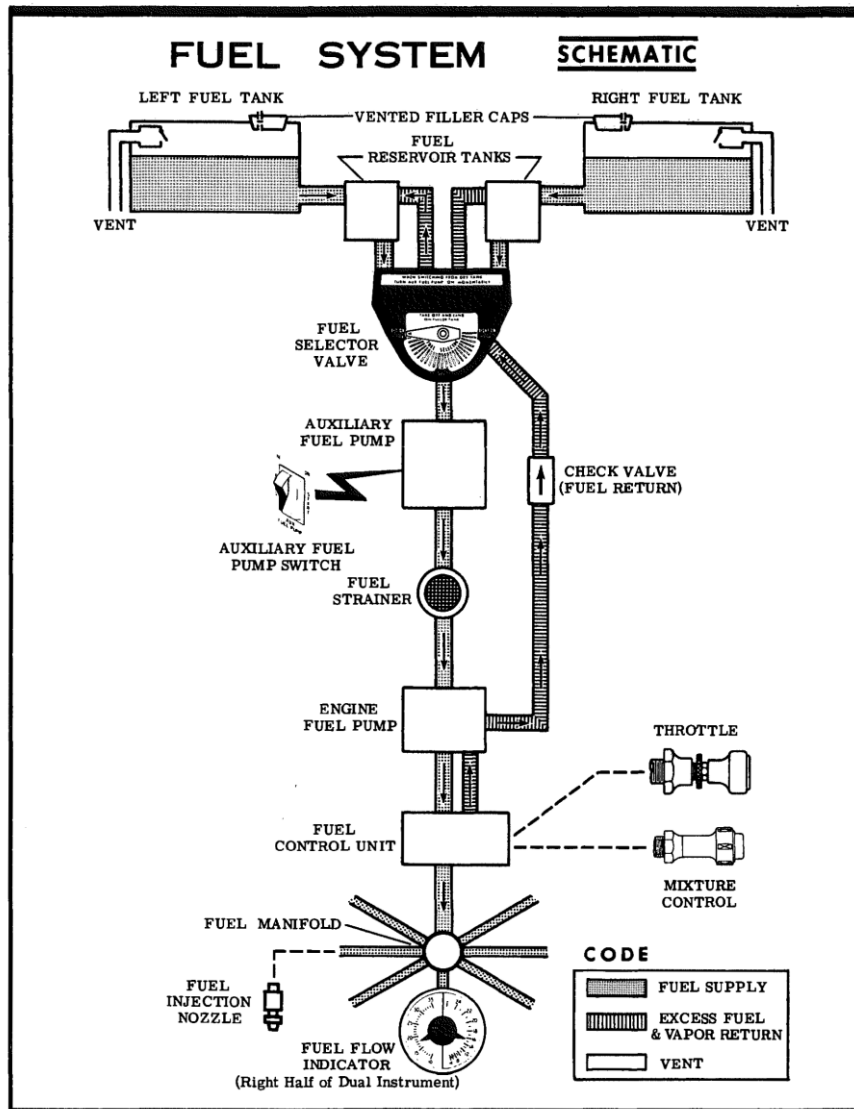
Figure 3: diagram of the aeroplane's fuel system

F-BXAM was equipped with two "long-range" fuel tanks for a total capacity of 303 litres including 15 unusable litres. Each fuel tank could hold 151.5 litres including 7.5 unusable litres. The diagram of the aeroplane's fuel system is given in Figure 3 below.

It is specified in the aeroplane Owner's Manual that the engine might shut down due to fuel starvation when the remaining quantity of fuel is equal to or less than one quarter of the tank's capacity<sup>7</sup> and the aeroplane has been flying for a long period in an uncoordinated configuration such as sideslips.

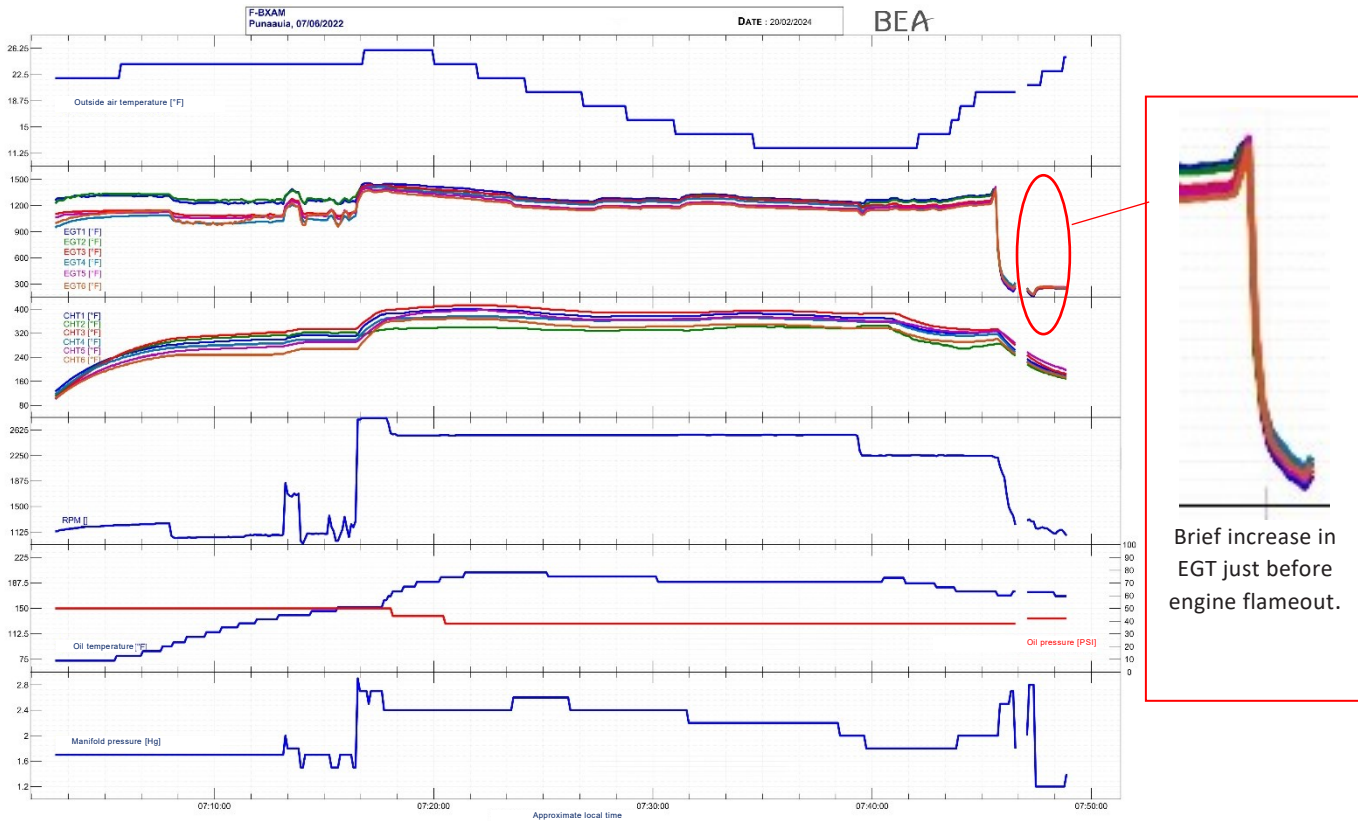
**Figure 4: flight parameters (Source: BEA)**

The CHT<sup>12</sup>, RPM, oil temperature, oil pressure and intake pressure values do not call for comment. However, just before the engine flameout, a brief increase followed by a sudden drop in the EGT values was noted. This phenomenon is characteristic of a transient lean mixture that occurs when the fuel system is starved of fuel. This information was shared with the engine manufacturer, who indicated that it was in agreement with the BEA.
