**Accident to the BELL 206 B
registered F-BXPF
on Friday 3 May 2024
at Peyriac-de-Mer**

Time	Around 10:10 ¹
Operator	Helicoandrone
Type of flight	Spraying
Persons on board	Pilot
Consequences and damage	Helicopter destroyed

Collision with surface of water during a transit leg of a mosquito eradication flight

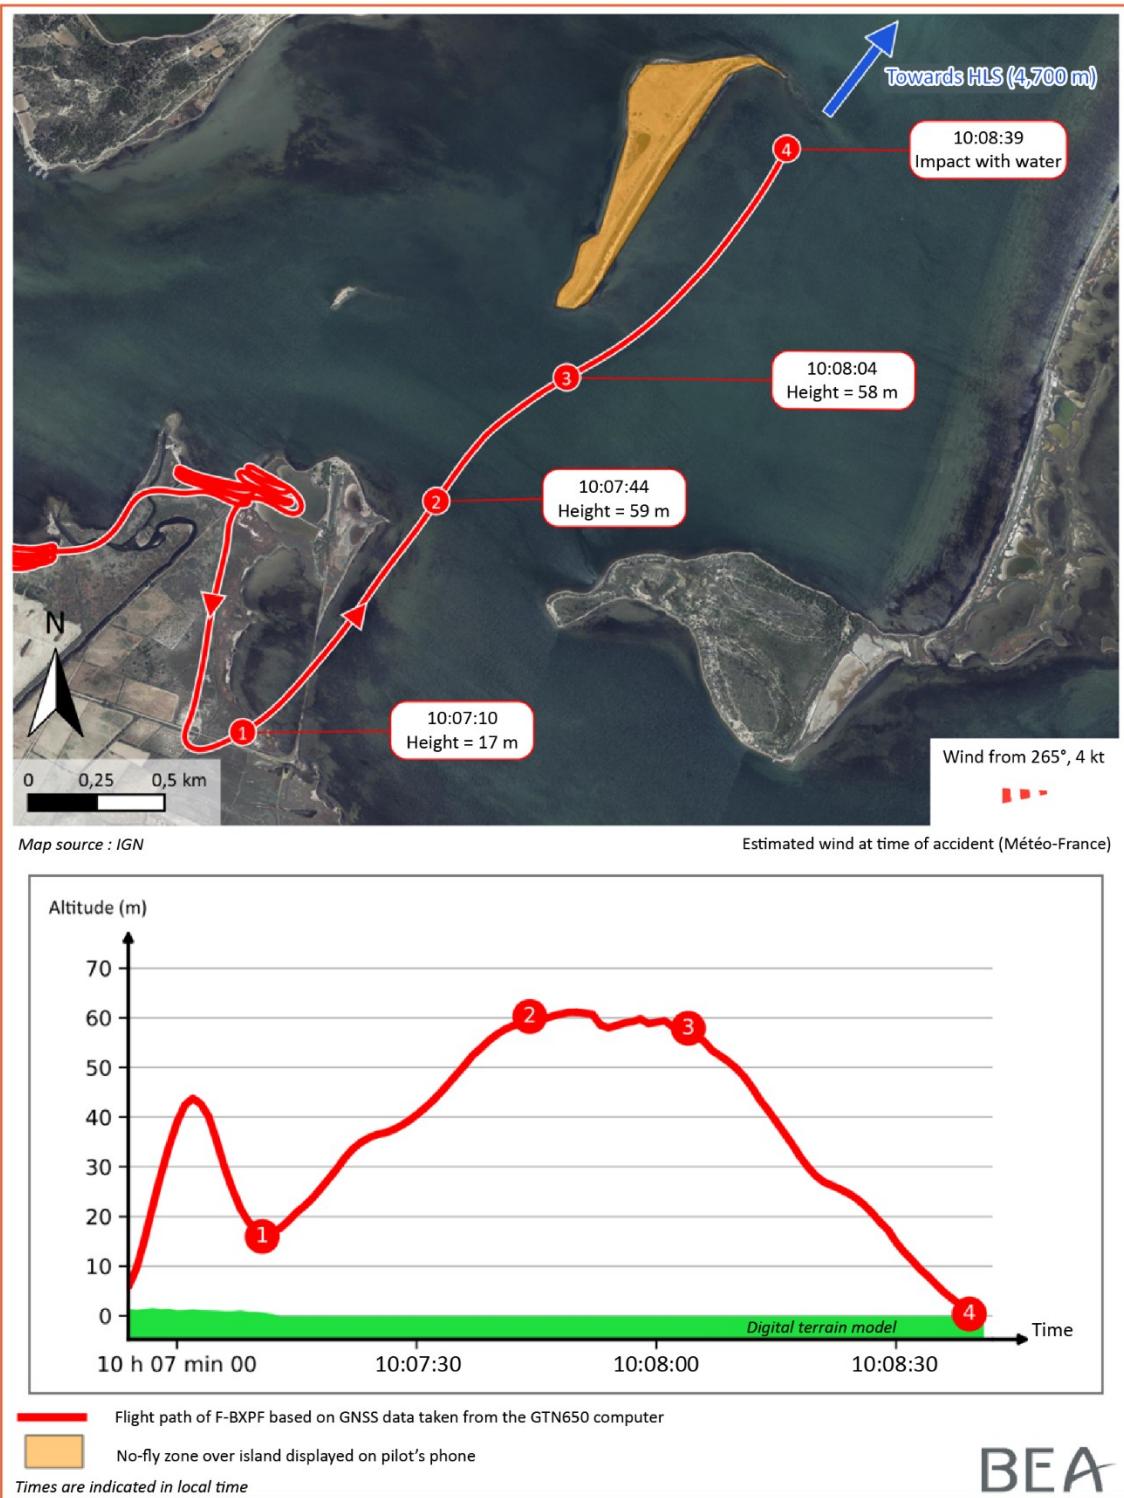
The pilot, sat in the right-hand seat, took off at around 09:40 from the helicopter landing site (HLS)² for the fifth mosquito eradication flight of the day. He treated a first area close to HLS, crossed Bages lake, treated new areas and then started flying back across the lake to return to HLS (see **Figure 1**, point ①).

Initially, the helicopter climbed to a height of around 60 m (point ②). After level flight at this height for around 20 s (point ③), the helicopter smoothly descended with an average vertical speed of 350 ft/min. After descending for roughly 35 s, it struck the surface of the water and sunk (point ④). The pilot managed to unfasten his seatbelt and exit the helicopter through the broken canopy. He was picked up by a fisherman who was close to the accident site.

Figure 1: flight path (source: BEA)
