**Accident** to the CAPRONI Calif A-21S  
registered **F-CALI**  
on Friday 26 July 2024  
at Aspres-sur-Buëch

**Cable release by the glider pilot during a towed take-off,  
attempted U-turn, collision with an obstacle then  
the ground**

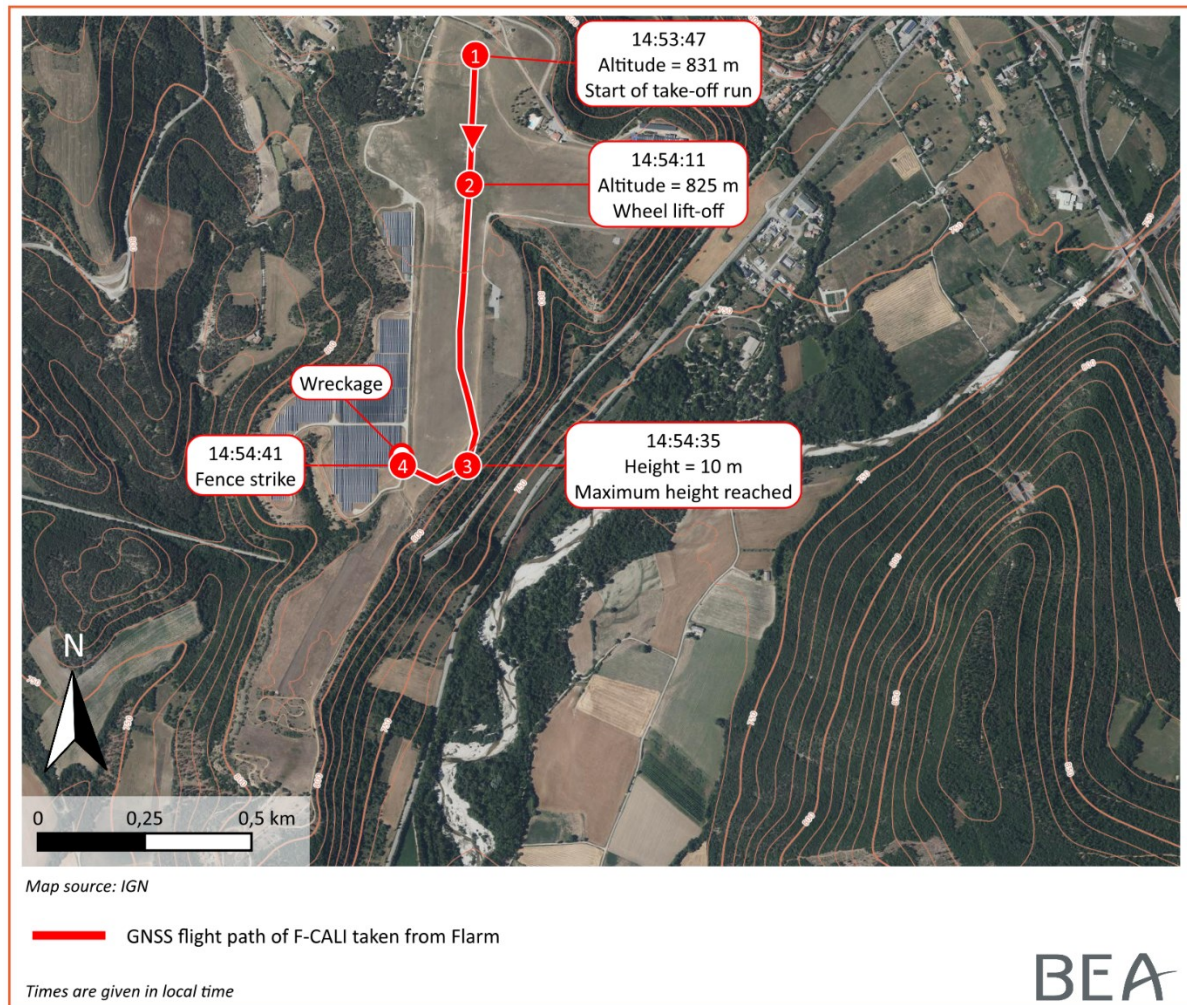
The glider pilot carried out a towed take-off from runway 18<sup>2</sup> at Aspres-sur-Buëch aerodrome. At a height of approximately 100 ft, in initial climb and approaching the end of the runway, the tug pilot observed an irregular operation of the engine. He immediately adopted a nose-down attitude before switching the fuel selector to the opposite tank. Following this tank change, the engine delivered rated power again. The tug pilot adopted a climb attitude and realised that the glider pilot had released the cable.

After releasing the cable, the glider pilot initiated a U-turn to come back to the runway. During this manoeuvre at low height, the right wing tip struck the fence of a photovoltaic array field bordering the aerodrome. The glider collided with a row of photovoltaic panels and came to a stop.

Figure 1: glider's path

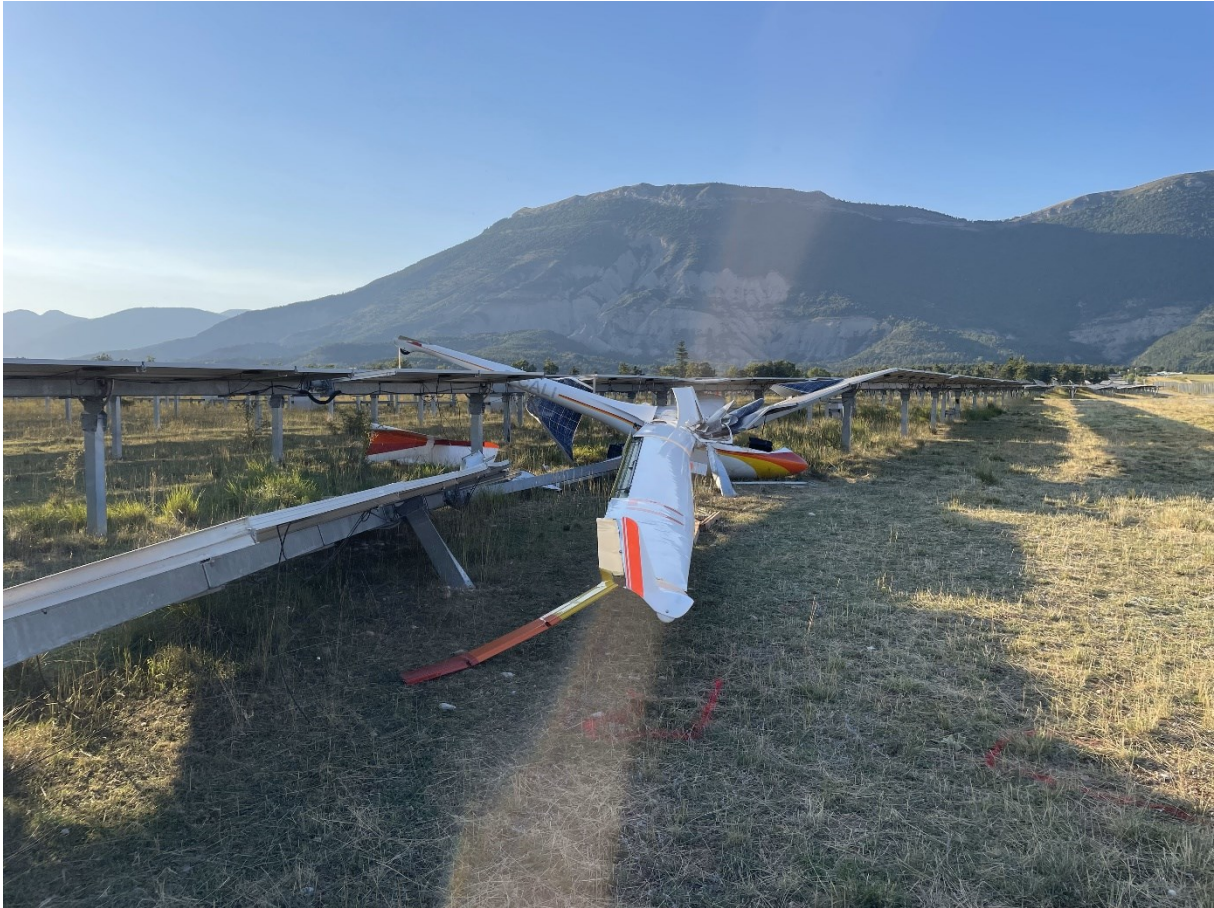
The accident site was located in a photovoltaic array field adjoining the aerodrome to the west of runway 18/36. Examination of the site and the wreckage showed that the glider's right wing came into contact with the field fence, which destabilised the glider. The latter then hit the ground, slid and embedded itself in the first row of photovoltaic panels.

*Figure 2: overview of the accident site (Source: BEA)*
