**Accident** to the S.T.R.A. CB 15 CRYSTAL  
registered **F-CBCJ**  
on Wednesday 31 July 2024  
at Sigloy

**Loss of control during a field landing, collision with  
vegetation, during a competition flight**

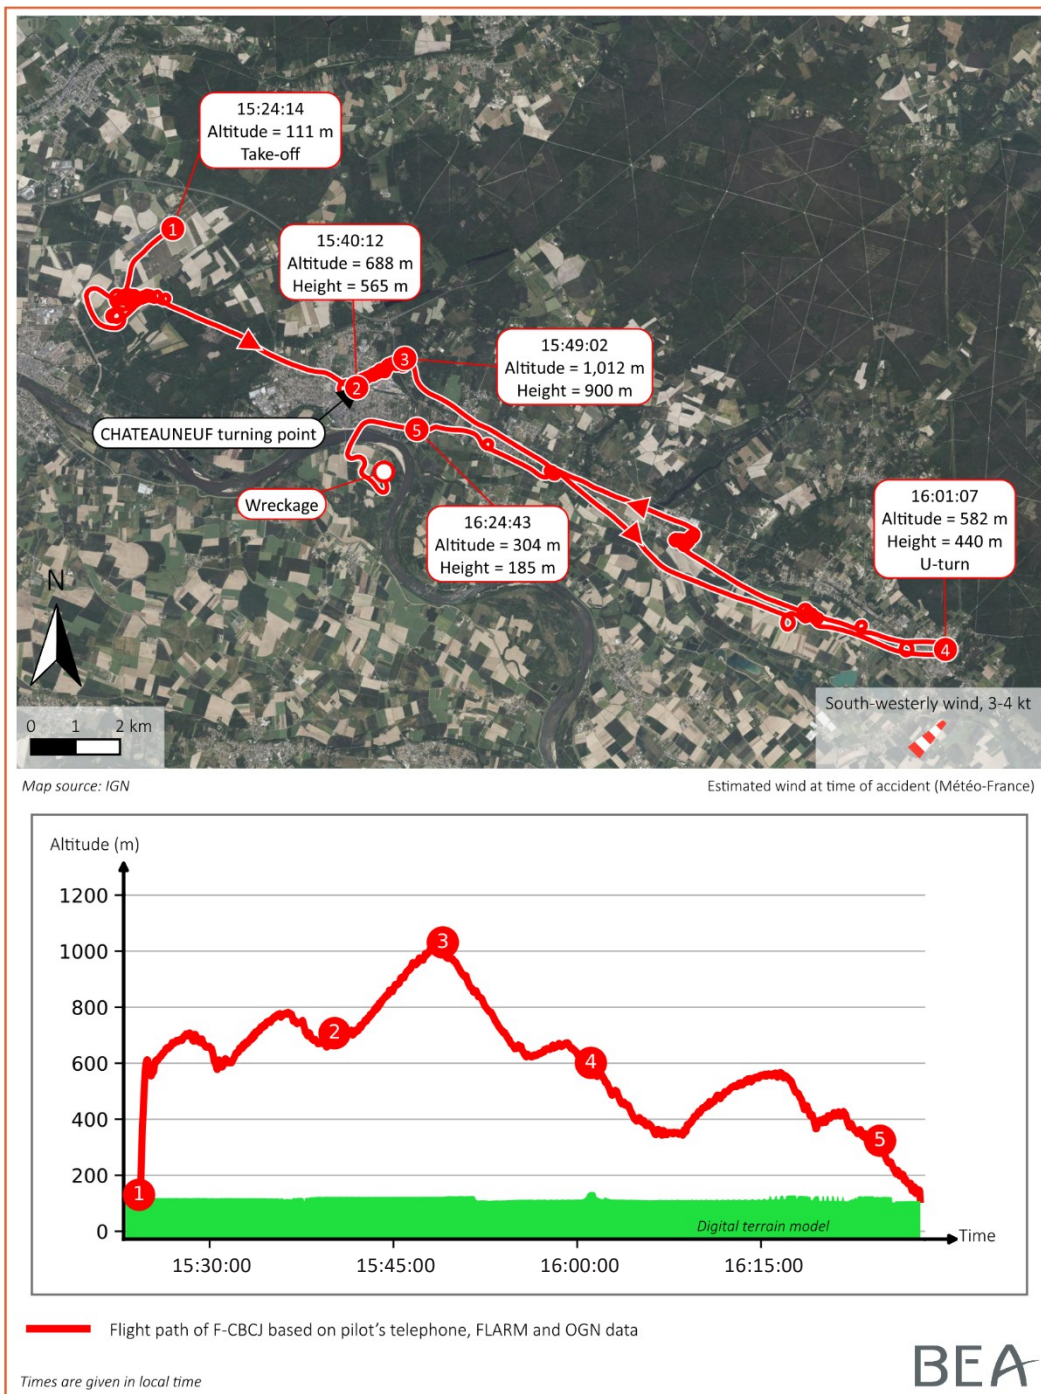
Figure 2: flight path of F-CBCJ

The pilot managed to gain altitude and pass the first turning point at an altitude of around 700 m (point 2) at the same time as the pilot of the glider registered F-CPLO, who was also taking part in the competition. He used the lifts close to the turning point until he reached an altitude of 1,000 m (point 3).

He then headed towards the second point. As the glider was losing altitude, the pilot turned around at an altitude of around 600 m (point 4). On approaching Châteauneuf-sur-Loire, he was at an altitude of around 300 m (point 5) which he considered too low to continue the flight.

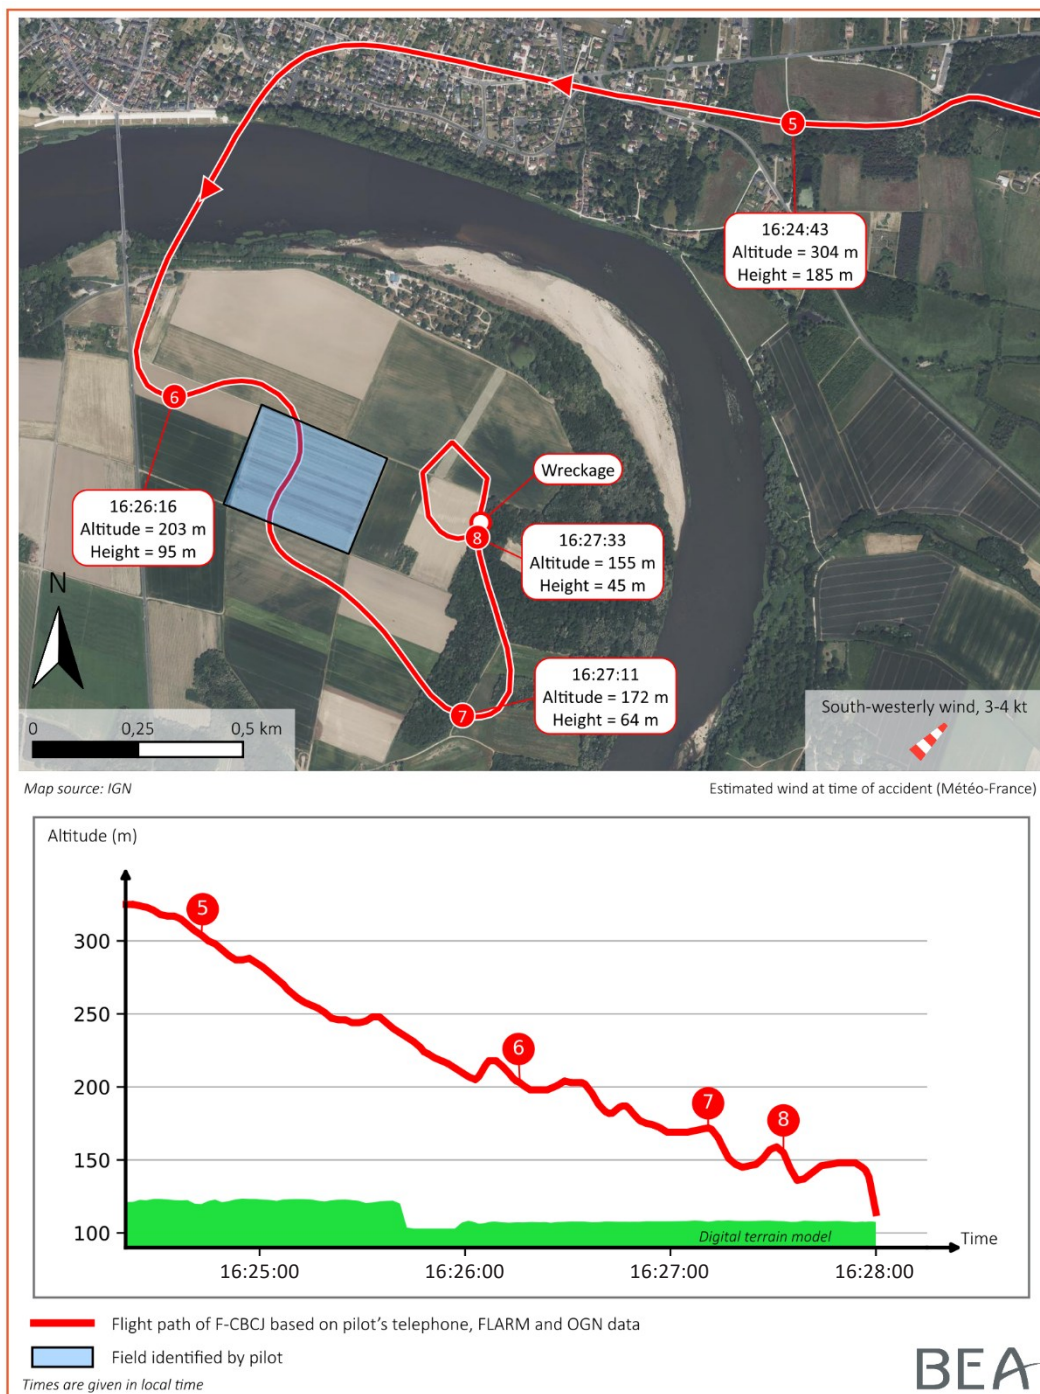
He therefore decided to land in a field that he had previously identified to the south of the town (see **Figure 3**, shown in blue). During the landing pattern (points **6**, **7** and **8**), he lost control of the glider which collided with vegetation.

Figure 3: end of flight path of F-CBCJ

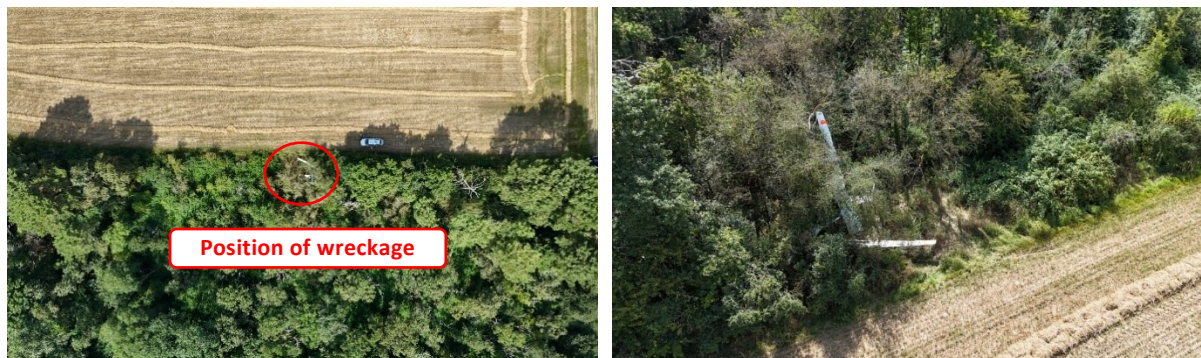
The wreckage was complete and grouped together. It was situated at the edge of a wood. There were no marks in the vegetation beyond a restricted area around the wreckage.

Figure 4: accident site (source: BEA)

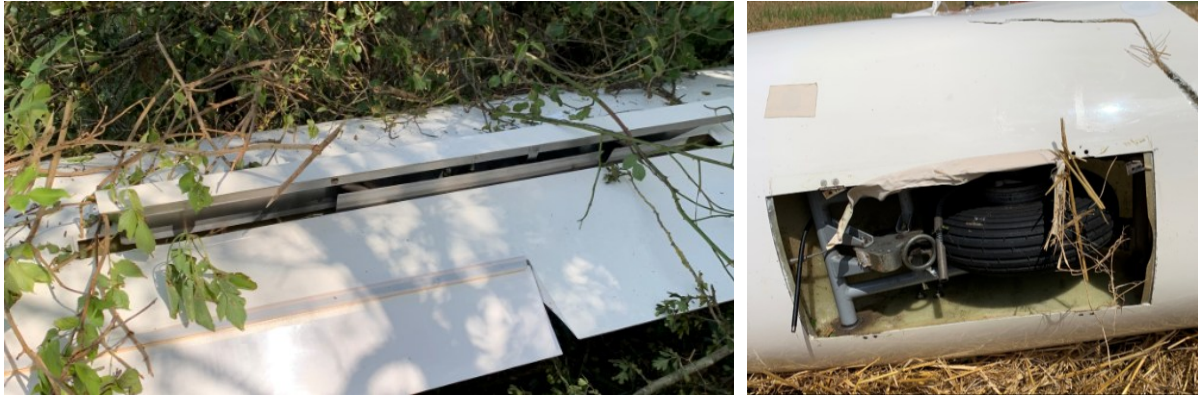
The airbrakes were found fully extended on both wings. A few branches were found inside the left-hand airbrake (see **Figure 5**). The right-hand airbrake was blocked in its maximum deflection due to the ruptures and deformation of the wing structure in this area.

Figure 5: left-hand wing airbrake and landing gear (source: BEA)

These elements and the position of the controls in the cockpit could indicate that the airbrakes were fully extended before impact<sup>3</sup>.

If the landing gear was extended, it is possible that it retracted during the impact with the ground (see **Figure 5**).
