**Accident** to the SCHLEICHER ASK13  
registered **F-CEAV**  
on Friday 8 March 2024  
at Claviers

**Slope soaring flight, off-field landing, power line strike,  
collision with ground, in instruction**

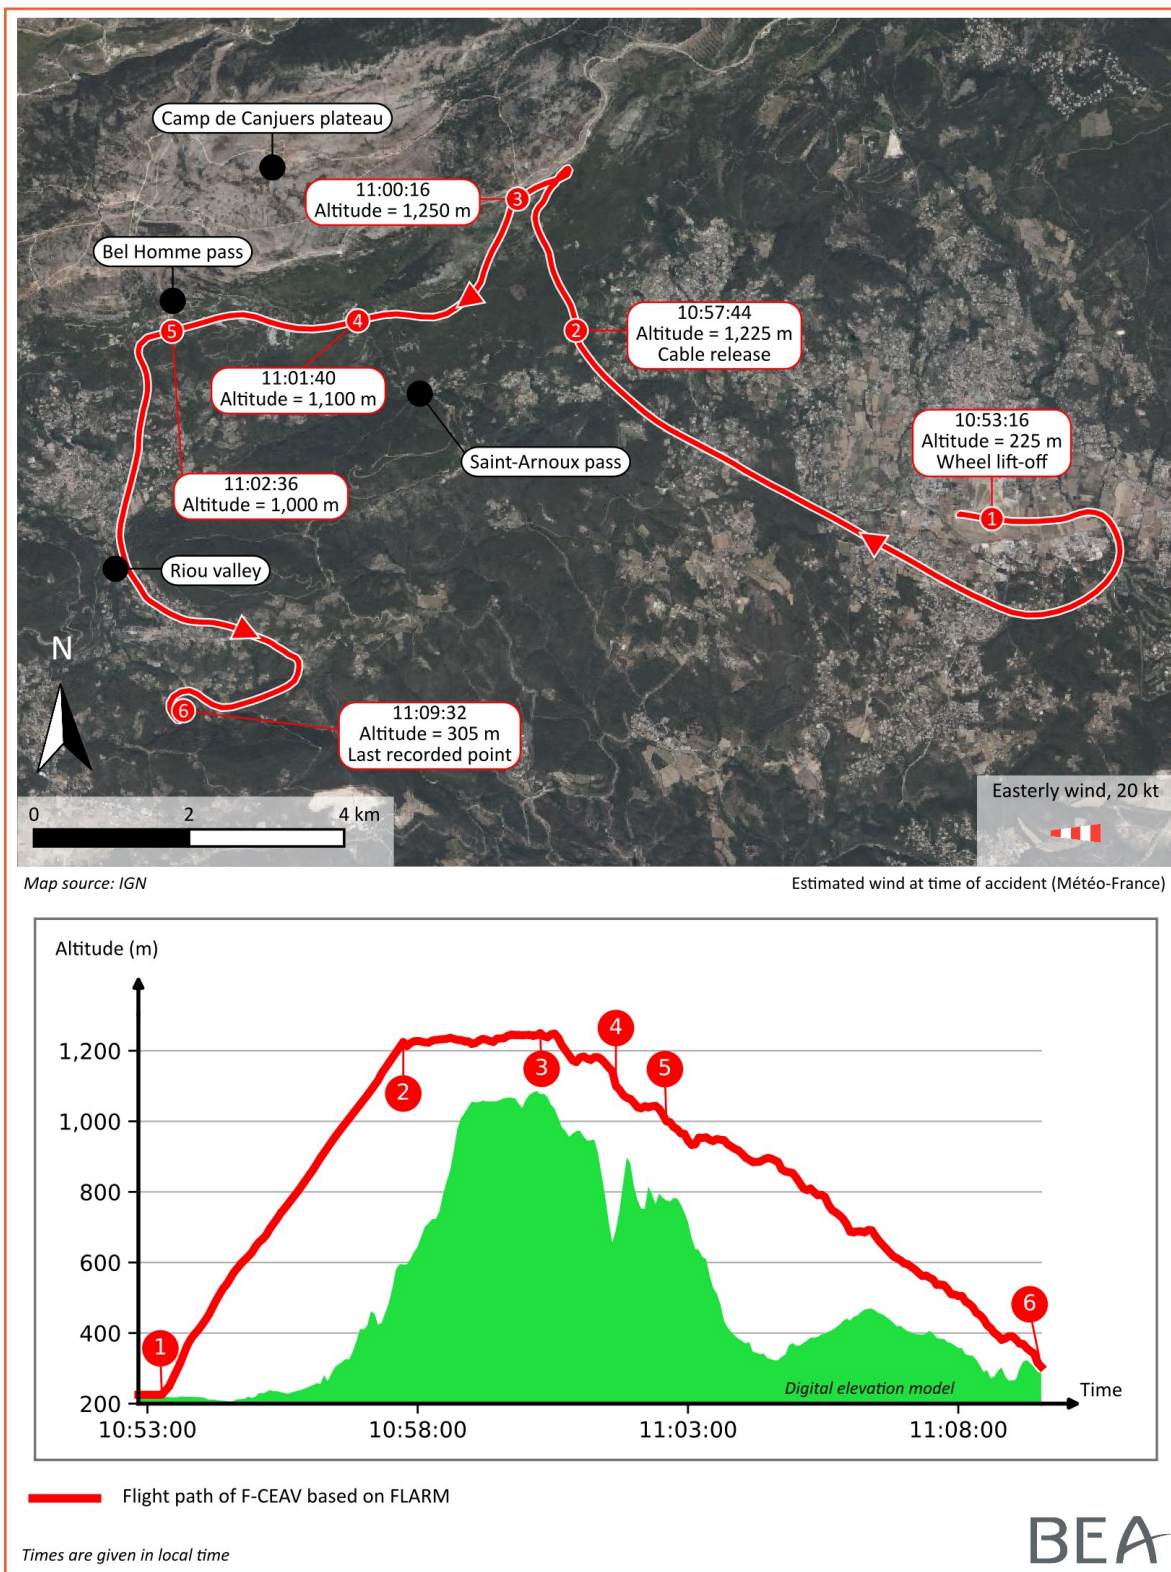
Figure 1: flight path

At 10:53, the student pilot accompanied by an instructor, carried out a towed take-off from Fayence aerodrome for a slope soaring flight over the south-east slope of Camp de Canjuers plateau (see **Figure 1**). F-CEAV was the first glider to take off that day. At 10:58, the glider arrived in the vicinity of the slope at an altitude of 1,225 m and the student pilot released the towing cable (see **Figure 1**, point ②). She flew back and forth using the slope and gained a small amount of altitude, reaching 1,250 m (point ③). During this manoeuvre, the calculated average vertical speed remained low, of the order of +0.15 m/s.

The instructor then suggested that the student pilot joined the south slope of the terrain. The glider then started to sink with an average rate of the order of -2.8 m/s. At 11:01:40, it reached an altitude of 1,100 m at 2.7 km east of Bel Homme pass (point ④). The instructor took the controls. At 11:02:36, the glider reached an altitude of 1,000 m and was situated 400 m south abeam Bel Homme pass (point ④).

Observing that it was not possible for them to return to Fayence aerodrome, the instructor turned southwards and followed Riou valley. There was no listed field nearby. With the help of the student pilot, he found an area that seemed to him to be sufficiently clear to carry out an off-field landing. During the last turn, the glider struck a power line which came away from its attachments without breaking which had the effect of braking the glider and causing a hard landing.

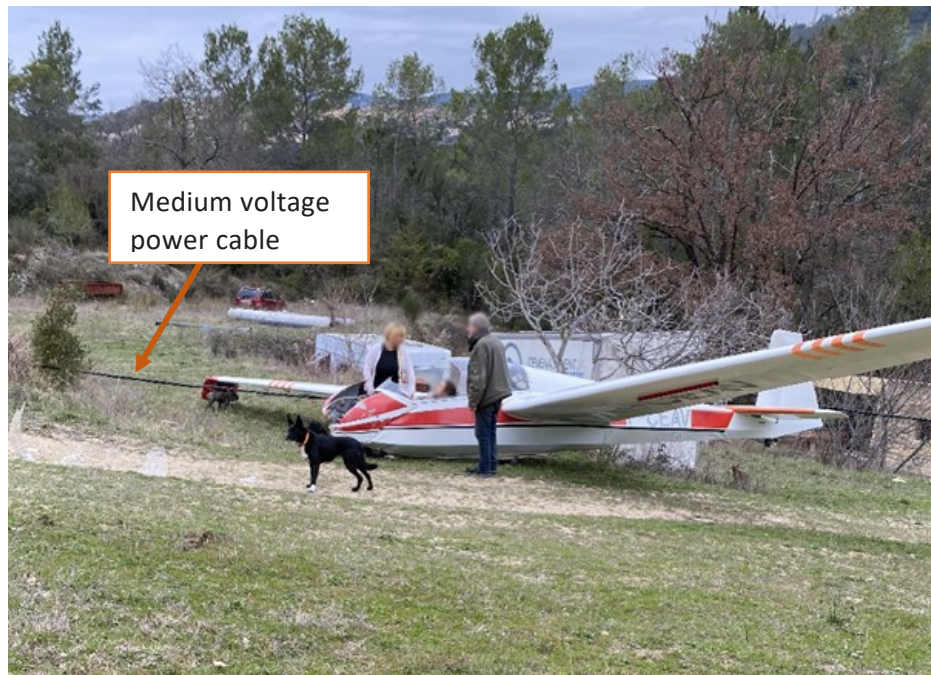
*Figure 2: glider before arrival of emergency services  
(source: witness to accident, annotated by BEA)*

The student pilot indicated that she searched for and then proposed a suitable field for an off-field landing. The instructor flew a complete circuit around the chosen field. During the last turn, although the glider had not seemed to her to be too banked, the RH wing struck a power line. She believed that if they had not collided with the line, it would have been possible to land in the field.

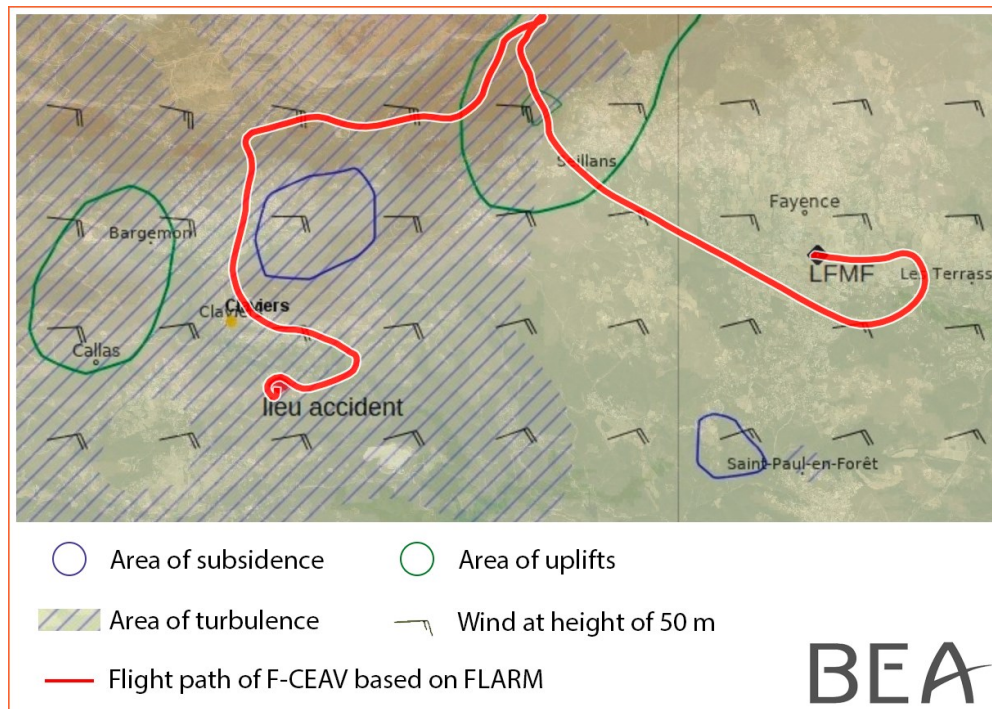
The meteorological conditions estimated by Météo-France at the site of the accident were as follows: easterly surface wind of 24 km/h with gusts reaching 55 km/h, visibility greater than 8 km, very cloudy to overcast, with a cloud base at 2,400 m, temperature 9°C, moderate surface and low-level turbulence. The weather forecasts indicated the arrival at noon, of a storm disturbance approaching from the south-west.

Figure 3: map of terrain, gusts and areas of subsiding air at 11:00  
(Source: Météo-France, annotations BEA)
