**Accident** to the Centair ASW 20 F  
registered **F-CFFF**  
on Saturday 3 June 2023  
at Bailleau-Armenonville

**Loss of pitch control during take-off, collision with ground,  
during a competition flight**

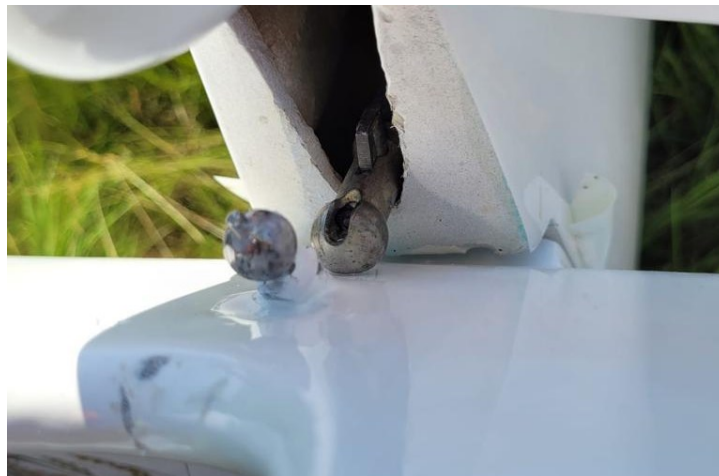
The elevator control was continuous and functional from the stick up to the socket of the elevator ball and socket connector. This ball and socket connector was found disconnected between the vertical control rod situated in the fin and the elevator (see **Figure 2**).

*Figure 2: ball and socket connector found disconnected (source: GTA)*

The ball and socket connector of the elevator control was found disconnected. The examinations carried out did not reveal a failure of the socket. The immediate environment of the connection was not deformed. No locking pin was present on the system. These elements seem to indicate that the elevator control was incorrectly or not connected during the accident.

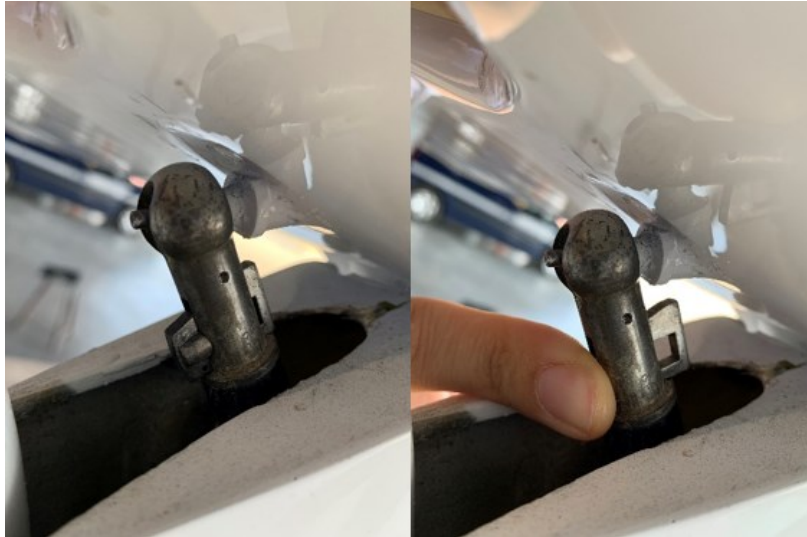
The ball and socket connector was not equipped with a locking pin, the pilot did not use one (see paragraph 2.7.2). The functionality of the system was checked by connecting the elevator and then checking that actioning the control moved the elevator. After assembling the ball in the socket, a manual load was applied to try to separate the connector, which remained connected. The environment of this ball and socket connector was neither damaged nor deformed.

*Figure 4: locked and unlocked positions of ball and socket connector (source: BEA)*

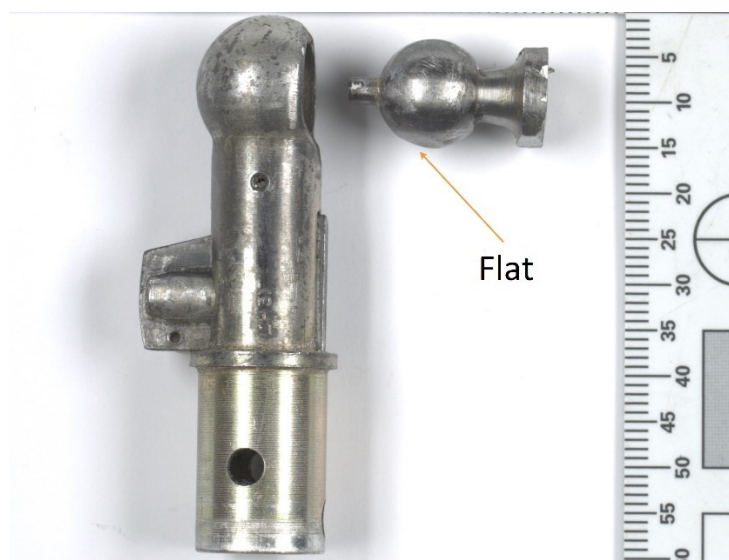
*Figure 5: socket on LH side and ball on RH side (source: BEA)*

The ball had a flattened area where its surface came into contact with the socket seat (see **Figure 5**). In this flattened area, the maximum difference between the various measurements taken of the diameter of the sphere was around 0.3 mm. According to L'Hotellier's maintenance instructions, available in the glider's maintenance manual, this difference must not exceed 0.1 mm, after this limit it is considered to be abnormal wear. The sphericity criterion mentioned in the maintenance instructions was therefore not complied with. An update to the maintenance instructions which was not included in the glider's maintenance manual, required at least four diameter measurements to be carried out.

However, the ball showed abnormal wear according to the criterion defined in the maintenance instructions. The in-flight disconnection of the elevator ball cannot therefore be totally excluded.
