**Accident** to the SCHLEICHER ASK21  
registered **F-CHIN**  
on Monday 10 April 2023  
at Sarreguemines - Neunkirch

**Cable release during a towed take-off, attempted U-turn,  
stall then collision with ground, in instruction**

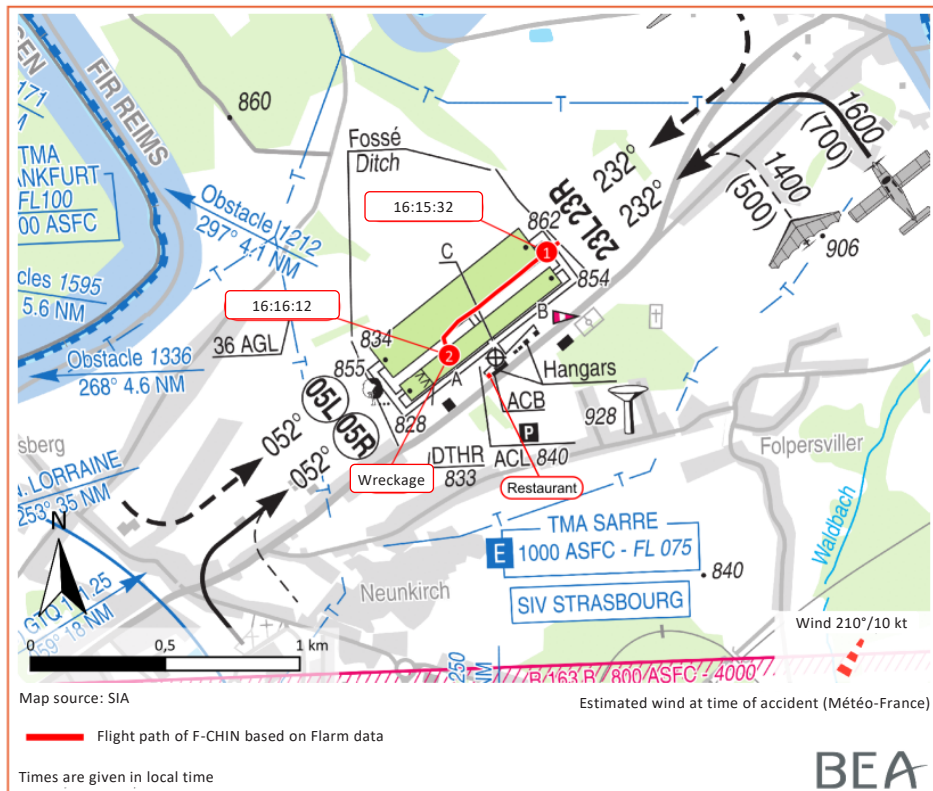
Figure 1: flight path of F-CHIN

The data recorded by the FLARM shows that at the time of the turn, the height of the glider was around 10 m and its ground speed, calculated by the BEA, was around 80 km/h. It then had around 240 m of runway ahead of it. The distance to the ditch was around 290 m.

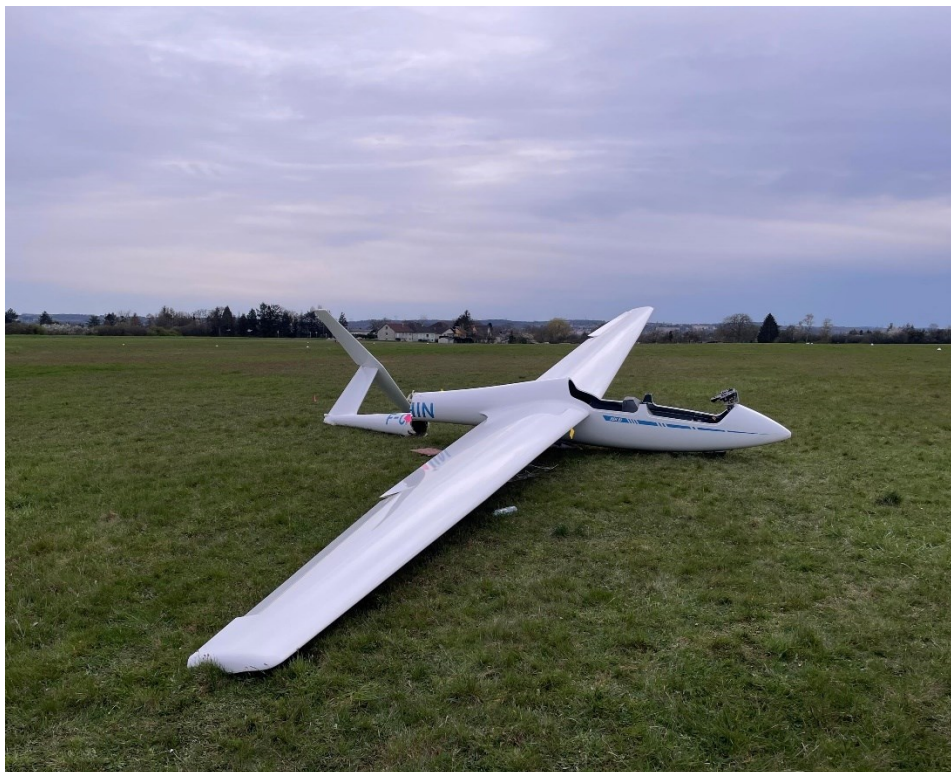
Figure 2: wreckage of glider F-CHIN (source: GTA)

The glider came to a stop with the forward section of the fuselage facing north-west. The tail boom had completely ruptured and separated from the main fuselage. The BEA did not carry out an examination of the wreckage.
