Accident to the SCHLEICHER ASK21
registered **F-CHMF**
on Thursday 18 July 2024
at Orléans - Saint-Denis-de-l'Hôtel

Time	Around 13:10 ¹
Operator	Les Planeurs d'Orléans
Type of flight	Instruction
Persons on board	Instructor and student pilot
Consequences and damage	Instructor seriously injured, student pilot injured, glider slightly damaged
This is a courtesy translation by the BEA of the Final Report on the Safety Investigation. As accurate as the translation may be, the original text in French is the work of reference.

Untimely separation of cable during winch take-off, hard landing, in instruction

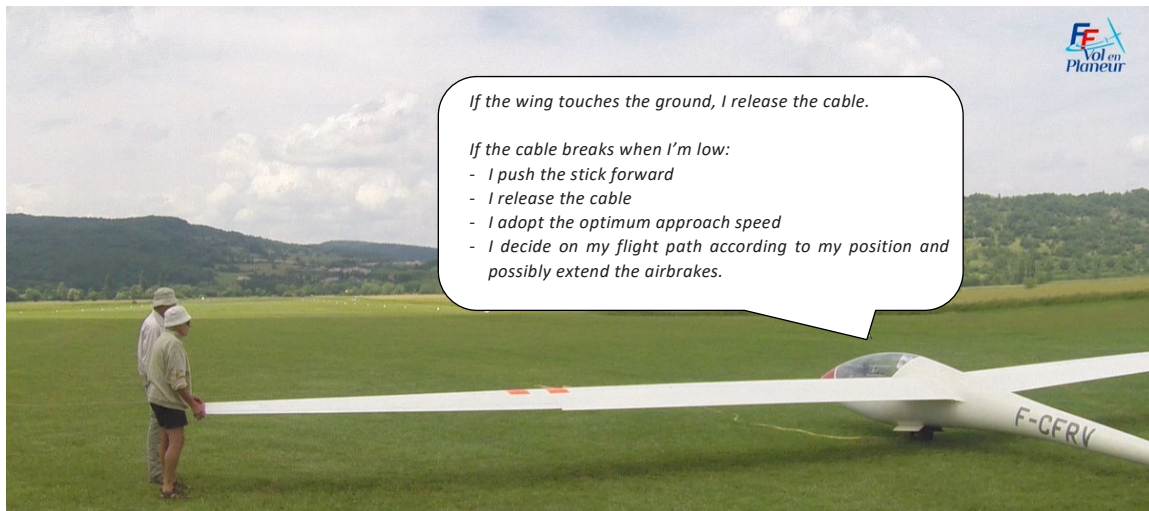
The French glider federation, the FFVP, proposes several before-flight briefings in the video series "[Briefings avant vol](#)" on its website. In video 28/46 about preparing for a winch launch, "[Préparation au vol treuil](#)", an example of a briefing in the event of a cable break at low height is proposed (view from 14 min 50 s onwards). The video, "[Le treuil - procédures normales](#)" covers normal winch procedures.

Figure 1: excerpt from preparation for winch launch briefing (Source: FFVP, translation BEA)

- in instruction, in the event of a cable break at low height, the instructor immediately takes the controls;
- during the before take-off safety briefing, the pilot performs the actions on the stick while reciting the briefing, the aim being to ensure that the actions become reflex actions.
