Accident to the GLASER DIRKS DG800 B
registered **F-CHYD**
on Saturday 3 August 2024
at Blesle (Haute-Loire)

**Loss of uplifts, late engine extension, forced landing,
collision with vegetation**

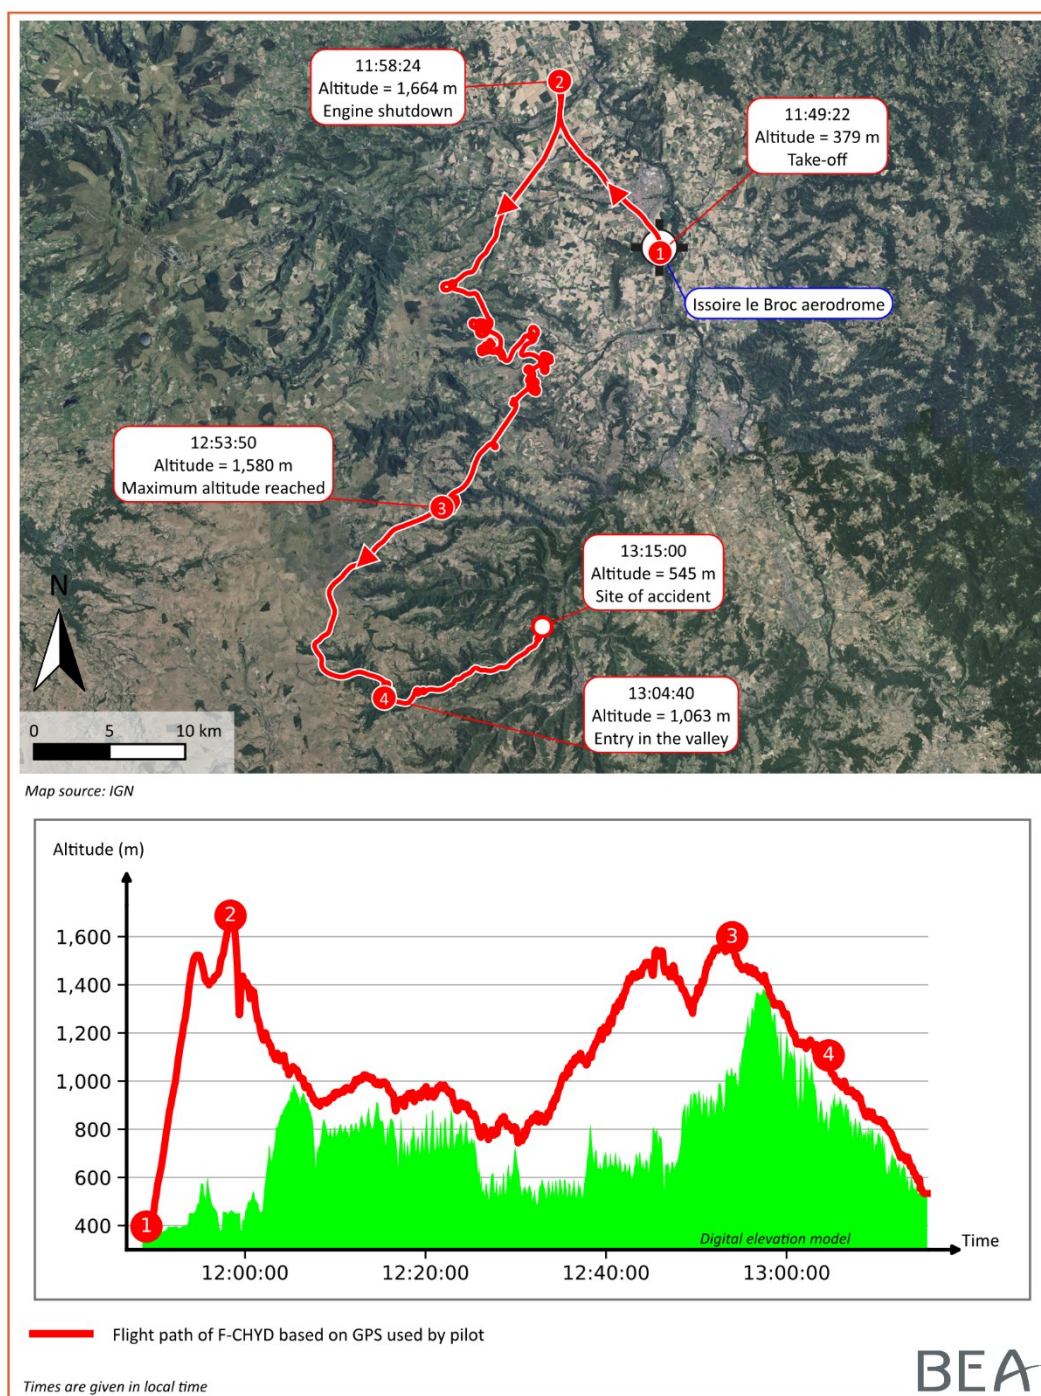
Figure 1: whole flight path

The pilot took off without assistance from Issoire - Le Broc aerodrome (Puy-de-Dôme) at 11:49 (see **Figure 1**, point ①). He used the uplifts and flew for 1 h and 15 min. While he was south-west of the aerodrome, searching for uplifts, he headed east and entered a valley (point ④). He made a few attempts to regain height and after ten minutes in the valley, he realised that the aerological conditions there were also adverse. He continued the flight, searching for a suitable field for an off-aerodrome landing so that he could extend the propeller.

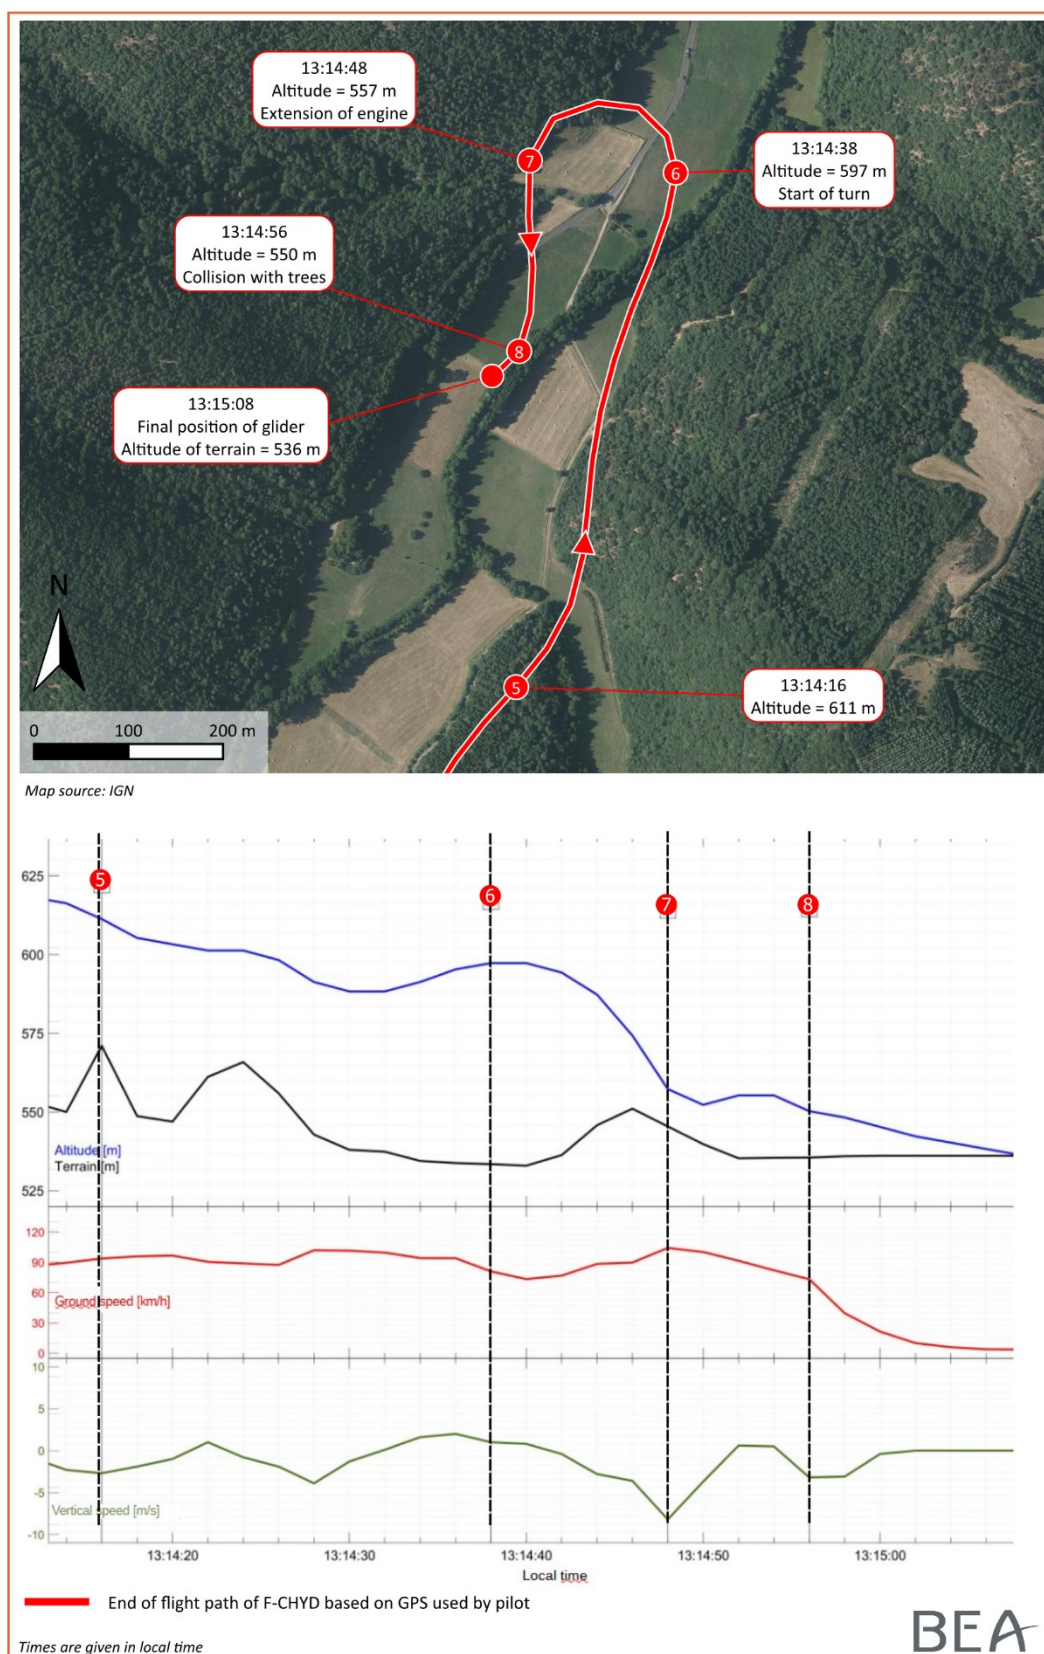
Figure 2: parameters recorded and path followed during the last five minutes of flight

He identified a field (see **Figure 2**, point ⑤), started his circuit and turned left (point ⑥). At the end of the turn, he extended the engine while at a height of around 20 m (point ⑦). Eight seconds later, the glider on the flight line collided with the top of the trees (point ⑧) and fell into a field.

The pilot started his U-shaped landing pattern. At the end of the turn and while on final at a height of around 20 m compared with the chosen field, he extended the propeller of his self-launching glider.

Before the pilot had time to start the engine, the glider struck the top of trees located before the selected field and then crashed into the trees at the edge of a field.

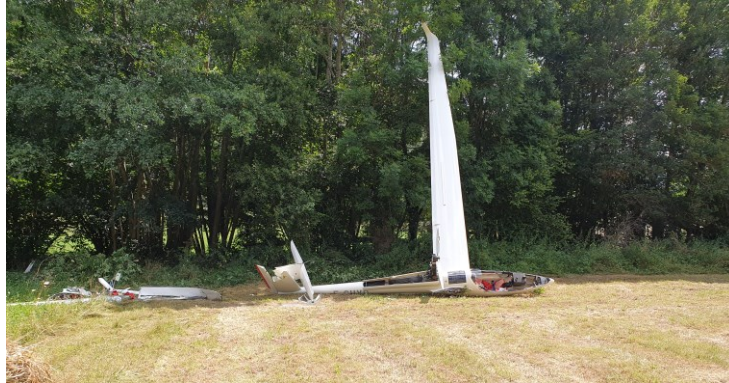
Figure 3: accident site (source: pilot)

The glider was lying on its right side at the edge of a field and of a row of trees about 20 m high. The glider's left wing was resting against the trees. The right wing was torn off, the tail fin was ruptured and the canopy was broken. The pylon supporting the engine was in the extended and locked position. Both blades of the propeller were damaged, and no signs of propeller rotation was found.
