**Accident** to the SCHEMPP HIRTH - VENTUS 2C  
registered **F-CIGJ**  
on Tuesday 22 August 2023  
close to Issoire - Le Broc aerodrome

**Pilot incapacitation while being towed, loss of control  
during final approach, collision with ground**

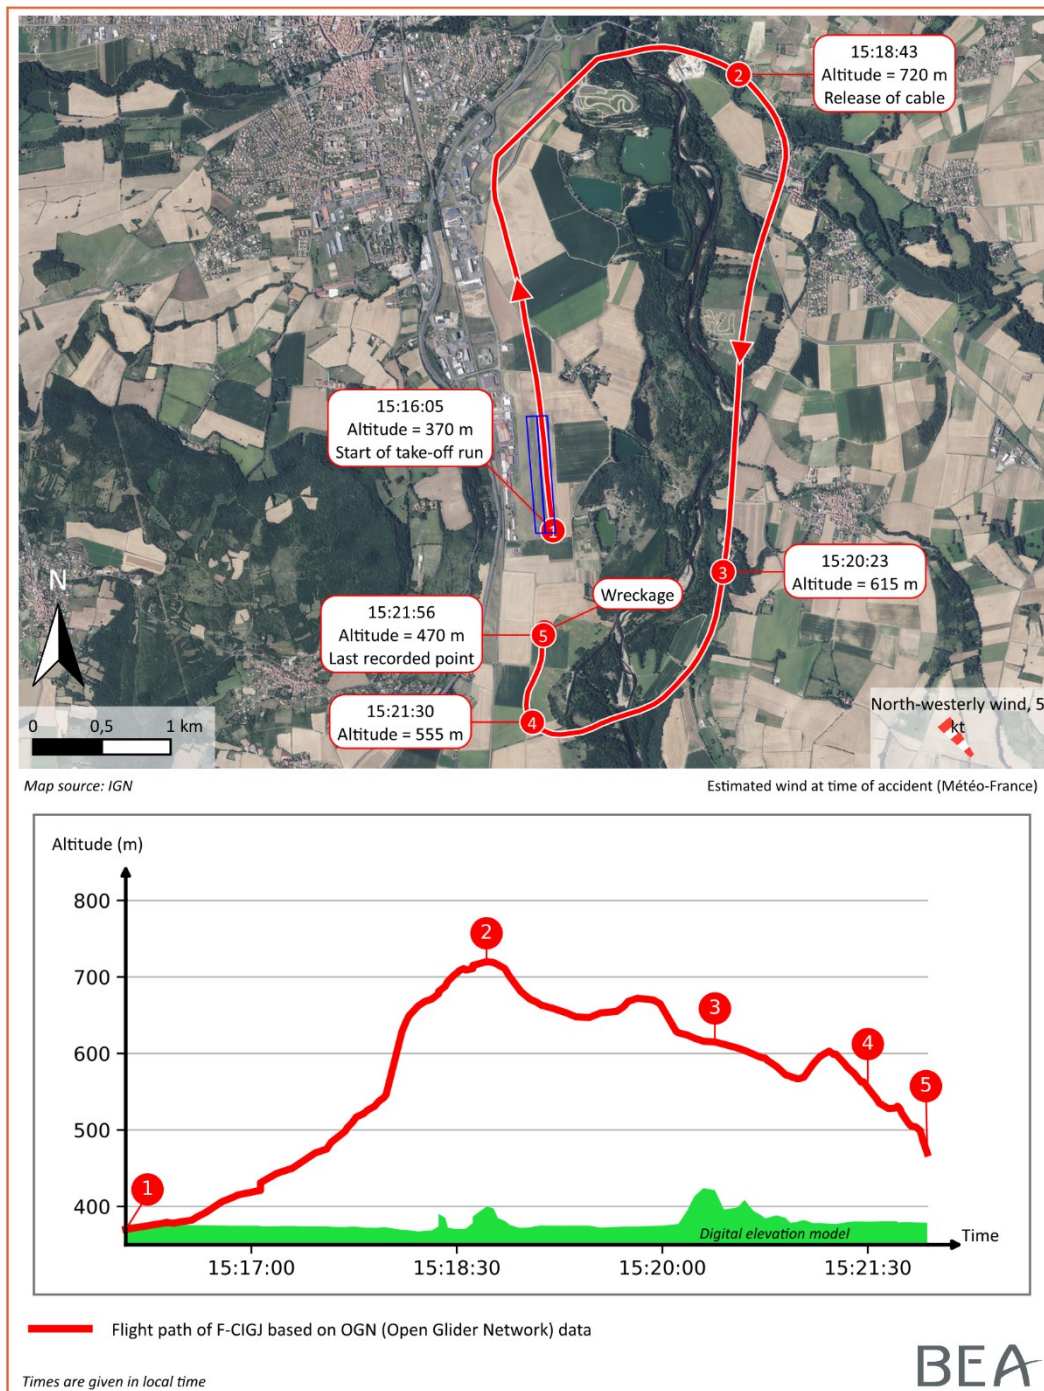
The pilot carried out a towed take-off from runway 36R of Issoire - Le Broc aerodrome. After a flight time of two minutes thirty seconds, he released the cable at a height of 350 m and headed towards the downwind leg while getting closer to the aerodrome. He turned onto the base leg and then the final approach. During the final approach, the glider suddenly nosed down and collided with the ground a few hundred metres before the runway threshold.

Figure 1: flight path of glider
