Accident to the DG500 ELAN TRAINER registered F-CILE on 7 September 2021 at Saint-Sulpice-des-Landes

Time	Around 15:05 ¹
Operator	Planeurs d'Ille-et-Vilaine
Type of flight	Instruction
Persons on board	Student pilot and pilot supervised by an instructor trainer
Consequences and damage	Glider substantially damaged

Wing tilt during winch take-off run, release of cable, collision with an obstacle on the ground, in instructions

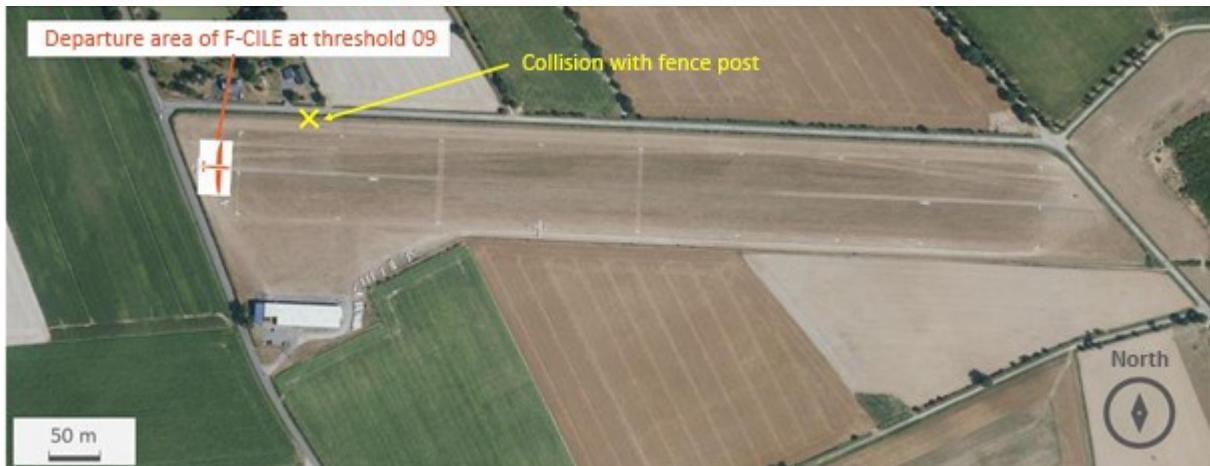
The pilot, supervised by an instructor trainer in the scope of a glider flight instructor (FI(S)) training course, and the student-pilot were ready for the winch take-off from grass runway 09. During the take-off run, the supervisor, acting as a wing runner, held the left wing of the glider horizontal by running several metres before releasing it. Approximately 10 m further on, the left wing touched the ground and the glider started to turn left. The glider speed was approximately 60 km/h. The pilot, who was at the controls, immediately released the cable using the release handle that he had already been holding. He also applied inputs on the stick and the pedals to the right, braked and extended the air brakes. The glider's path continued to deviate to the left and the landing gear wheel skidded on the runway. The glider exited the left side of the runway. The pilot was unable to prevent the left wing from striking a post of the aerodrome's perimeter fence. The glider came to a stop alongside the fence around 70 m beyond the place where the cable was released and 110 m from the departure area (see Figure 1).

Figure 1: glider departure area for take-off and position of fence post struck

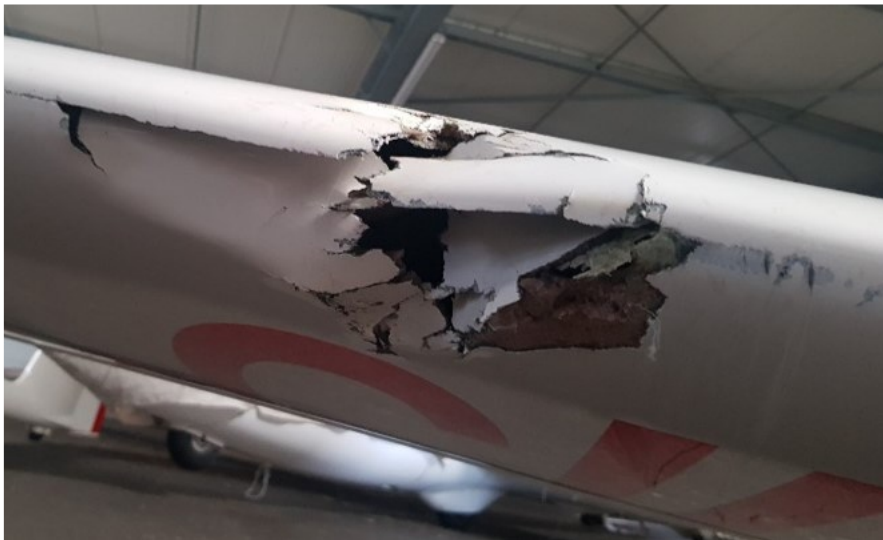
The leading edge of the left wing was damaged (see Figure 2).

Figure 2: damage on the leading edge of the left wing

During the winch take-off run, the left wing touched the ground, around 10 m after the wing runner released it, probably due to insufficient input on the ailerons to counter the effect of a gust of wind blowing from the right. The pilot in FI(S) training, who already had his hand on the release handle, immediately released the cable. This action prevented the glider from entering a ground loop or cartwheel. The glider's path deviated to the left and the glider veered off the runway. Due to the speed reached during the take-off run, as well as the proximity to a fence, the pilot's actions to counter the path deviation to the left did not allow him to prevent the left wing from striking this fence.

The pilot's grasp on the cable release handle just before the cable becomes taut, whether it be a towed or winch take-off, facilitates the abortion of the take-off as soon as the pilot detects that they cannot hold the wings horizontal in a very dynamic and short flight phase. This recommendation is now indicated at the bottom of the reverse side of the "CRIS" pre-take-off vital actions checklist, which has been standardized at FFVP club level³.
