Accident to the ROLLADEN SCHNEIDER - LS4 - A registered F-CLMF

on 25 June 2021
at Vinon-sur-Verdon (Var)

Loss of altitude after cable release in towed flight, collision with vegetation

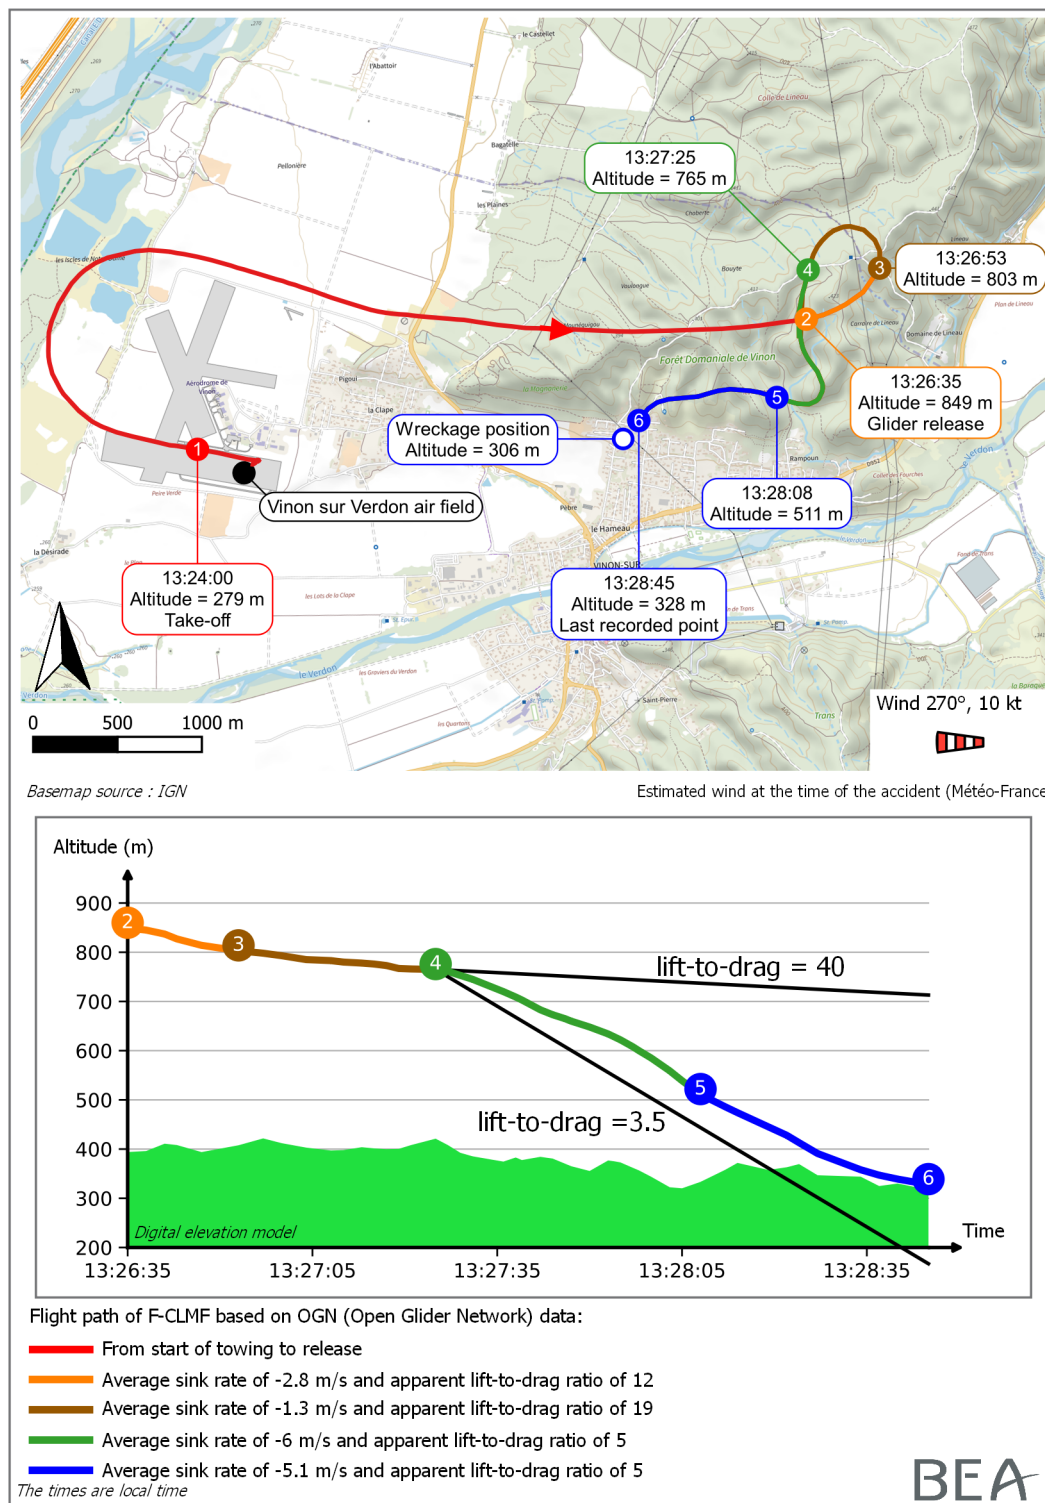
Figure 1: flight path of the accident flight

The pilot took off at around 13:25 in towed flight from runway 28 at Vinon aerodrome (Var) (see [Figure 1](#), point ❶). The combination then headed towards the glider release area located on a hill to the east of the aerodrome and to the north of the commune of Vinon-sur-Verdon. Arriving at the release area, the glider pilot released the tow cable at an altitude of approximately 850 m (see [Figure 1](#), point ❷), in the vicinity of the aerodrome⁽³⁾, and made a left turn to find uplifts (see [Figure 1](#), point ❸). The glider's altitude decreased during this manoeuvre⁽⁴⁾. While the glider was at an altitude of 765 m (see [Figure 1](#), point ❹), its rate of descent suddenly increased up to -6 m/s. The pilot continued southwards accelerating up to 100 km/h to clear the hill then, at around 13:28, he turned west towards the aerodrome to attempt to return to land on runway 28 (see [Figure 1](#), point ❺).

He flew along the north of Vinon-sur-Verdon, flying over a wooded area at a height varying between 10 and 20 m, then curved to the south west to attempt to land ahead in a field, beyond the houses. While he was flying over the first houses, the glider struck the top of the trees located on a housing estate and came to a stop on the land of one of the houses, near the house. The pilot made a radio call to the starter to report his landing in the trees. The owners of the plot immediately arrived to help the pilot.

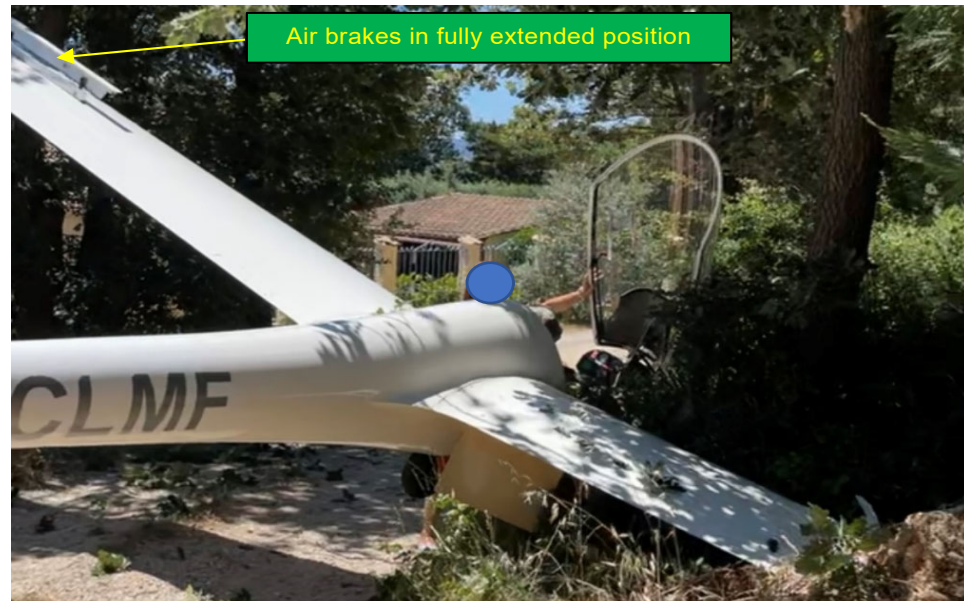
Figure 2: position of the glider just after the accident

The glider was found approximately two kilometres from the threshold of runway 28. It was lying on the front section of the fuselage and on the right wing. The right wing was broken around 1.5 m from its root as a result of the impact with a tree trunk. The photos taken by those first on the scene showed that the landing gear was extended and that the air brakes were completely extended on the left wing and partially extended on the right wing (see Figure 2).

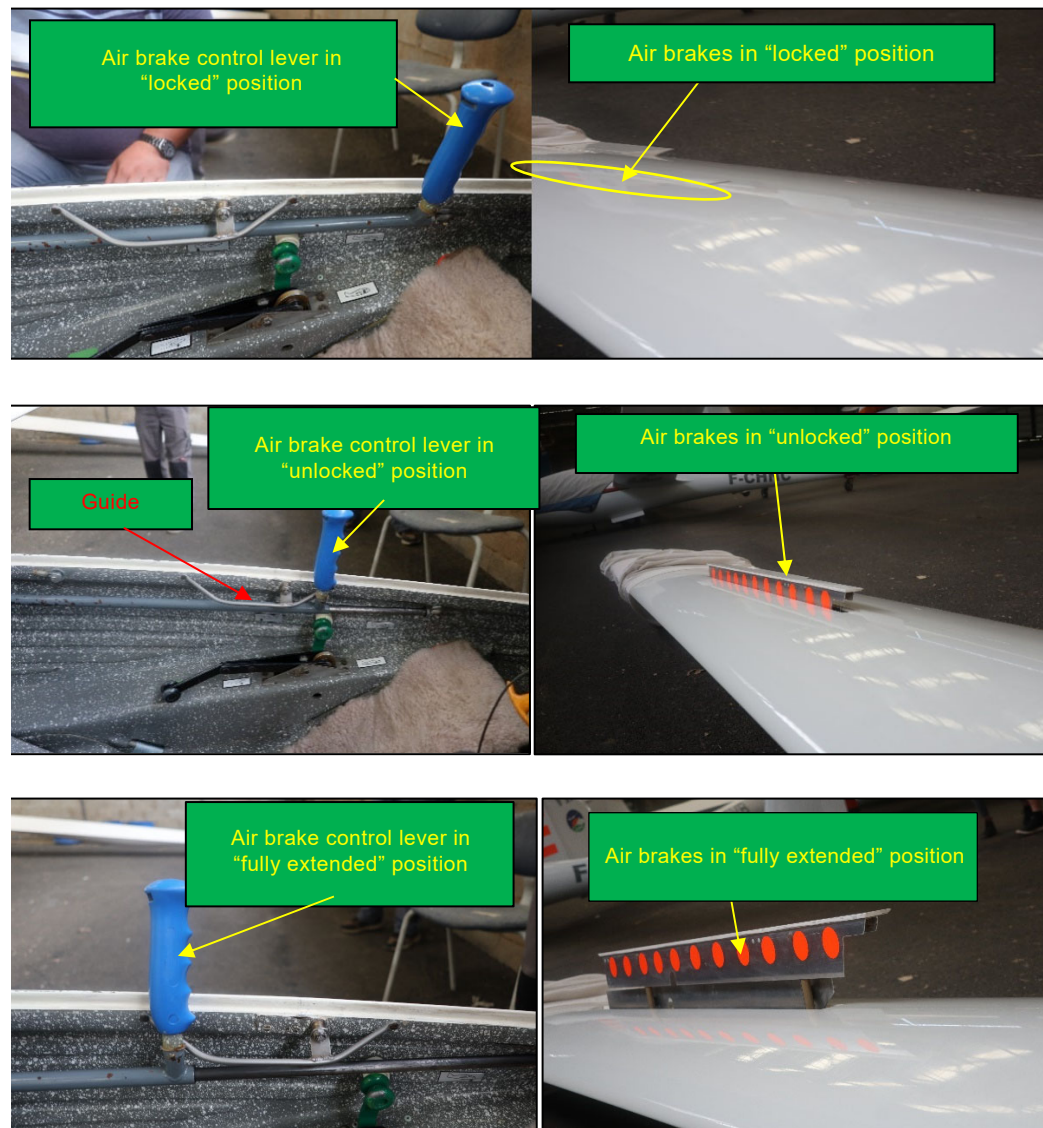
Figure 3: air brake control positions

The blue lever is located on the left, inside the cockpit. When it is pushed fully forward, the control is locked and the air brakes are retracted⁽⁵⁾. When the control locks, the springs inside each air brake hold it against the upper surface of the wing. Two pictograms conforming to the flight manual were present in the cockpit to identify the corresponding positions of the lever. Red circles on the air brakes visually signal their deployment to the pilot. To unlock the control, the lever needs to be pulled backwards with a certain amount of force; this partially extends the air brakes (red circles partially visible). To completely extend them, the pilot must continue to pull on the lever that shifts by sliding along a guide, to prevent any interaction with the canopy release knob (see Figure 3).

The AAVA's chief-pilot explained that on an LS4-type glider, when the air brakes are unlocked in flight, they will only extend partially under a negative load factor and retract on their own if the pilot releases the control lever. When they are fully extended, they will not retract unless the pilot manually moves the lever forward to clear the guide. He also explained that

After the cable release, when he wanted to retract the landing gear, the pilot very likely operated the air brake control instead of the landing gear control.

He thus positioned the air brake control aftward in the “air brakes extended” position. Observing an unusually high rate of descent, he supposed that the glider had entered a descending air mass. He focused on the marked deterioration of the glider’s performance and did not check the position of the two levers, nor that of the air brakes on the upper surface of the wings.

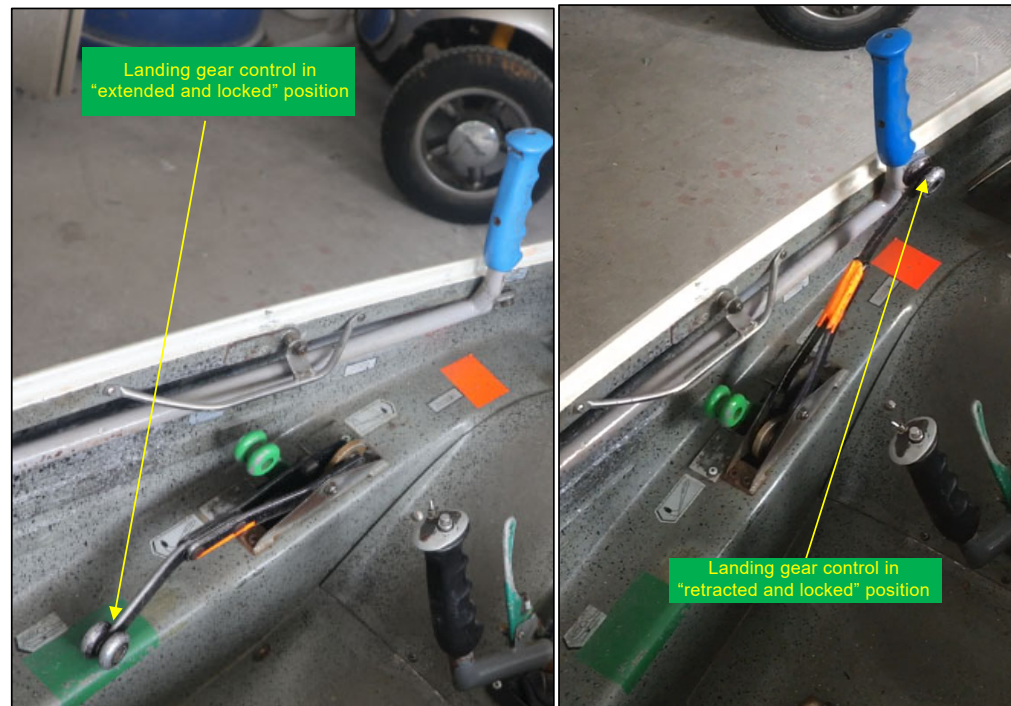
Figure 4: landing gear control positions

The manufacturer's flight manual specifies that when the lever is pushed fully forward, the landing gear is retracted and locked. When the lever is in the fully aft position, the landing gear is extended and locked. The F-CLMF flight manual used by the AAVA describes the operation of the landing gear control incorrectly by indicating the opposite. However, two pictograms conforming to the manufacturer's flight manual indications were present in the F-CLMF cockpit as a reminder of the two positions of the landing gear, and the AAVA had added green and orange labels to avoid any confusion⁽⁶⁾ (see Figure 4).

⁽⁶⁾ Green label aft for the landing gear extended position, orange label forwards for the landing gear retracted position.
